POST OCCUPANCY EVALUATION

KIMI ORA SCHOOL NAENAE, UPPER HUTT

June 2016

Date: June 2016
Reference: 1-46083.00
Status: Final

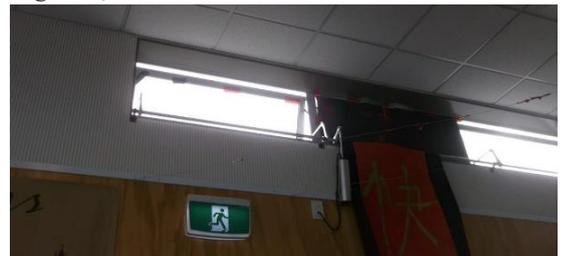
Figure 5

- Window control are simple and easy for staff to operate. Window controls are a combination of automatic/powered for openings at height, with manual controls for lower level windows. See the louvres and automatic winders in Figure 5.

- Windows control for the high level louvres are electrical with no manual override. When a power failure occurs the windows are unable to be closed. See Figure 5.

- Install a means of closing the main entry door and high level ventilation louvres in the event of a power outage. The current systems rely on electricity, and the windows and the main entry are unable to be operated at all during loss of power. The main door is more critical due to the building not being secure after hours, and the installation of a UPS (Universal Power Supply) to provide backup power to the door for a few hours could resolve this issue. Manual winders to high-level windows would be more resilient control system.

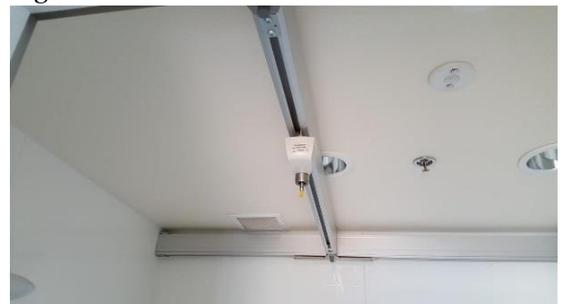
- All toilets throughout the school accommodate high dependency users. Staff report that access to the toilets and the facilities within are of a good standard. The bathrooms meet NZBC requirements for accessibility. See Figure 6.
- The High Dependency Spaces each have a power outlet located appropriately for a hoist. Emergency call/panic buttons are installed. There is an additional power outlet adjacent to the WC, both RCD protected. These aspects are in line with the MoE Guidelines. See Figure 7 and Figure 8.

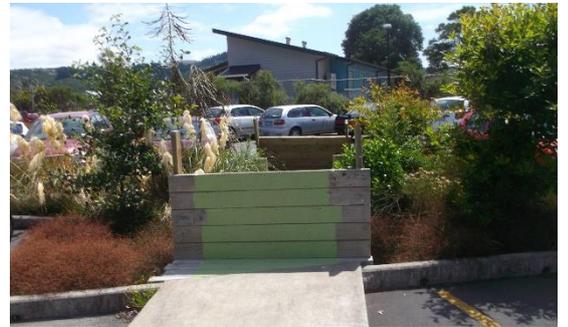
- The wooden bridge over the landscaping in the carpark was designed to provide a shorter route from staff car parking to the main building entrance. Staff considered this bridge unsafe and the school subsequently closed access to it. Staff report that the bridge would frequently ice over and its surface offers limited grip underfoot, which is of particular concern when bringing resources into the school during inclement weather. See Figure 9.

- Early into the occupation of the school the wooden access bridge over the landscaping in the carpark was deemed unsafe. Cold mornings would see a build-up of ice on the bridge, and the lack of slotted surface or sufficient tactile tread meant underfoot grip was insufficient. The school maintenance staff applied a grit paint over the surface, but this was ineffective so the school resolved to block the bridge off. See Figure 9 and Figure 21.

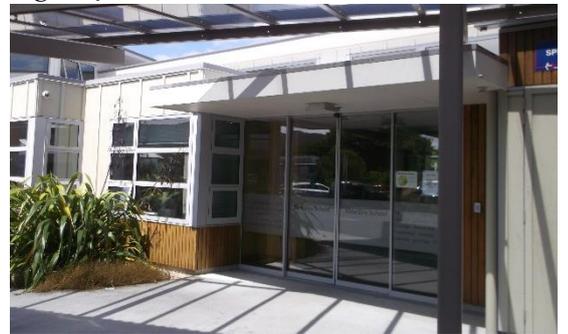
Figure 10

- The main entry doors have required considerable maintenance and up keep. Staff report that the doors continually keep breaking and are very expensive to have repaired. See Figure 10.

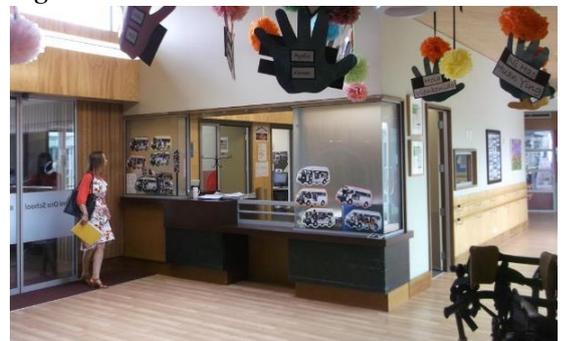
Figure 11

- Teachers report that the hot desk room behind reception (which is intended as the teacher workspace) has insufficient noise suppression. The lack of enclosure between the circulation areas the reception and teacher work space, as well as how loud many students at the school are, means that this becomes a very noisy and disrupted space. See Figure 11. The school is considering enclosing this area and implementing sound proofing. See Figure 11.

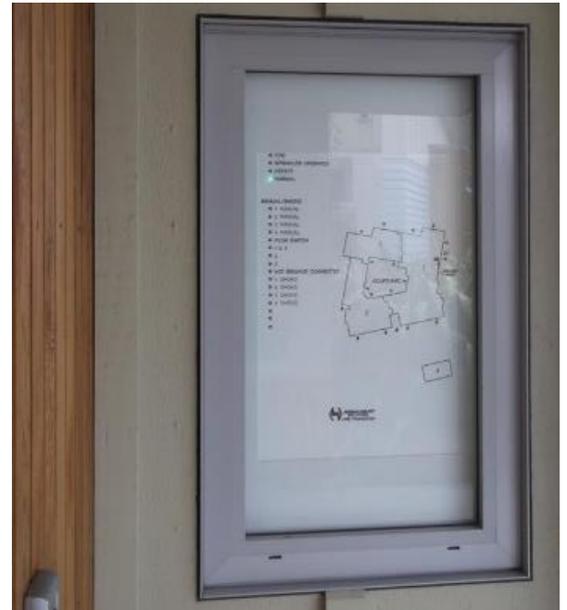
Figure 18

- The building is well equipped to warn occupants of an emergency event. The building has a zoned fire detection system – see Figure 18. An alarm sounds to notify occupants of an emergency. Sections of the building are able to be closed off in a fire event to control spread of fire. There were some initial faults with the automated fire curtain system early into occupation, but these appear to have been resolved during the defects period.

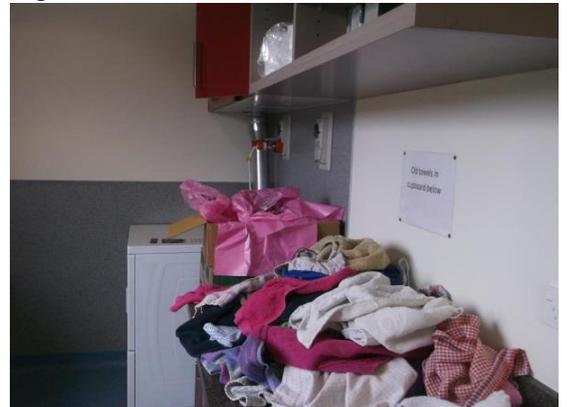
Figure 19

- Power outlets throughout the school have Residual Current Device (RCD) protection installed as required by MoE guidelines.
- Toilets are effectively ventilated through a mechanical system. Discharge from the clothes dryer is adequately flued. Both spaces are ventilated. See Figure 19.

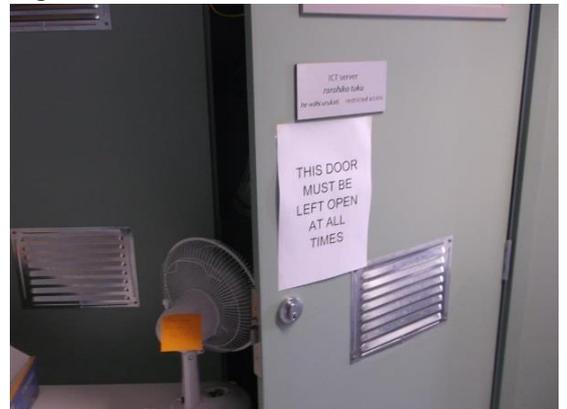
Figure 23

- The network server for the school is located within a non-air conditioned cupboard in the staff room. The door does have the recommended vent, but the cupboard has become a fire risk due to overheating. The cupboard doors have to be left open to provide enough ventilation to keep the equipment cool, which is against MoE guidelines for requirement for two layers of lockable security for ICT equipment, and results in the staff room getting overheated. The staff have placed a desk fan in the doorway to provide cooling, but a more permanent solution is required. See Figure 23.

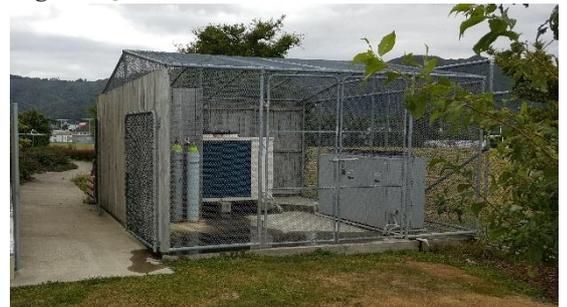
Figure 24

- External building services are behind lockable service cages/enclosures which are suitably located to avoid impeding circulation around the site, as required in the MoE Guidelines. See Figure 24.

- The heat pump installed on site lacks a floor/ground drain. As a result condensate pools around the units. This is unsightly, promotes algae growth and can become slippery. See Figure 24.

- The heat pump for the underfloor heating (water heating) has been functioning well, following some initial problems. See Figure 24. The heat pump required replacement early into occupation as it was frequently icing over and failing. The pool is maintained by staff, with compliance testing undertaken by an external contractor.

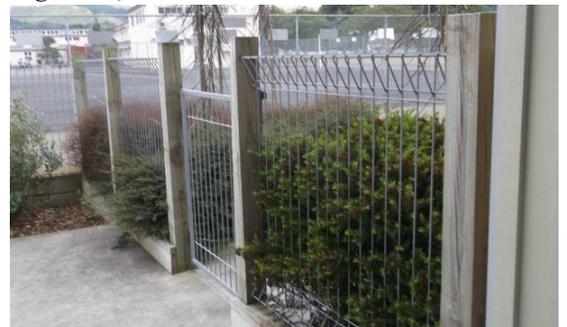
Figure 25

- The only exception to good quality fencing mentioned by staff was the gate and fence at the northwest of the site adjacent the multipurpose space and main vehicle entry/exit. The gate is too low which staff advised had been a repeated issue for students that like to climb and leave school grounds. See Figure 25.

- Consider replacement of the fence and gate at the north-west corner of the grounds with one that is taller and prevents students from being able to climb over and leave the grounds unsupervised. Staff identified this gate as a concern from an H&S perspective as the gate is climbable, and there is minimal oversight to it from adjacent areas.

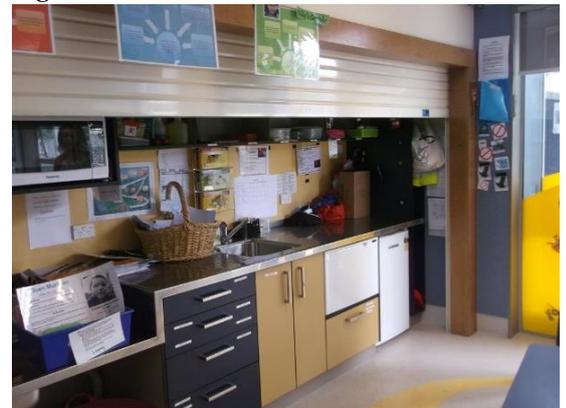
Figure 27

- Lockable roller doors are in place to close off kitchenette and computer desks within the learning spaces to protect equipment. See Figure 27.
- The school has hydro-pool for physical therapy. According to staff the pool facilities work well for the users, aside from the room temperature (noted overleaf). See Figure 28 .

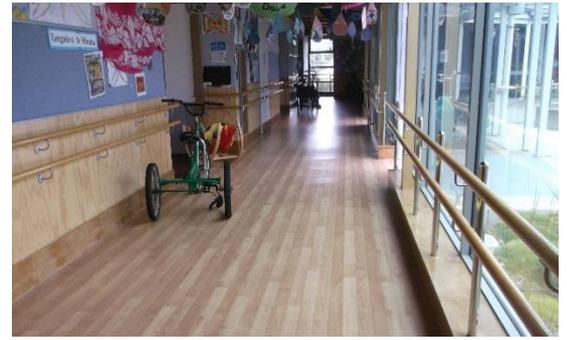
- Internal linings within the school have stood up well to impacts and general wear. Minor maintenance has been required, but this has been as per expectation (caused by scrapes from wheelchairs and general use). Hard-wearing impact resistant materials (such as plywood) have been used for skirting boards and linings. See Figure 38 of the linings in the circulation routes.

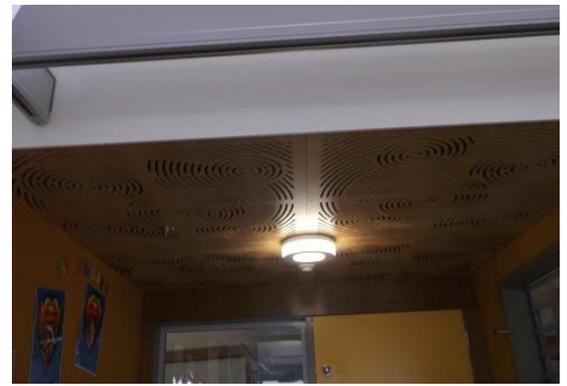
Figure 47

- The staff report that the specialised architectural lamps in the entrance are aesthetically pleasing, but the bulbs are very expensive to replace in comparison to similar more common light fittings. The bulbs originally fitted to these lights were extremely expensive, so the school found an alternative bulb they could substitute to bring the cost down. This alternative bulb is still expensive in comparison to that for standard lamps. Standardised fittings, or specification of lamp with lower replacement cost would be less onerous for the school to maintain. See Figure 47.

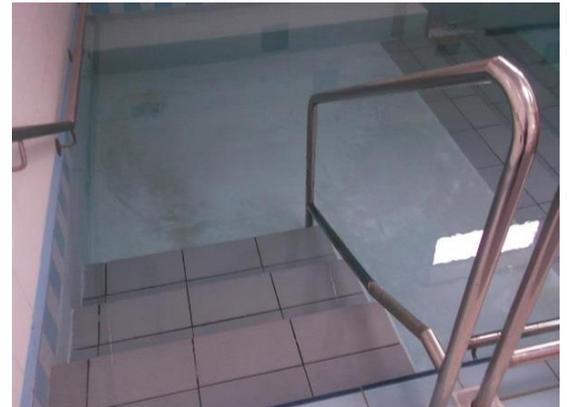
- The floor of the pool was replaced in 2014 due to advanced degradation, and at the time of survey the lining appeared to be failing again. The liquid-applied plaster type lining is chipping and flaking, and these particulates go through pump system and cause damage. The staff have reportedly had some difficulty in getting the firm responsible for the pool to respond to these issues in a timely manner. See Figure 49 showing the degrading pool floor.

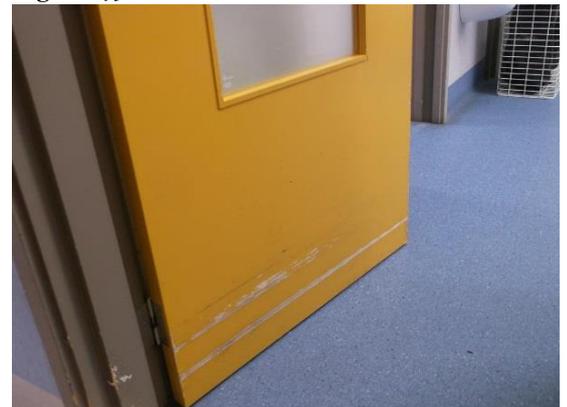
Figure 50

- There are a few isolated oversights in of high traffic areas where impact protection and hard wearing linings have been missed. These are uncommon throughout the school, but these items will have a higher maintenance requirement. See Figure 50.

- Install impact protection to doors and walls on the circulation route where they have been missed in the design. Staff noted a few areas where the impact-resistant lining and fittings (doors, missing kick-plates, etc.) had not been carried through in circulation routes, and these were evident by the signs of damage on these.
