POST-OCCUPANCY EVALUATION REPORT

TKKM O TAUMARUNUI

TAUMARUNUI | FEBRUARY 2016

DRAFT REPORT

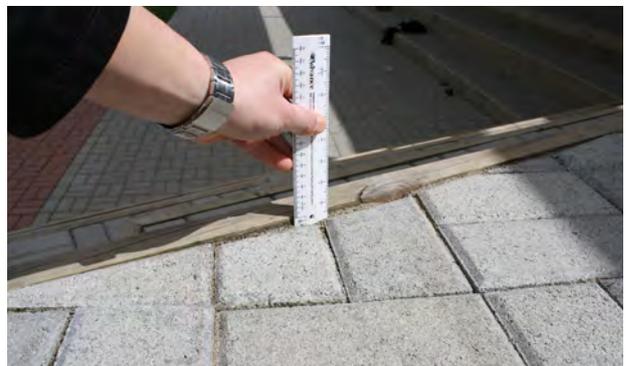
The staff member who completed the survey stated that the finishes were 'unsafe' due to 'the paving to the entertainment stage being slippery in cold and frosty weather'. The evaluation team did not observe this slip-hazard as it was a fine, warm day. The evaluation team did observe however that those pavers had slumped in areas. Staff stated that the slumping had caused a trip hazard, therefore it is recommended that the pavers in this area are lifted and re-set.

Pavers have slumped creating a trip-hazard

7. The pavers of terraced steps, which surround the outdoor learning area, have slumped and the timber risers have formed a trip hazard. This terraced area is relatively high and steep, therefore it is recommended that these pavers are relaid level with its timber risers. If this is not possible for any reason, we recommend that the top section of the timber riser should be replaced with concrete to overhang the riser. Further investigation is required in order to provide a safe and long term solution.

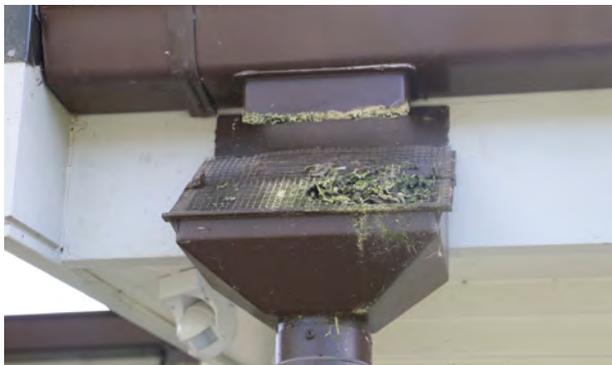
The roof and gutters collect water for re-use. The water tank has a town supply back-up. First-flush divertor's are located at the top of the down pipes which offer a good solution for removing debris, and helping with maintenance.

Potable water system requires the gutters to be cleaned regularly

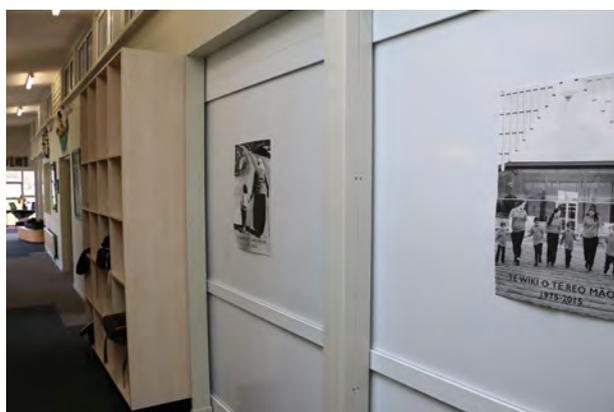
During the interviews it was stated that the interior sliding doors in the learning environment required track realignment from time to time. Future design teams should give consideration to the specification of doors, their size and their associated hardware. The internal sliding doors have been replaced with smaller ones in the hope that they will function better. This is an ongoing maintenance item for the kura.

Internal sliding doors

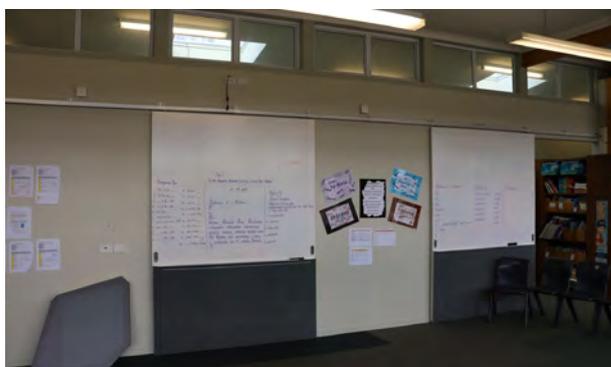
When the white board doors are closed it minimises the cross-ventilation

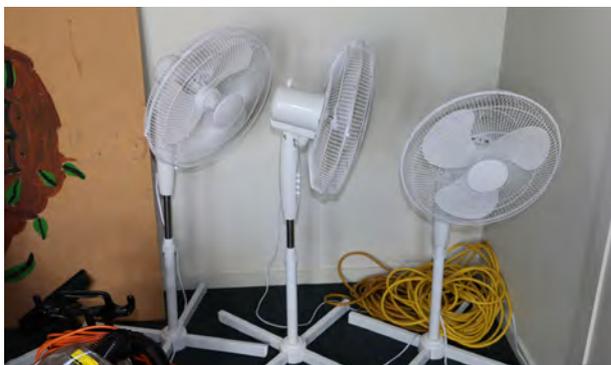
The survey respondent stated that they had ‘little control’ of the heating and cooling in their space. They also stated there was ‘insufficient cooling’ in their learning space. The kura has attempted to mitigate the over-heating of the space by purchasing mobile floor fans which are used extensively in the learning environments during the warmer months.

Kura uses floor fans in the learning environment to help cool the spaces

6. The natural ventilation system does not provide sufficient cooling in the warmer months. The evaluation team recommend that additional external solar protection is installed on the north facing windows of the learning environments in order to reduce the heat-gain in the space. In addition, a more effective cooling strategy, which includes both passive and active systems, is recommended.

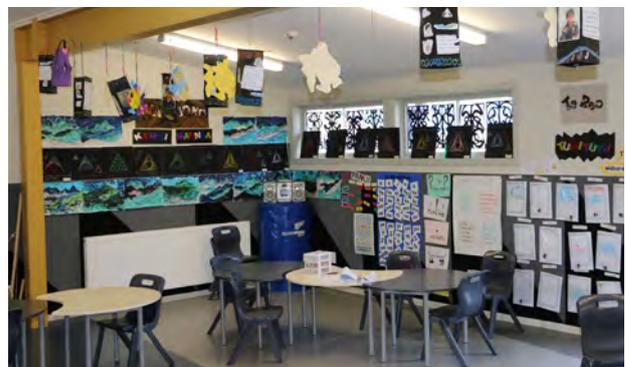
The evaluation team noted that the acoustics of the learning spaces could have the ability to become quite 'lively' when at full capacity due to the plaster board ceilings, volume of glass and limited acoustic absorbing material on the walls and ceilings. This could be a particular issue within the Wharekura learning space when two classes are working simultaneously. During the interviews staff stated that they found the Wharekura space difficult to teach in at times due to the poor acoustics.

Lower ceilings and a limited amount of acoustic panelling in the Waenga teaching space

2. Staff who taught in the Wharekura learning space expressed that they found it difficult to deliver their pedagogy due to 'poor acoustics'. Although additional acoustic panels had been installed by the kura, the evaluation team recommend that an acoustic engineer undertake diagnostic testing.

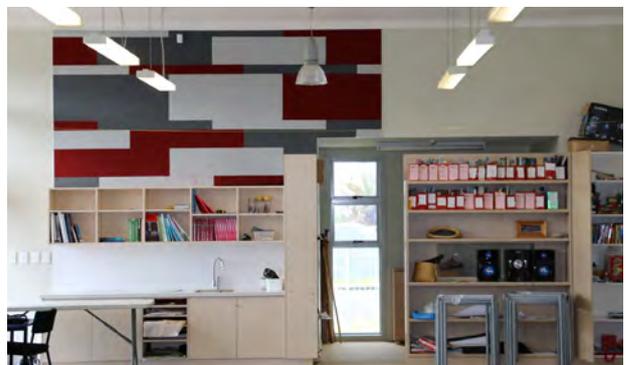
Limited acoustic pin board in learning spaces

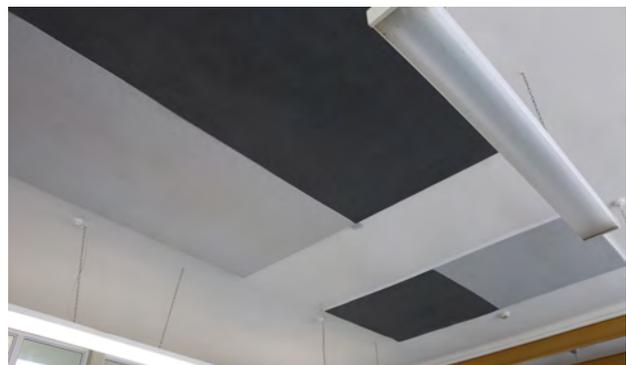
The survey respondent, when asked to rate the acoustic environment of their classroom, stated that it was 'poor' and it 'echoes'. The respondent stated that distracting 'noise from other classes' was also an issue. Since opening, the kura have installed additional acoustic wall and ceiling panels, however, the evaluation team recommend an acoustic engineer provide specialist advice on each space.

New acoustic panels installed in the Wharekura learning space

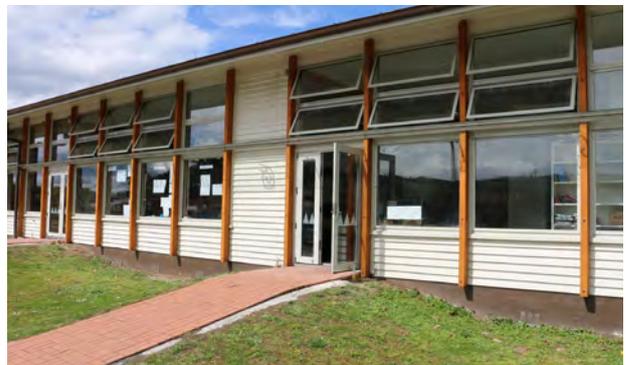
As the Tuakana and Wharekura learning environments are exposed to large amounts of north facing glass, additional solar protection should be provided. The Waenga and Wharekai learning spaces are south facing and generally rely on artificial lighting. The withdrawal spaces offer a small amount of transparency, however it is inadequate to allow sufficient natural light into these rooms. The evaluation team found these withdrawal spaces to have a below-average volume of natural light. It is not known if this was a requirement of the kura based on the pedagogy.

Large amounts of north-facing glass with limited solar protection

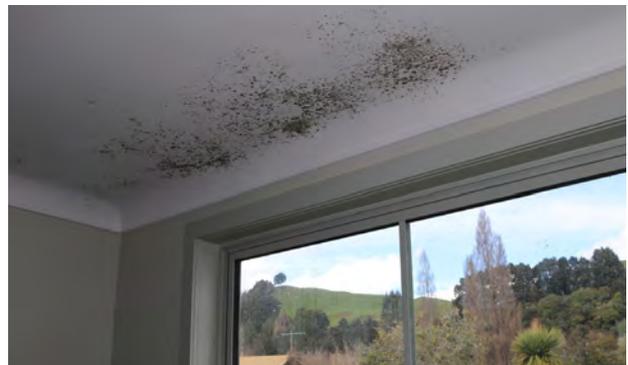
It was stated during the interviews that the kura experienced issues with the ICT facilities post hand-over. The kura particularly expressed the problems affecting the ICT in the dedicated video conference room, housed within a refurbished room within the learning environment. Considerable mould was visible on the ceiling and was deemed unsafe to use at the time of our evaluation.

The survey respondent stated that the ICT is 'effectively' positioned for teaching and learning. During the interviews it was stated that the school experiences power surges which can affect the security and IT system's. The kura had installed a battery back-up to ensure servers would continue running if a surge occurred. It was also stated that they had limited access to local technical support. The evaluation team recommends that further investigation is carried out to better understand the ICT issues of the kura before recommendations can be made. In addition, the video conference room should have a construction report completed to understand the cause of the mould as it does not appear to be a ventilation issue.

Mould is present in the video conference room

5. There was considerable mould present on the conference room ceiling which cannot be used by the kura in its present state. A comprehensive construction report of this area is recommended.

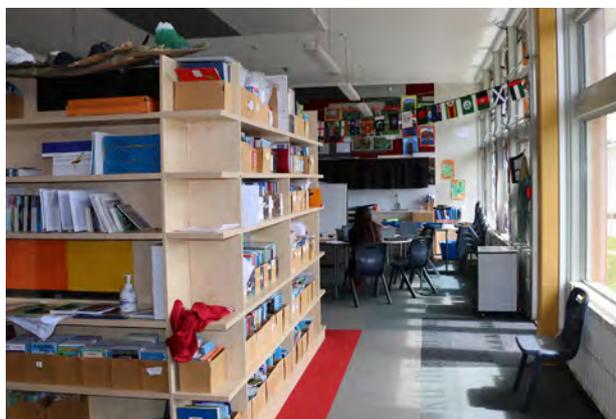
1. The 'learning spaces are too hot' due to the large volume of glass
2. The design of the 'kura represents our unique culture'
3. The 'poor acoustics make it difficult to teach in at times'.

The learning environment over-heats in the warmer months
