POST OCCUPANCY EVALUATION

TE KURA MANA MAORI O WHANGAPARAOA, NEAR OPOTIKI

May 2016

Date: May 2016
Reference: 1-46083.00
Status: Final

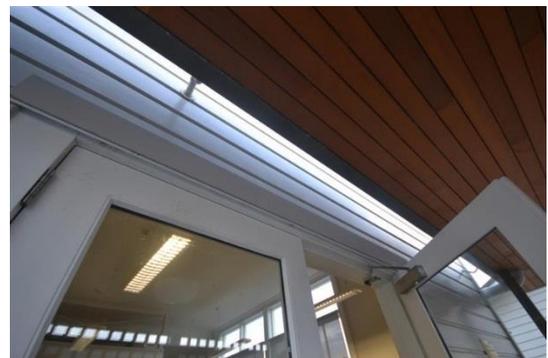
Figure 10

- The canopy above main entrance is not adjoined to building nor appropriately weatherproofed. Rainwater drips down near front entry door on wet days- see figure 10. This is being addressed by the addition of a flashing between the building and canopy.

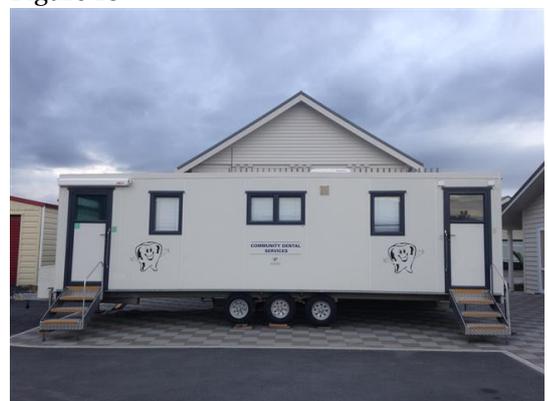
Figure 11

- The approach to the school entrance is partially obscured due to the positioning of the service connections for the temporary dental bus. This reportedly makes wayfinding for users less than obvious at times when the dental bus is on site, which is reportedly a few days per month. See figure 11.

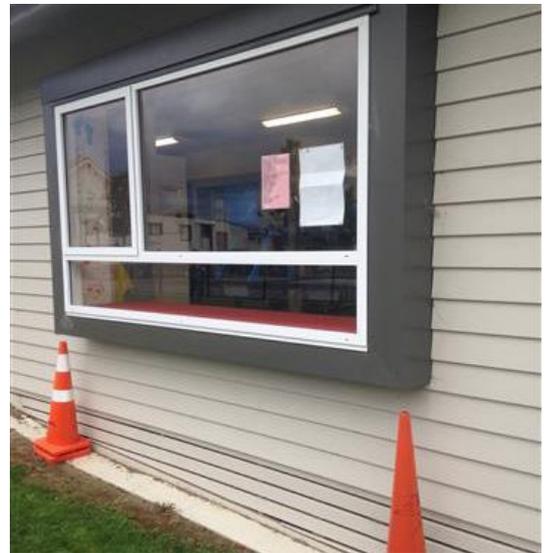
Figure 15

- The boxed windows to Block C protrude out of wall at a low level. The sharp edges and corners are hazardous. Staff report that this has caused accidents and currently traffic cones are placed beneath the window to warn pupils. See figure 15.

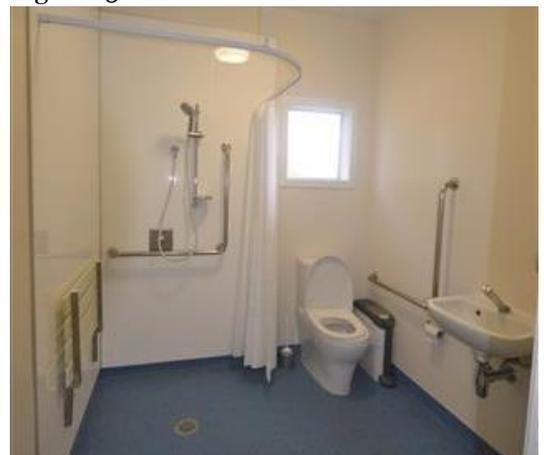
Figure 16

- The internal bathrooms are on exterior walls yet natural ventilation is not provided. The windows are fixed panels at a high level and could be openable to provide natural ventilation. See figure 16.

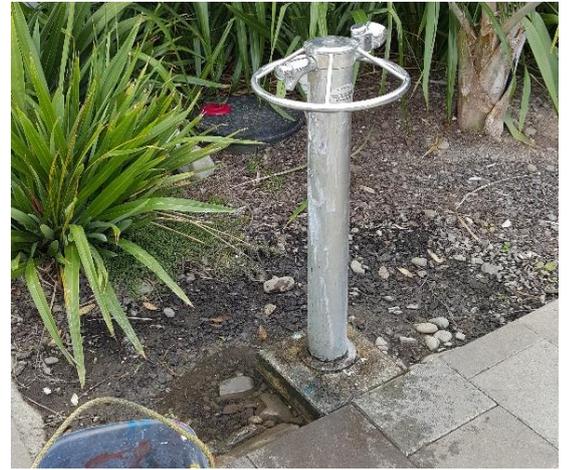
Figure 27

- There are two drinking fountains which the school staff believe to be an insufficient number due to their frequent use. See figure 27.
- Although heating and ventilation systems meet MoE guidelines, staff report that they do not cope as well in hot summer temperatures.

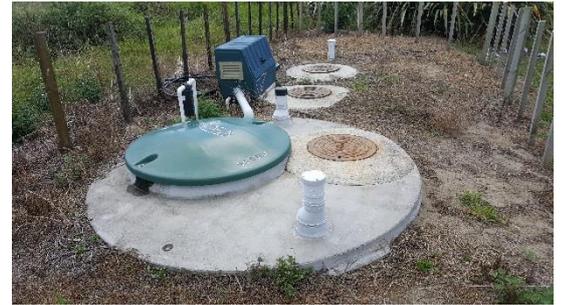
Figure 32

- The head of school commented that the site's waste treatment plant has been problematic, with the need for continuous maintenance. See figure 32.
- The head of school reported that it is the responsibility of the School's staff to manage the maintenance regime of building services systems, however relevant training and information was lacking.

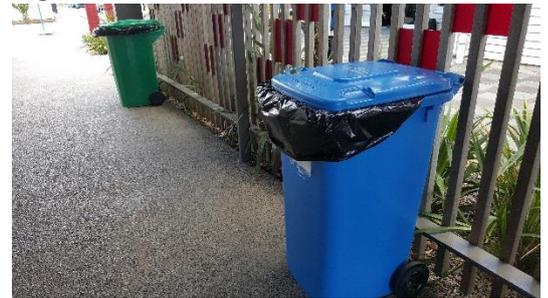
Figure 33

- There is no enclosure for the rubbish storage. Waste storage is completely exposed, which staff advise is less than ideal given the weather/wind in the area. MoE guidelines suggest but do not specifically require a rubbish enclosure, however without it this area is likely to become untidy. See Figure 33.
