POST OCCUPANCY EVALUATION

HOBSONVILLE POINT PRIMARY SCHOOL, HOBSONVILLE POINT, AUCKLAND

Date: July 2015
Reference: 1-46083.00
Status: Ver 10

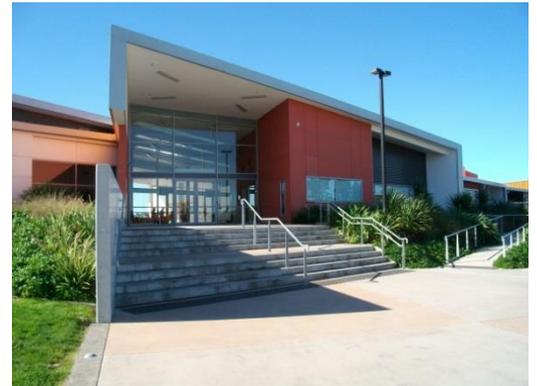
Figure 5

- The main entrance located adjacent to the road intersection is welcoming and directly connected to the pedestrian pathway from steps or side ramp. See Figure 5.

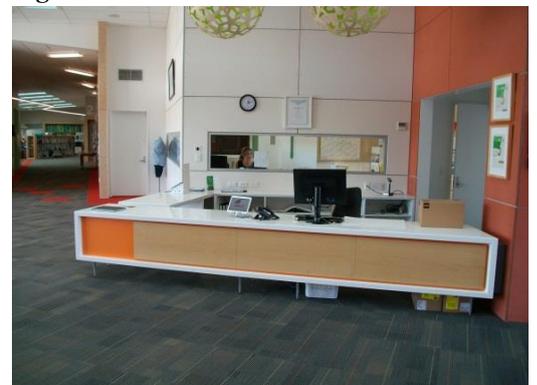
Figure 7

- The reception has space for both visitors and students. See Figure 7.
- The cafeteria is adjacent to reception and has a delivery entrance located to the rear with access from the road.

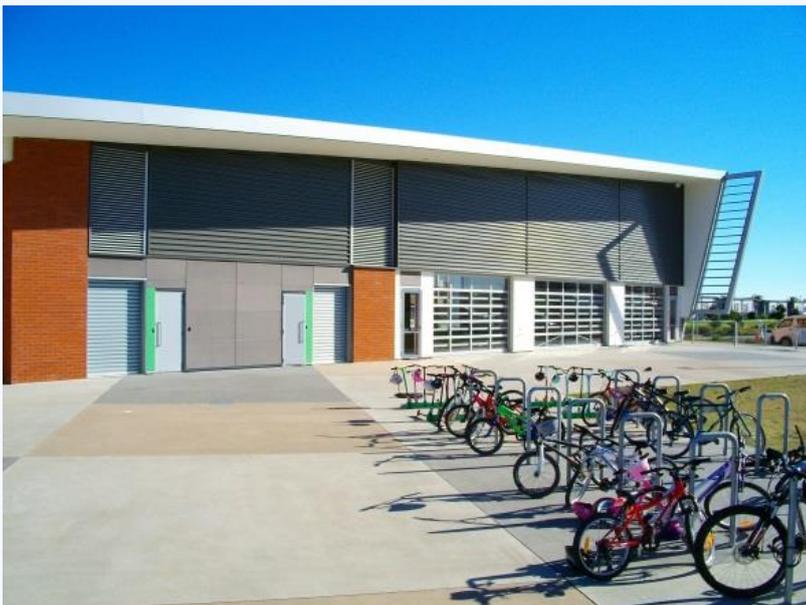
Figure 4 - Paved area and bicycle parking.

- Scooter and bicycle racks located at the rear of the building are accessed from the pedestrian pathway through a side gate. See Figure 4.
- The site has easy pedestrian access to all areas of the building and grounds including the rear playing fields.

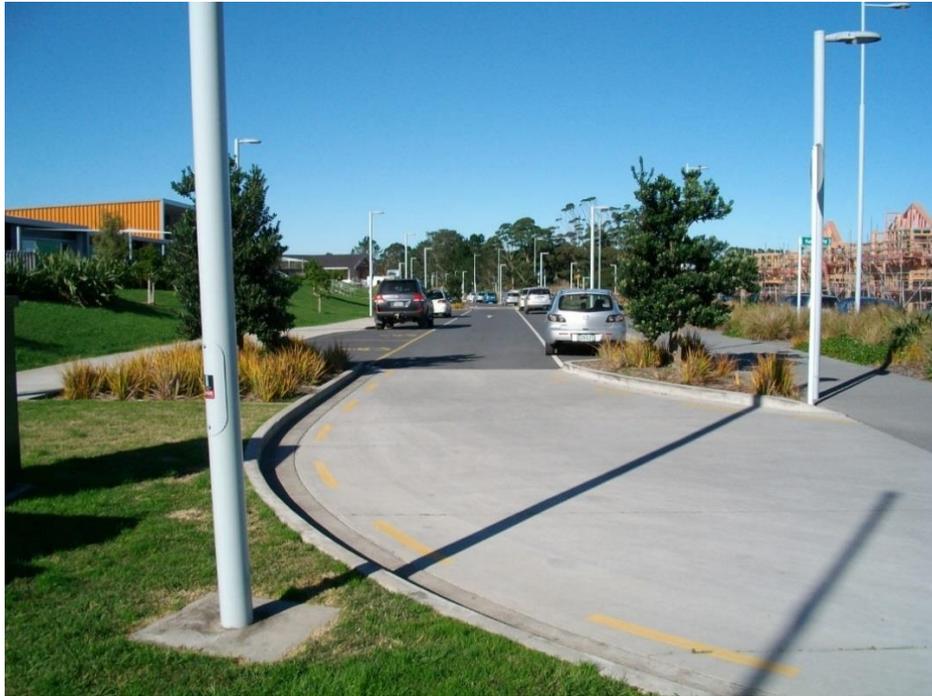
Figure 9 - Pick-up/drop-off zone

- Visitor car parking and drop off area is in close proximity to the main entrance. See Figure 9.
- Staff car parking is located to the rear of the site with ramp access to the grounds.

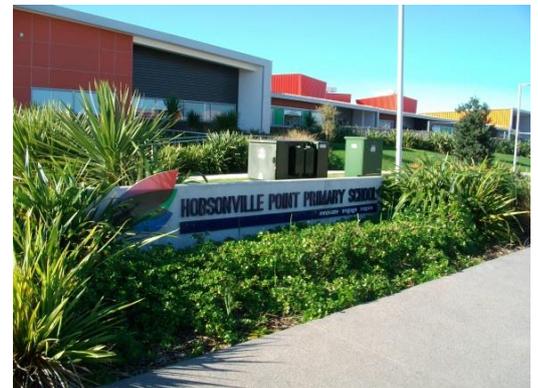
Figure 10

- The signage for the school is easily overlooked as it is mounted too low to be visible from the road and obscured by planting. See Figure 10.
- Visitors frequently attempt to enter the secondary entrance located in the middle of the building as it is more prominent along the road front. Provided to accommodate student access when the school is at full capacity it remains locked at all times as it is unmonitored. See Figure 11.

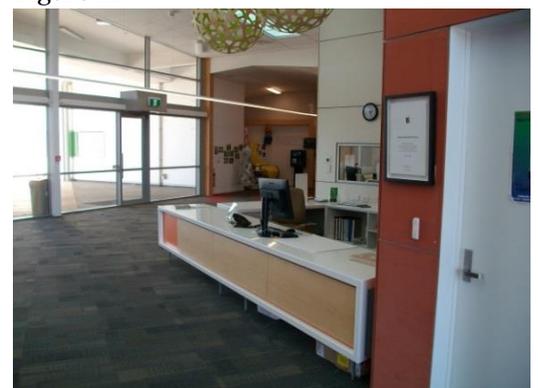
Figure 12

- The main entrance initially had automatically operating doors opening into the prevailing wind, manual doors have been retrofitted to mitigate the wind tunnel impact on reception. In strong wind conditions the main entrance doors are locked and visitors directed to the rear courtyard entrance as the manual doors cannot be safely operated. See Figure 12.

- The irregular building form and raised playing field prevents visual access to significant areas of the grounds. See Figure 13.
- Reception is located behind a meeting room without direct visual access to the main entrance and is rarely used with staff located in the administration area behind. See Figure 12.

Modify the building to protect the main entrance from strong wind conditions and to secure regular teaching spaces when facilities such as the Multipurpose Hall Space are being used after-hours.

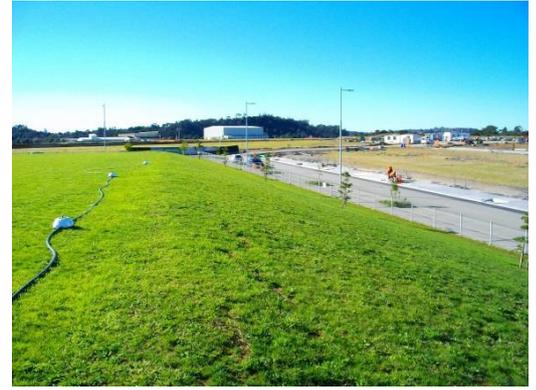
Figure 13

- Galvanised metal fencing to the entire site provides separation of the grounds and the road, and the grounds are overlooked from the road. See Figure 13.
- Galvanised metal fencing within the grounds provides effective separation of vehicle areas from play areas. See Figure 14.
- Play equipment has safety mat surface. See Figure 15.
- External lights illuminate exterior doorways.
- Mechanical plant is roof mounted with access restricted to specialist contractors.
- Mechanical extraction is installed at point of source in Food Technology and to the dedicated photocopy room in Administration and to fully enclosed student toilet cubicles located between learning areas.

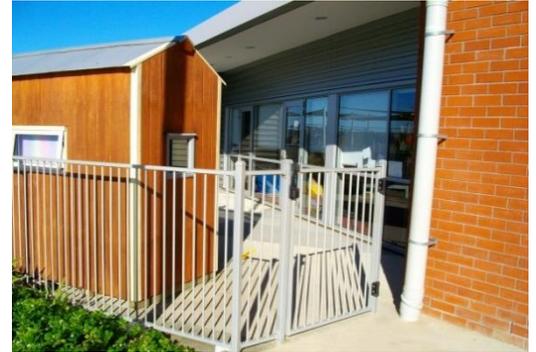
Figure 14

- The extensive fencing segregating outdoor learning areas is unsecured with a gap to the wall suitable for student egress. See Figure 14.
- Unsecured and unmonitored side access gates allow student access directly onto the main road. See Figure 17.

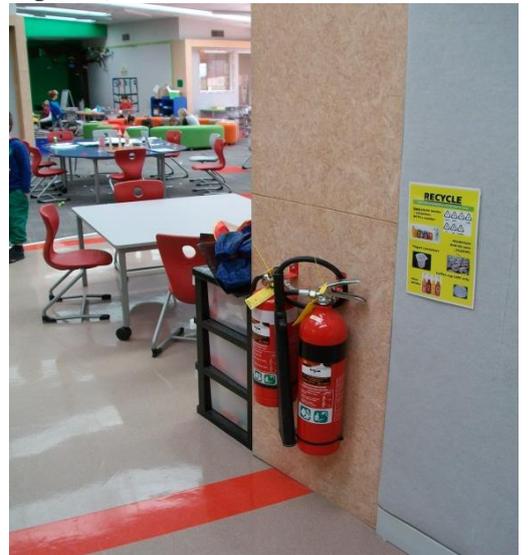
Figure 18

- Emergency equipment protrude into circulation areas. See Figure 18.
- Student toilets are unisex fully enclosed cubicles with no visibility for monitoring. See Figure 18.

- The fully enclosed unisex student toilet cubicles, heavy doors and lack of emergency lighting and lack of staff visibility for monitoring, are a serious hazard for safety in an emergency, an alternative solution should be developed and implemented.

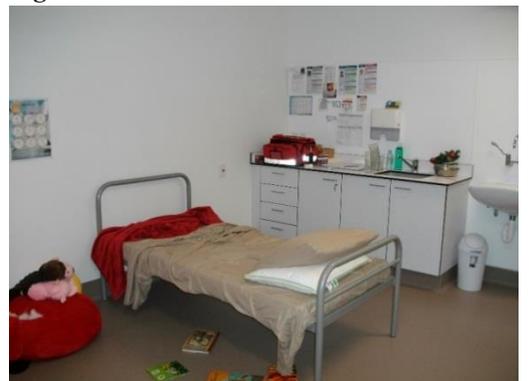
Figure 19

- Health Space is provided with sink and hand washing amenity but no toilet. See Figure 19.
- A washing machine and dryer retrofitted in a cleaners' cupboard located adjacent to the High Dependency Space and Multipurpose Hall Space has no dedicated fan extraction.

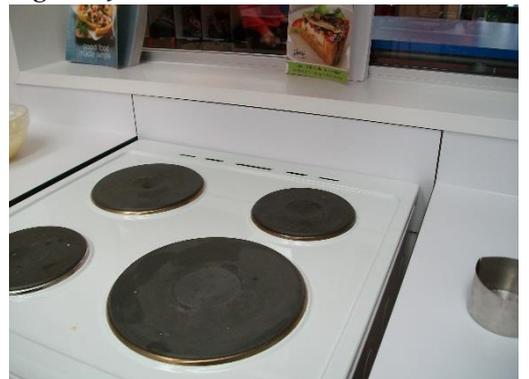
Figure 20

- Food technology does not have adequate heat resistant surfaces located adjacent to stoves. See Figure 20.

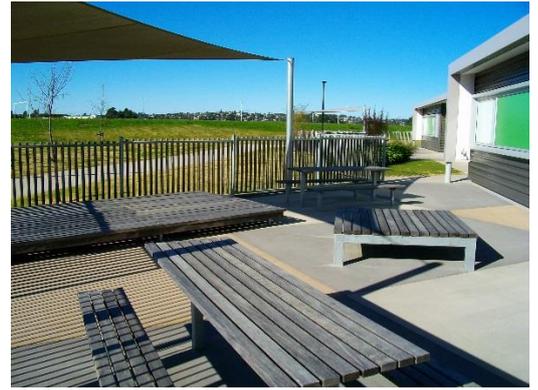
Figure 23

- Outdoor learning areas are located adjacent to teaching spaces with fixed seating and drinking fountains. See Figure 23.
- Student storage areas located along the central circulation spine are well overlooked by staff and innovative design provides storage, screening and student work space to the back of the lockers. Current capacity is 50 students in storage area designed for 90. See Figure 21.
- Teacher Work Spaces initially designed to be closed off from the general learning areas are included within the general area and utilised by students.
- The practical areas within the regular learning spaces are well defined with vinyl flooring.
- The Multipurpose Hall Space will accommodate approximately half the school when at full capacity, is naturally ventilated and located with access to an outdoor paved area. See Figure 26.

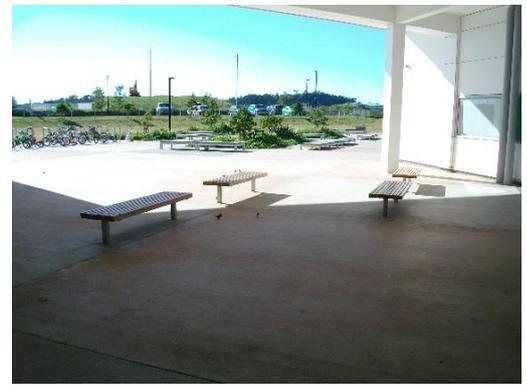
Figure 27

- The rear courtyard with access to reception provides a large covered outdoor learning area adjacent to the Multipurpose Hall Space however the flexibility of this space is compromised by the location of 4 fixed bench seats placed centrally across the space. This does not utilise the space effectively for seating and prevents the outdoor area being used for other activities. See Figure 27.

- The flexibility of paved outdoor space is compromised by the location fixed seating and has no shade or protection from the wind. See Figure 27.
- Outdoor learning areas are not well used due to the mechanical systems requirements to keep the doors closed at all times.

- The covered outdoor learning environment could be greatly enhanced with the removal of fixed seating in the courtyard adjacent to reception.
- The Hall Multipurpose Space suspended ceiling tile system should be replaced with an impact resistant ceiling system to prevent damage to emergency systems such as fire protection sprinkler heads and ongoing maintenance for impact damage.

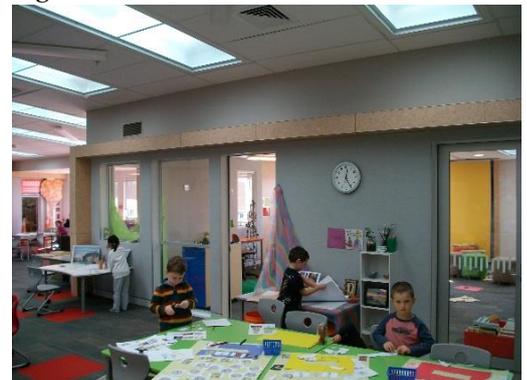
Figure 29

- The flexibility of the internal learning environment is compromised by the location of skylights throughout preventing the ability to have dark spaces and allow the use of projectors. Black paper has been retrofitted to the skylights in some rooms to provide black out conditions required for some activities. The fixed interactive whiteboards have been replaced with mobile whiteboards, however these are not often used due to glare. See Figure 29.

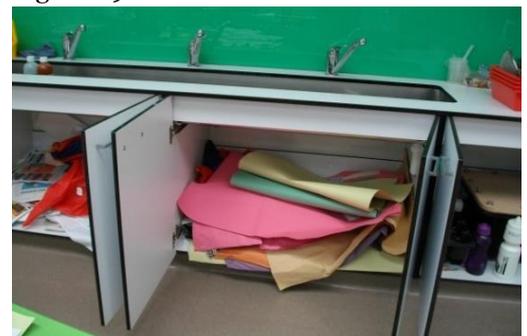
Figure 30

- Practical benching under bench storage is not ideal for materials and the sink has been retrofitted with a waste separation system. See Figure 30.
- Specialist space located remote from general learning areas are not flexible for student use or easily monitored by staff.

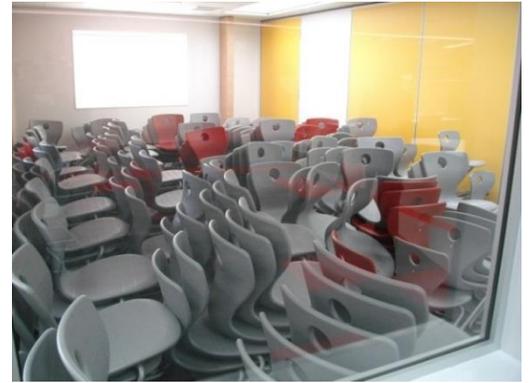
Figure 32

- The furniture type and layout provided are unsuitable for the school environment. The furniture was initially white and beige causing issues with glare. The tops have been retrofitted to darker colours. Too much furniture was supplied and the excess is currently stored in unoccupied areas, however as occupancy increases there will be insufficient space for learning. See Figure 32.

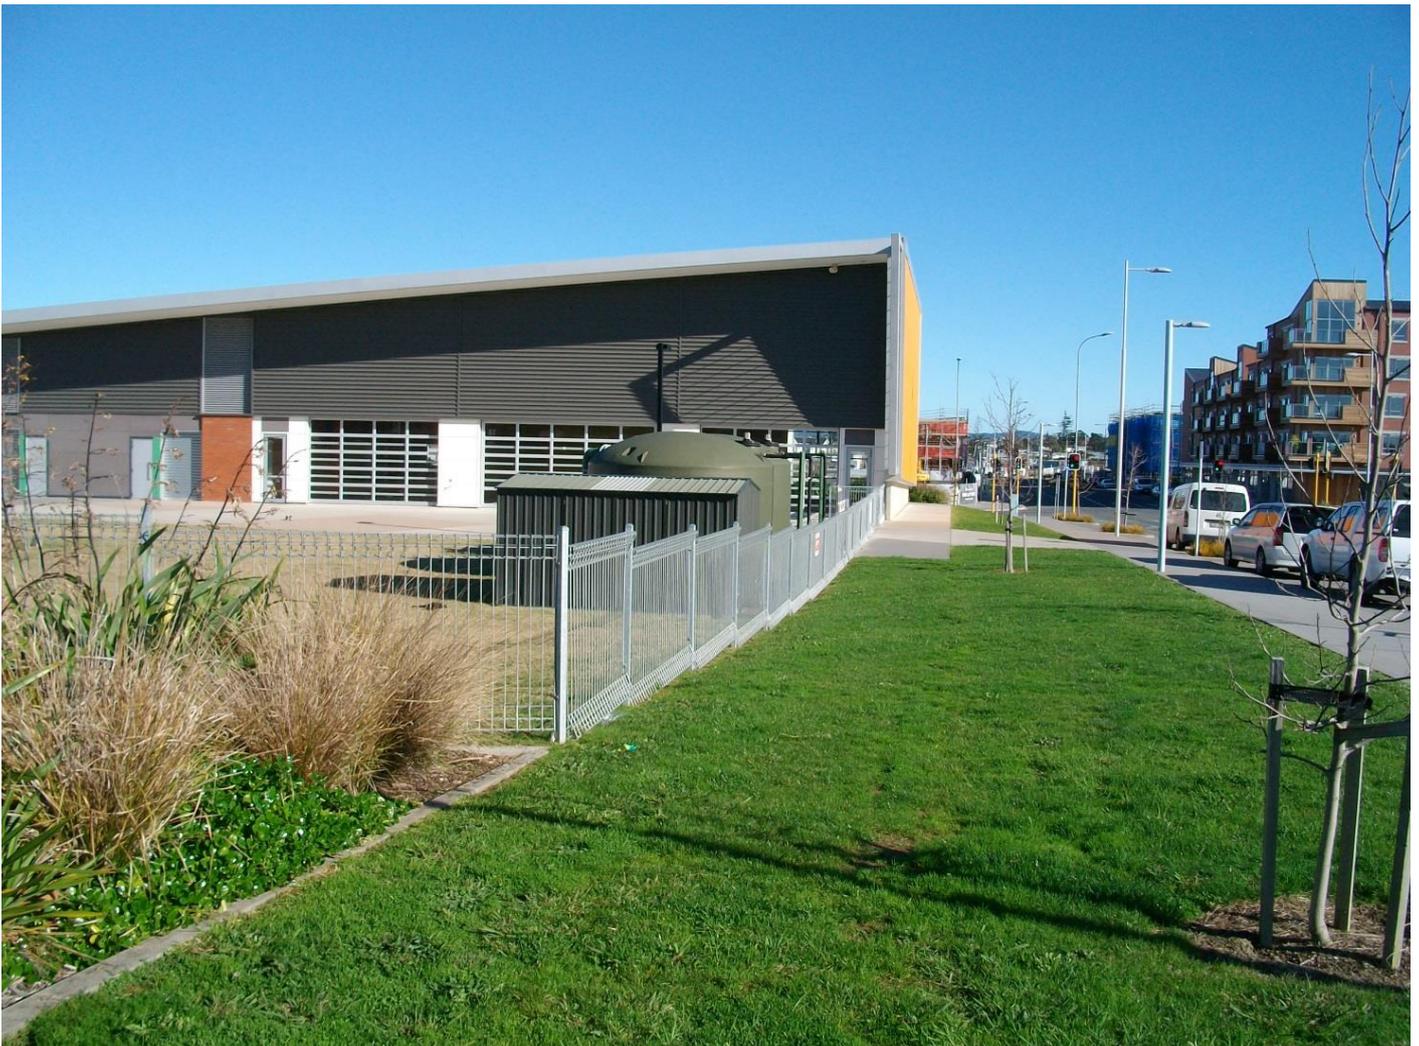
Figure 37

- Green Star 5 star rated building.
- The facilities management by external providers has transferred the responsibility for property management away from the Principal.
- Roof water collection is recycled for toilets.
- Lighting has motion sensor automatic control supplementing the natural light from windows and skylights to reduce electricity use.
- Brick veneer cladding system in some areas is a low maintenance and durable solution. See Figure 35.
- Waste storage area is in a fenced enclosure easily accessed for maintenance. See Figure 37.

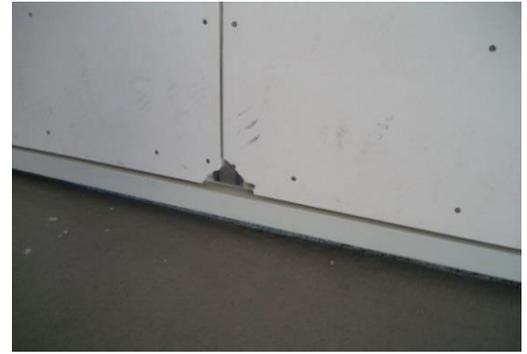
Figure 39

- External cladding panels of wood fibre resin are damaged at low levels do not provide sufficient impact resistance. See Figure 39.
- Flaking paint system failure to PVC rainwater pipes. See Figure 40.

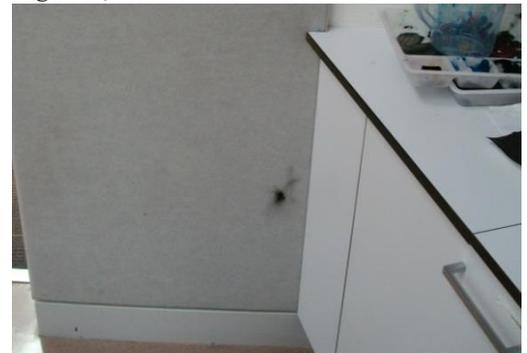
Figure 42

- Stainless steel sinks in practical areas under mounted in laminate tops and wall linings lack resilience. See Figure 42.
- Perimeter waterproofing systems installed at ground level will require the removal of cladding to maintain.

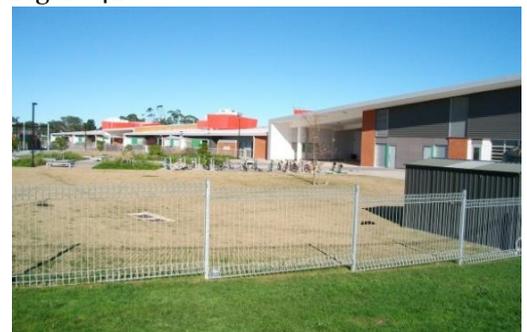
Figure 43

- Lack of irrigation to planting has resulted in replacement planting. See Figure 43.
