POST OCCUPANCY EVALUATION

PEGASUS BAY SCHOOL PEGASUS, CHRISTCHURCH

Date: July 2015
Reference: 1-46083.00
Status: Final v 7

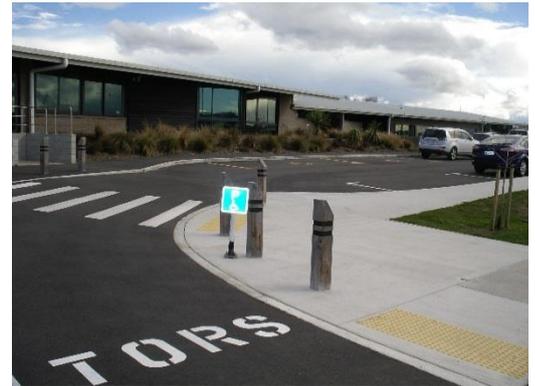
Figure 1

- The site has level access with the appropriate use of surface materials. See Figure 1.
- Specially designed scooter racks, sourced locally, together with bike hoops are located close to the main entrance and are well used. See Figure 3.

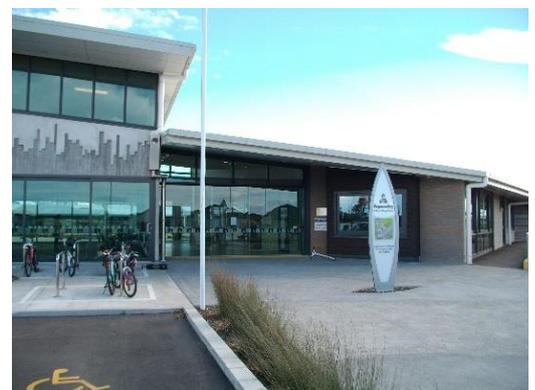
Figure 2

- The school entry is easily accessible from level access car park adjacent to the entrance. See Figure 2.
- The school entry provides a covered enclosed foyer linking the Multipurpose Hall Space and Library.

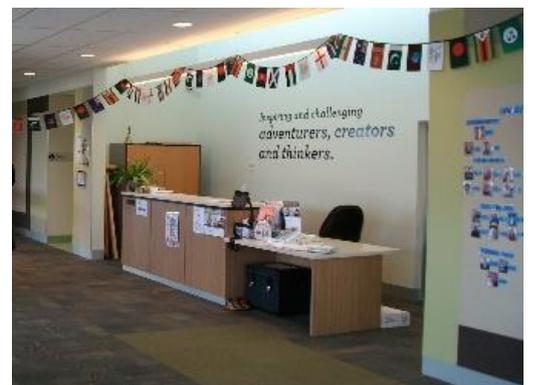
Figure 4

- The reception area has automatic opening doors accessed from the central courtyard. See Figure 25.
- School reception area has a lowered countertop and adequate space for both visitors and students. See Figure 4.

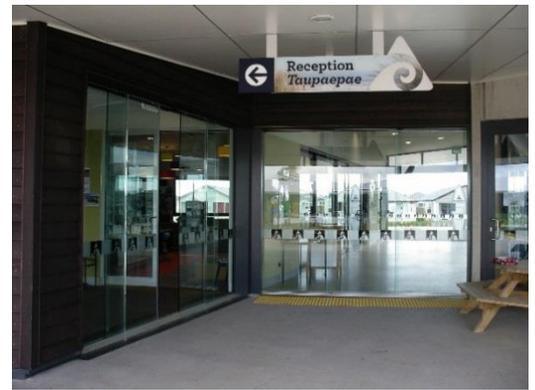
Figure 5

- The reception does not engage with the entrance into the school. The visitor is required to enter the building and exit the building prior to arriving at reception. See Figure 5.

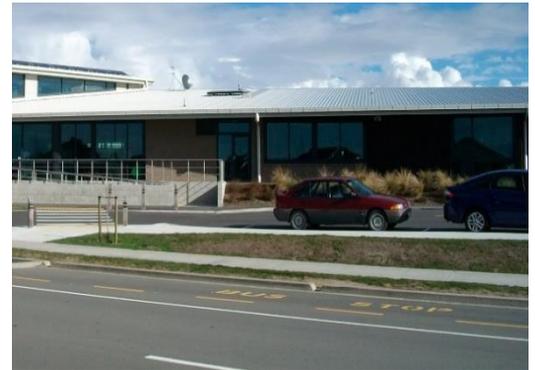
Figure 6

- The bus stop was originally within the school parking area, however this has been relocated to the road and the space utilised as a drop off-car parking. See Figure 6.

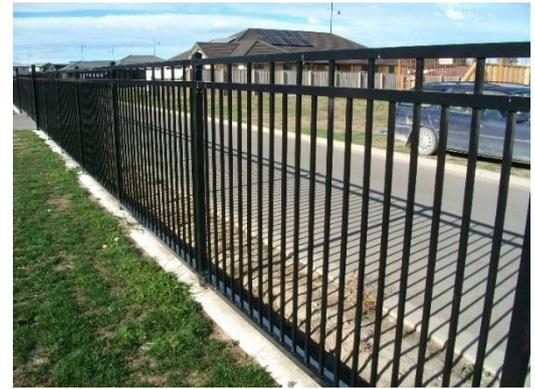
Figure 7

- The school is surrounded by residential properties overlooking the grounds. No reported issues of vandalism.
- Fencing to the entire site provides separation between students and areas of potential harm. See Figure 7.

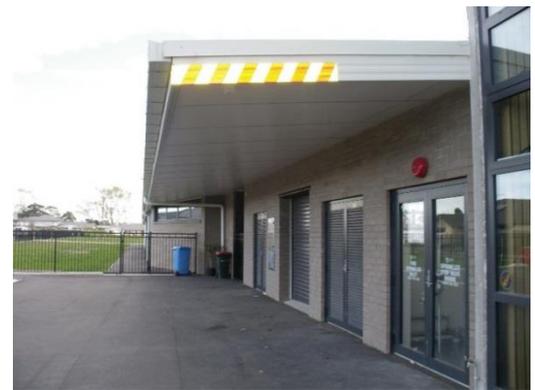
Figure 8

- External service and maintenance area is separated from students and incorporates a covered working area. See Figure 8.
- Administration office overlooks the central courtyard.

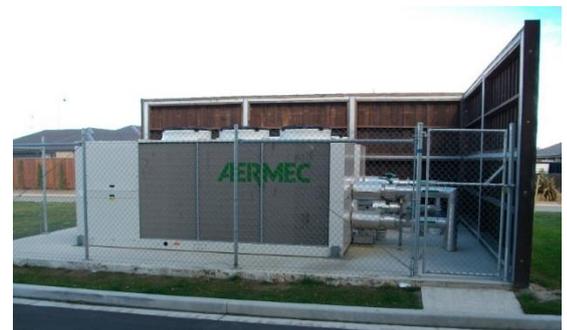
Figure 9

- Health room has a treatment and rest area incorporating 2 beds.
- Specific items of plant are securely installed behind fencing. See Figure 9.

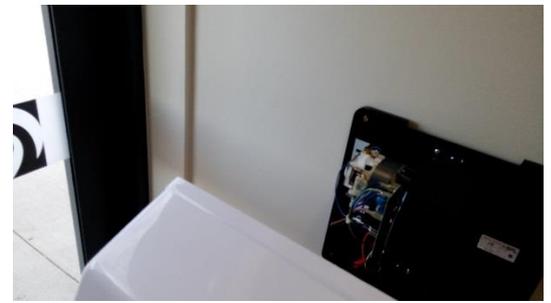
Figure 11

- North wing students' toilet, hand dryer cover is not securely installed and can be easily removed exposing live electrical terminals. See Figure 11.
- Half of the power socket outlets in student areas are not RCD protected. Where RCD devices are provided the rating of circuit breaker is 40A while sockets of which that circuit breaker protects are 16A so in case of overload condition the protection device will not work.

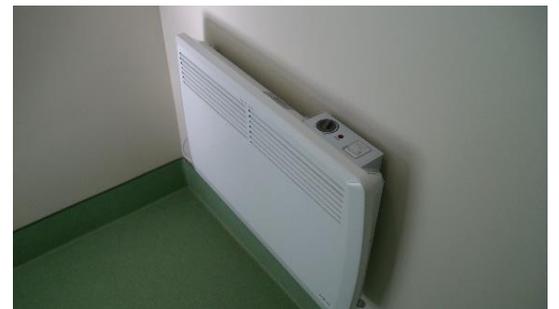
Figure 13

- Student toilet areas have low level heating convectors with exposed controls. See Figure 13.
- Window handles have been installed inconsistently – some are upside down/opposite to others. Teachers need to check each window latch physically rather than be able to scan to see the locks are all in the "up/locked" position for example.

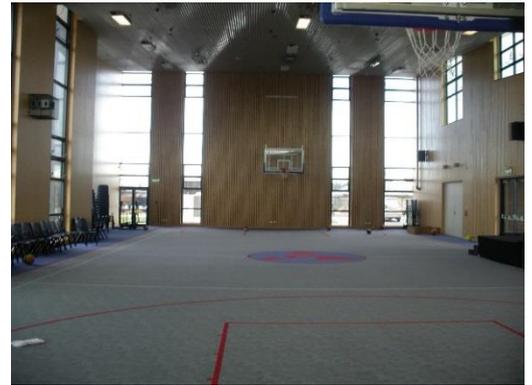
Figure 14

- The Multipurpose Hall Space has high quality finishes with lights, monitoring and control systems protected by wire mesh or recessed against impact damage. The design also includes sound attenuation measures. See Figure 14.

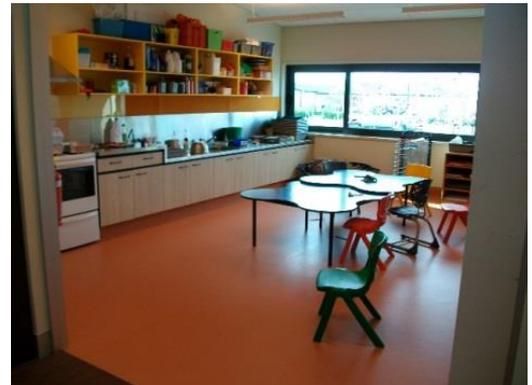
Figure 15

- Separate spaces are provided for practical activities. See Figure 15.
- External drinking fountains not originally incorporated in the project scope are provided in stainless steel.

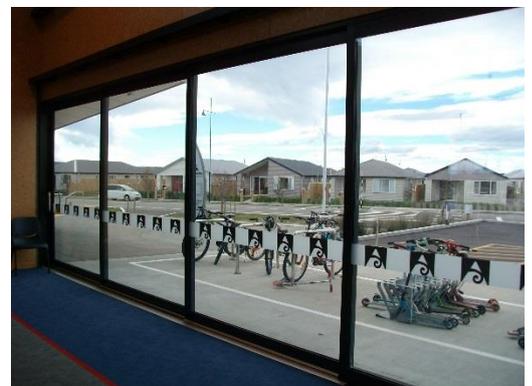
Figure 16

- The lighting levels were measured at 350-450 lux in room corners away from natural light. Day lighting is very good with generously sized glazed windows. See Figure 16.

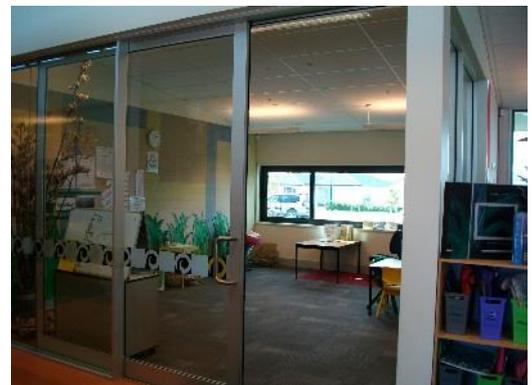
Figure 17

- Learning areas have sliding glazed partition walls between general areas and breakout spaces. See Figure 17.
- Covered walkways are provided between buildings.

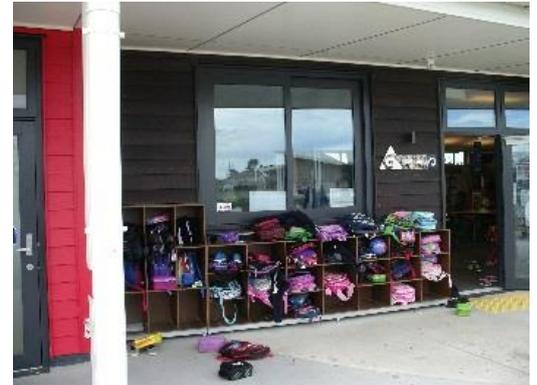
Figure 18

- Wet areas are located in circulation areas. Main use appears to be for storage. See Figure 19.
- Lack of storage for student bags. Located externally lacks adequate protection from solar gain providing hot lunches. See Figure 18.

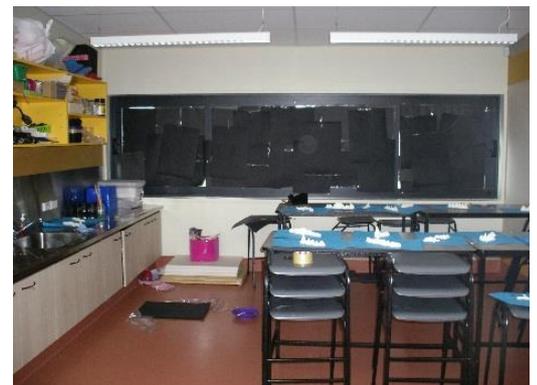
Figure 20

- Glare is a major issue, the school are arranging for solar blinds to be fitted throughout as necessary. School have resorted to sticking black paper to the windows. See Figure 20.

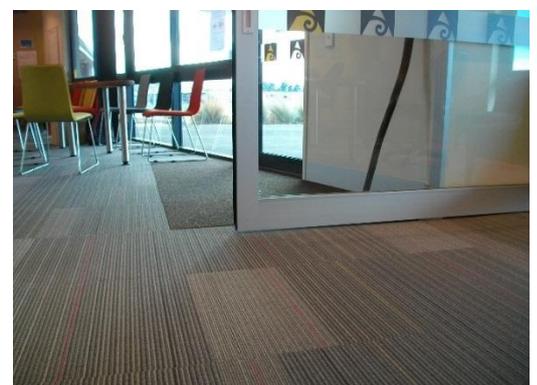
Figure 21

- Large gaps between the bottom of the sliding doors and the floor. As a result they are of limited use as regards sound attenuation between spaces. See Figure 21.

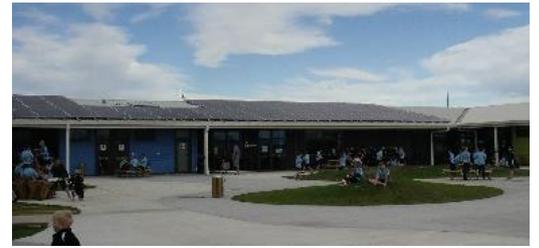
Figure 22

- Designed to achieve a 5 star rated Green Star building by extensive use of roof mounted PV cells to generate electricity to contribute towards the zero energy rating. See Figure 22.

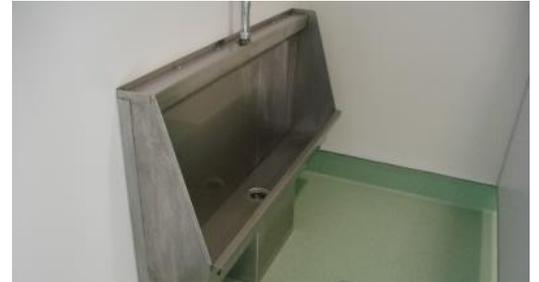
Figure 23

- A trough urinal as opposed to individual urinals are easier to maintain. See Figure 23.
- The use of generous eaves to the roof perimeters of all the buildings provides excellent protection to facades.

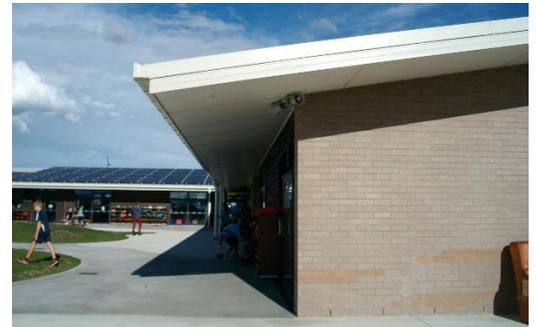
Figure 24

- Roof pitches which carry the rainwater to external gutters and downpipes decreasing the likelihood of internal leaks. See Figure 24.
- High level natural light provided by roof level ribbon windows. See Figure 25.

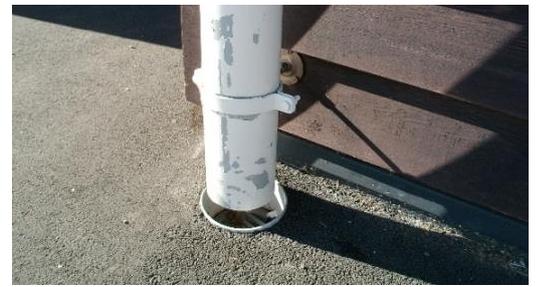
Figure 266

- After hours use areas cannot be measured separately for energy use, only on a block by block basis.
- Poor specification finish to external downpipes. Paint already peeling off. See Figure 266.

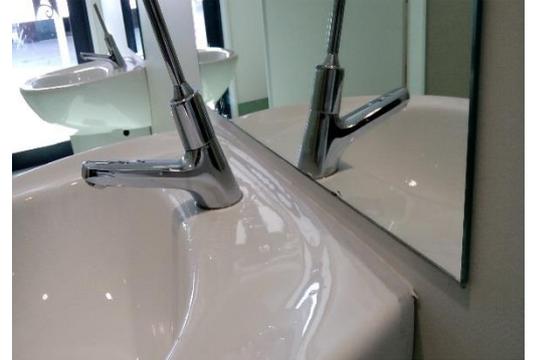
Figure 27

- No splash back or water resistant material behind hand basins. See Figure 27.
- Low grade specification door closer, premature failure. See Figure 28.

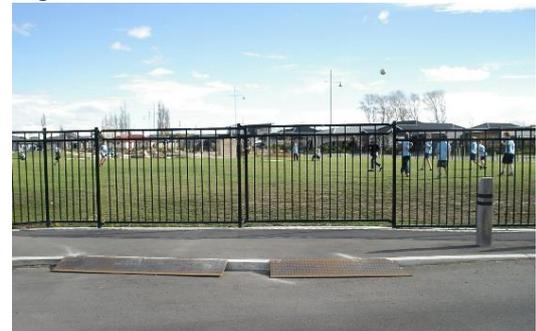
Figure 29

- Boundary fencing (not part of the original design documentation) was added using the contract contingency budget and is of poor quality and durability. Aluminium fencing and gates require constant repair with entire panels having to be replaced. See Figure 29.

The aluminium fencing is sub-standard. In appearance and dimension the fencing is compliant, however it already requires maintenance due to a lack of material quality. The sliding door system is sub-standard, it is identified as not functionally appropriately and requires an alternative design solution.

The school double gates are poorly designed and their failure is likely. Additional supports required investigate improvements in design and material. As fence panels fail replace with steel, not aluminium.

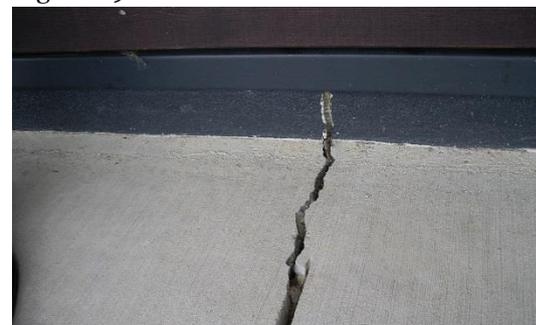
Figure 30

- Concrete surfaces have cracks appearing in many areas suggesting increased maintenance will be required over time. See Figure 30.
- Internal sliding partition doors. They have no floor guides or supports. They are very prone to deflection by the application of horizontal forces and thus being put out of alignment. Any misalignment causes the doors/partitions to rack resulting in numerous doors getting stuck. This is a constant issue.

Various defects which the school has listed, which include water stained ceilings, faulty space heating, cracked concrete etc. which have longer term maintenance implications if not remedied, need to be rectified within the scope of the building contract, before issue of the final certificate.
