# POST OCCUPANCY EVALUATION

## TE KURA KAUPAPA O WHANGAROA, MATAURI BAY, NORTHLAND

Date: November 2015  
Reference: 1-46083.00  
Status: Final Rev 05

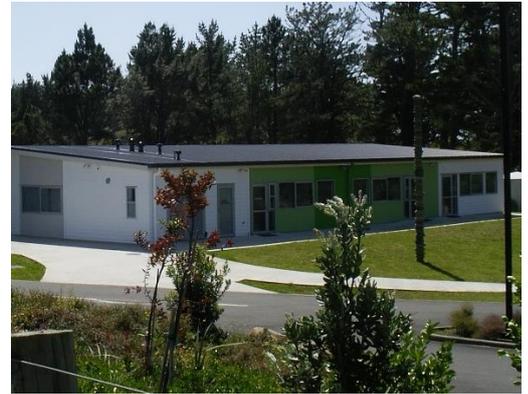
Figure 12

- There is inadequate vehicle and pedestrian separation on school grounds. Children are free to run into vehicle areas with no restriction. See Figure 12.

- There is no physical barrier between the vehicle access and drop off to the school and the car park and the children. This issue needs to be examined generally as there are a number of possible options to minimise the risk to children.

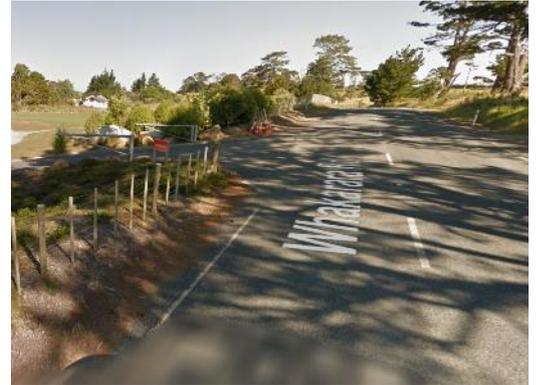
Figure 13

- There is no designated main road kerb-side parking provision for cars or cyclists to use to pull over or to park. See Figure 13.
- Sliding doors are too heavy to be easily used by the younger students. Over use of force and the lack of frictional resistance means that they are frequently pushed back onto their door stops and early signs of damage are apparent.

- Potential pedestrian risk on the main road outside the school at busy times due lack of a hard shoulder, off road parking or pedestrian pavement. See Figure 13.

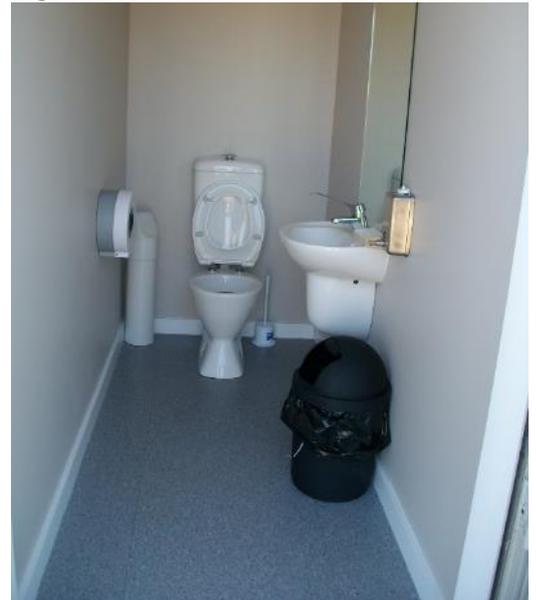
Figure 14

- The staff toilet in the classroom block 01 is in an odd location relative to the rest of the school, being at a far corner and accessible only from outside of the building. See Figure 14.

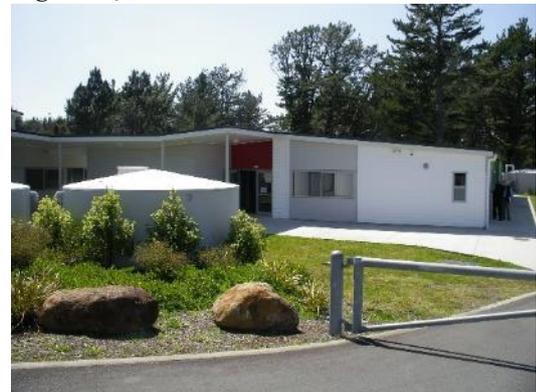
Figure 15

- Minimal physical barriers to control the visitors walking on to the site and into the school buildings. Large open gaps between batten and wire fencing and the gates. See Figure 15.

- The vehicle gallows style gates are not a barrier to pedestrians. The side access gates are unsuitable for the school environment and should be replaced.

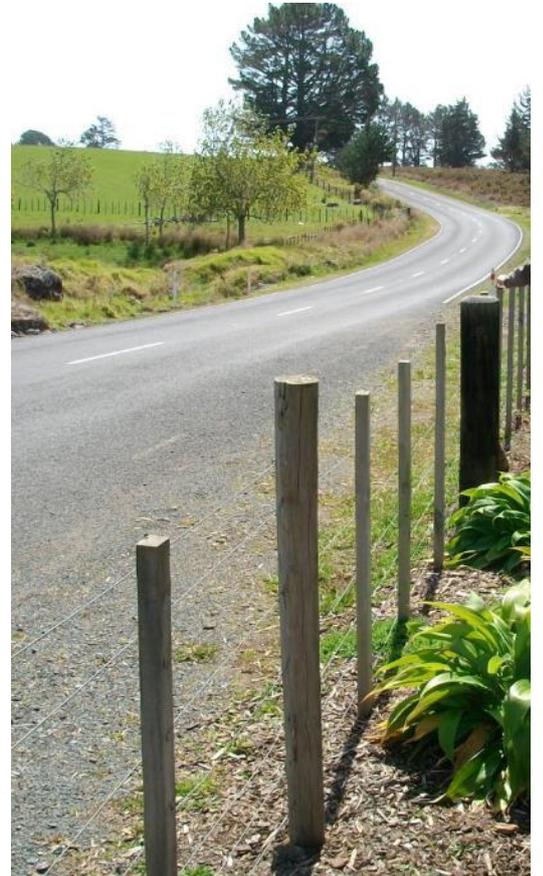
Figure 22

- Boundary fencing consists of open strained wire with intermediate wooden spacers between fixed posts. Easy to climb through and of low height this is ineffective at keeping students in, thus insufficient for protection towards the main road and towards forested areas at the rear of school. See Figure 22.

- Test and review the incoming electrical supply to identify the tripping out issue should it reoccur.
- The strained wire boundary fencing is of poor quality. Its purpose is to define the school boundaries, yet it provides no effective barrier to access or exit from the school site. Replace with a more robust and secure fence.

The strained wire boundary fencing is of poor quality, its purpose is to define the school boundaries, and it provides no effective barrier to access or exit from the school site. Replacement with a metal railing fence is recommended.

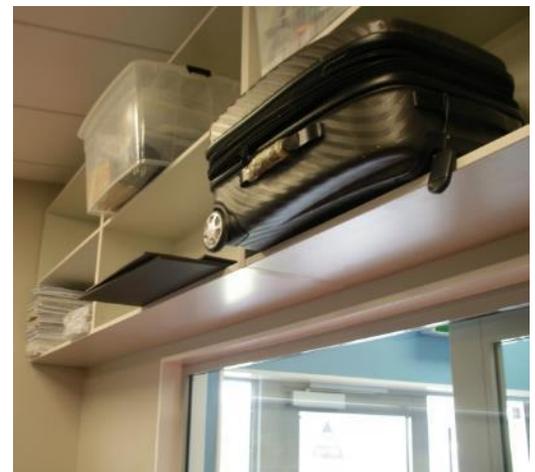
Figure 38: Resource room

- Sheltered outdoor learning areas on the new blocks are minimal due to lack of large overhangs.
- Provision for storage for both staff and students is insufficient. Staff reported “not enough storage” and that there are “Not enough places to keep documentation or play equipment” and advised that this had been the case since prior to the new block’s design being conceived. Classroom storage limited to 3.9 cubic metres. The school have purchased some shipping containers and installed them on site to create additional storage. See Figure 38 and Figure 39.

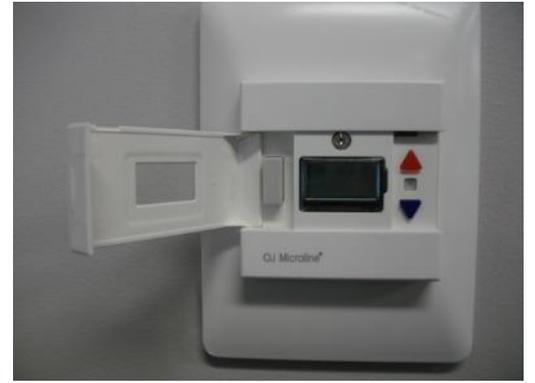
Figure 40

- Staff reportedly struggle to operate the heating system correctly due to its complexity. Thermostat controls govern the temperature in the building but local room control by teachers is being achieved by simply opening or shutting windows and doors leading to higher power consumption. This is a source of complaint from the School. See Figure 40.

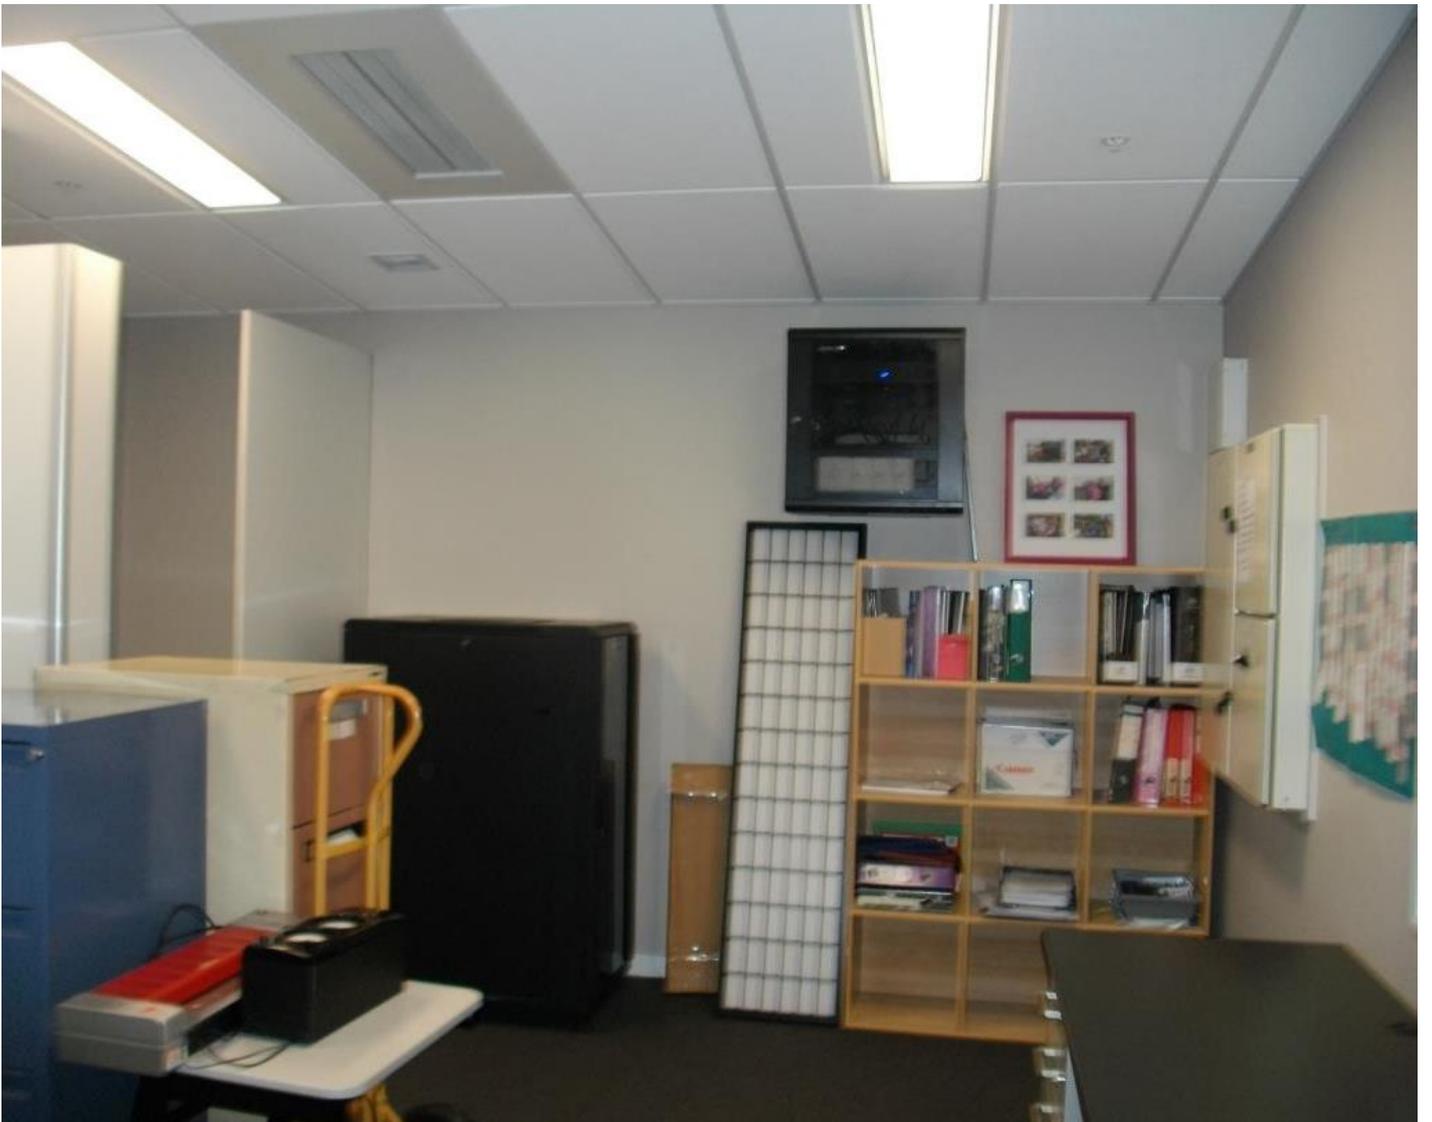
- Block 01: Resource room is not large enough. Photocopier in resource room was not in a separated area, and additional partition walls were required to be installed post-construction to meet guidelines for Greenstar (ventilation as per Greenstar). The new partition walls now compromise the efficiency of the ceiling extract vent, further modifications will be required.

Figure 41 - Block 01: Resource room – too small

- Address the ventilation issue and place the photocopiers in the resource room.
- Review the hot water capacity issue serving the showers to block O2 changing rooms.

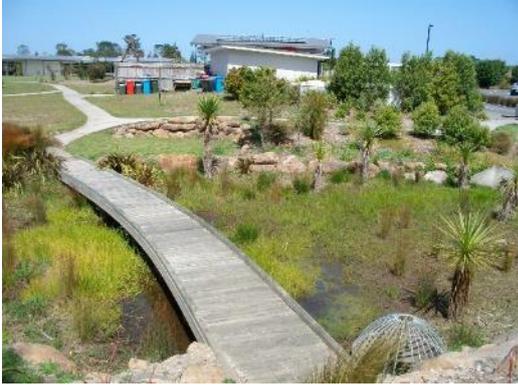
Figure 46

- No restrictions to the wet area pond or falling from the bridge over it. See Figure 46.
- Unable to observe visitors, who have not registered, from accessing the new school buildings, from reception.

- There is an unguarded bridge over the pond, which varies in depth, to the environmental area. Access to this area needs to be managed or guard rails provided.

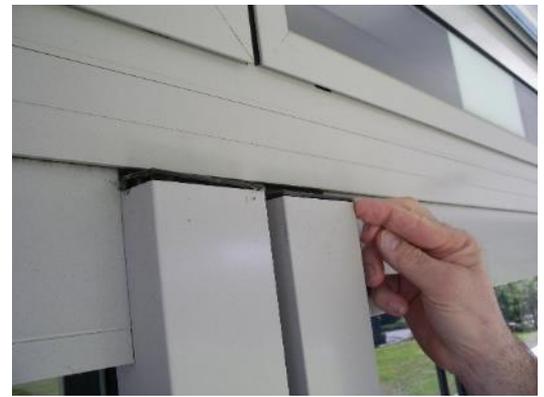
- The external sliding doors are likely to cause issues. Plastic capping's to the stiles and door stops are already deteriorating. The runners tend to get blocked and doors can stick and are hard to open for some students. See Figure 48 and Figure 49.

The sliding doors are already showing signs of premature wear and tear.

Regularly inspect and maintain all sliding doors to prevent premature failure.

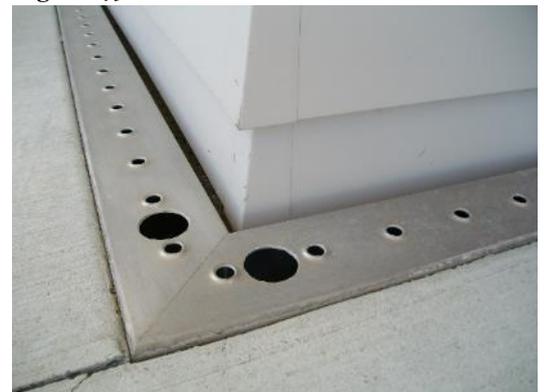
- An unusual detail has been installed externally to the perimeter of the building at the external wall/path junctions. This is assumed to have been installed to provide level door thresholds by having raised paths relevant to the wall whilst maintaining the ground to wall cladding separation. However, the resulting gap has been filled with sheet metal to remove a potential hazard. In covered areas this is not an issue, but in exposed areas it allows rainwater to splash up the wall cladding. The use of metal grilles would have been a more effective solution. See Figures Figure 50 and Figure 51.
