Ministry of Education

National Schools Weathertightness Survey

Report Version 1.1 | May 2012

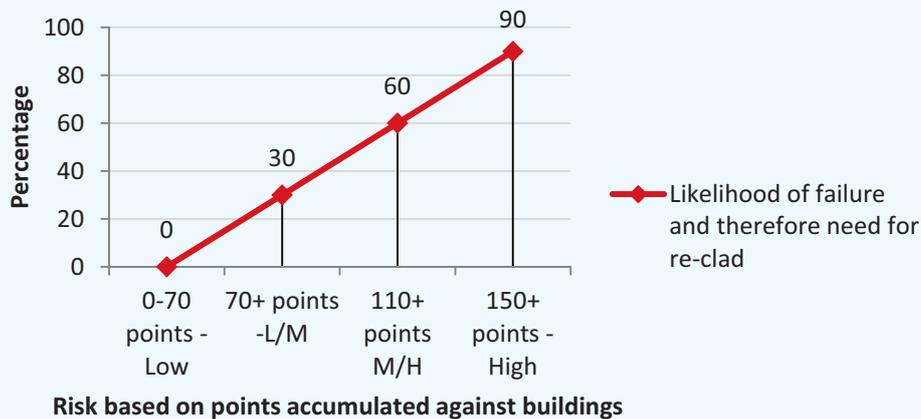
Figure 7: Decreasing risk of weathertightness failure model based on priority rating profiling

Buildings with the lowest points score (0-70) present the lowest risk of failing and therefore are unlikely to require full re-cladding (0% risk). Beyond this point, as buildings are introduced to the survey group their points score will sit within a range of 71 and 150+. Buildings that score over 150 points are considered high-risk with a 90% chance of requiring re-cladding and re-roofing. The simple graph at Figure 7 below shows a straight line relationship drawn between these two values (0% and 90%) which bisect the Low/Medium category at 30% and the Medium/High category at 60%.

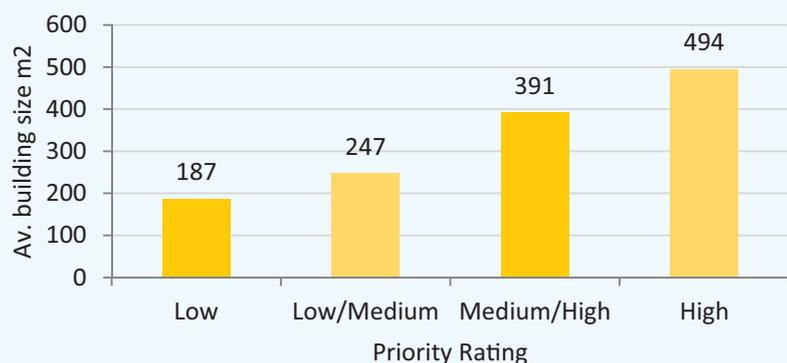
Figure 32: Relationship between permanent building size and risk/priority rating

A trend exists between the size of permanent buildings and their priority ratings. The larger the building area the greater the risk profile and therefore priority rating.

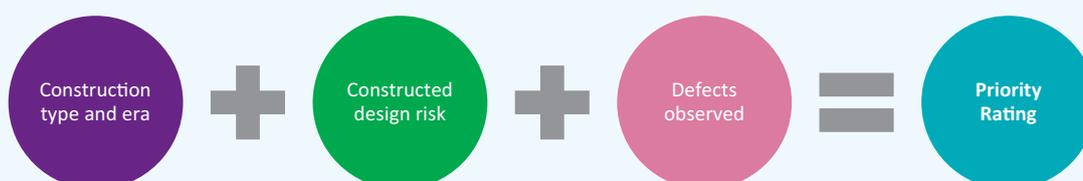
Figure 60: Building assessment methodology overview for priority rating

It was determined that buildings would be assessed by visual survey by a qualified Building Surveyor. A methodology was developed to profile buildings weathertightness risk against an accumulated points system. The principles of the Acceptable Solution to the Building Code E2/AS1 (3rd edition), 1 May 2008 (Risk Matrix) (the Acceptable Solution) and the DBH Weathertightness Guide have been used as a basis to develop the assessment values.

The assessment criteria fall into three main categories each that build a points-based outcome and end priority rating:

The assessment template incorporates the assessment methodology referred to in Figure 60 and automatically provides a points-based outcome. The accumulated points determine the end priority rating referred to at Figure 61.

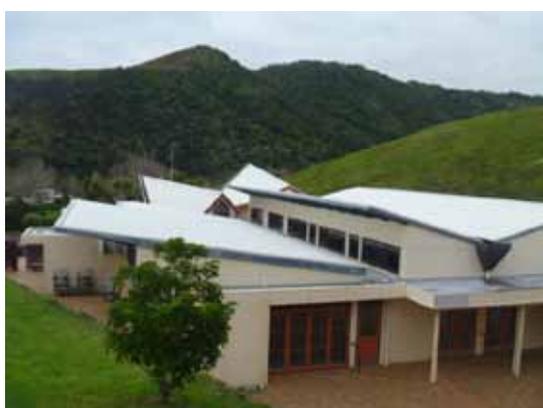
Example of a **High priority** building. Typical attributes include a large floor area and a high level of complexity. High risk weathertightness features are also present along with potential defects.

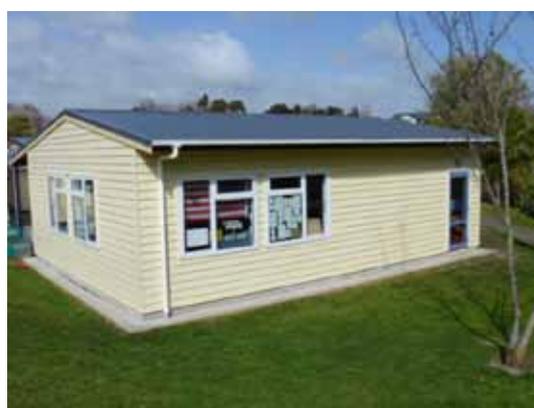
Example of a **Low/Medium priority** building. Typical attributes include, smaller floor area (compared to high priority buildings), simple design, low risk weathertightness features.
