# POST-OCCUPANCY EVALUATION REPORT

## GOLDEN SANDS SCHOOL

PAPAMOĀ | JULY 2015

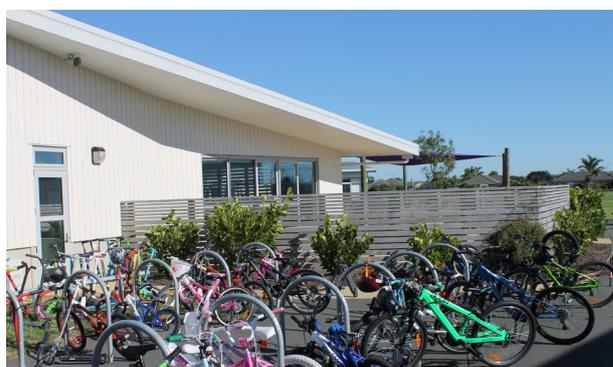
The bike stands were well utilised at the school, however it was stated during the interviews that due to its design it made securing bikes to the stands difficult. Due to roll growth additional bike stands are required, however extending the current bike stands in this location would not possible as the area is constrained by the adjacent service and emergency corridor.

Bike stands are well utilised

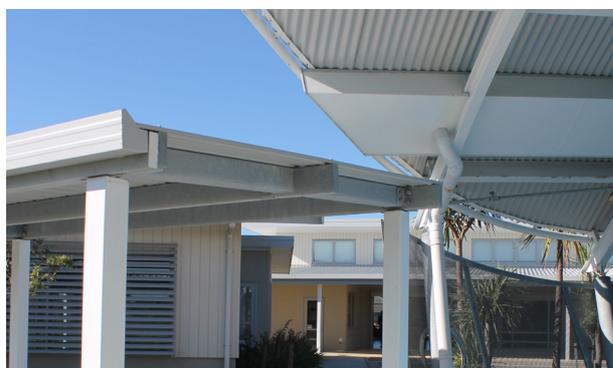
The external circulation routes are clear with canopies provided (in most areas) to protect students. Stage One is connected with external canopies which follow the irregular building placement. It was stated in the interviews that the “canopies do not extent over some of the toilet areas in Stage One and the students are affected by rain at certain times of the year”.

Stage One external canopies

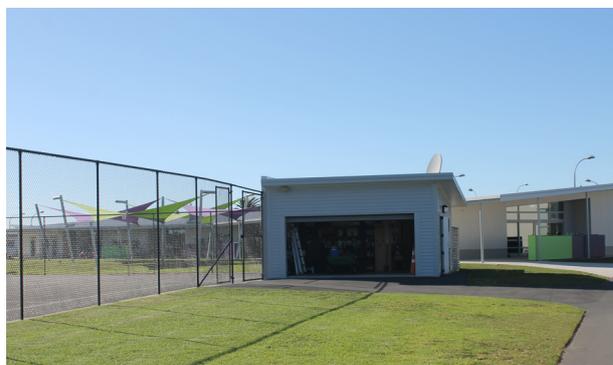
The Master Plan does not appear to have created a separate service entry for the removal of refuse and storage of maintenance equipment. The caretaker’s shed, which was built in Stage One, is positioned in the middle of the school. The evaluation team suggests that the caretaker’s buildings and maintenance equipment should be positioned away from learning centres and main student circulation paths.

Caretaker's shed

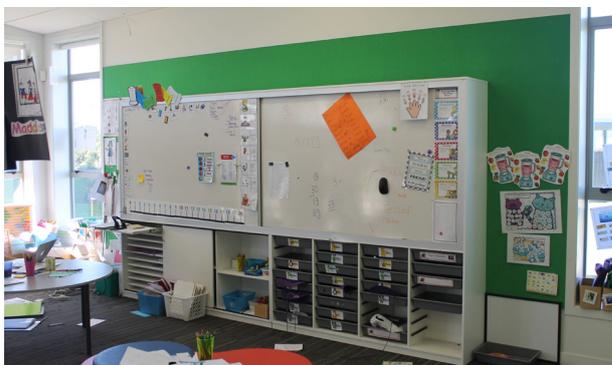
It was stated in the surveys that the withdrawal spaces were used for teacher work areas and resource storage overflow. Survey responses stated that the “storage space in the studios are limited”, and that “the storage provided is difficult to manage because it is covered by a sliding white-board and projection screen”. During the evaluation, the central space was used to gather all of the students from the four classes for a combined teaching lesson which was seen by the evaluation team as a positive use of the space.

Stage One storage unit in studio

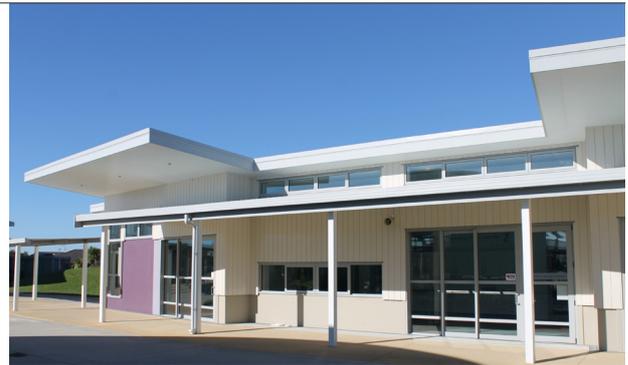
Cladding material selection of Stage One

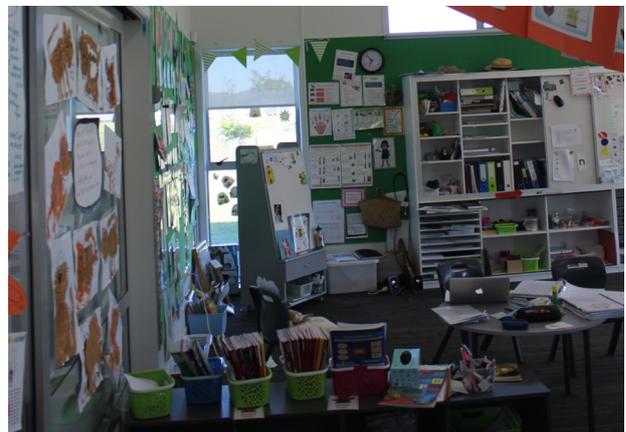
Limited storage options in the Stage One studio space as stated by staff

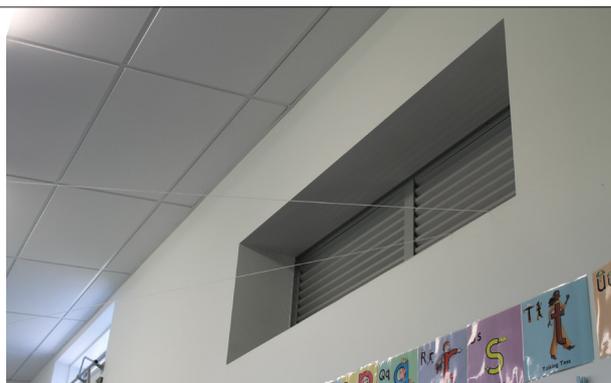
Stage One air grills between spaces

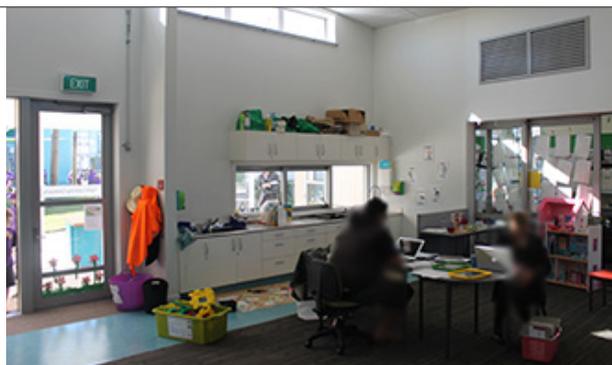
The Stage One central collaboration space was identified during the interviews as “being noisy”. Survey responses from staff also stated that “the acoustics in the Stage One central collaboration space were inadequate”. The evaluation team noted that the space had high ceilings (higher than 3 metres) and glass surfaces on three sides which limited the amount of acoustic wall panels. It was also evident during the evaluation that the doors were too heavy to move for the students with tracks experiencing wear and tear. Further investigation of this space is recommended.

Stage One central collaboration space

1. Occupants of the central collaborative space in Stage One expressed that the acoustics were poor. The evaluation team recommends that an acoustic engineer undertake diagnostic testing under normal working conditions to provide a better understanding of this issue. In the least, additional pin-board panels should be installed.

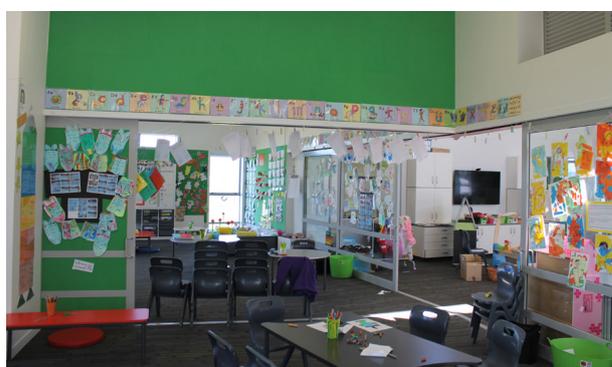
During the interviews it was stated that the interior sliding doors were too heavy for the junior users and that the bottom guides continually required realignment and on-going management by the school. Stage One had a number or external doors that were too heavy for the students to operate safely. Staff stated that the doors which swing 180° are of most concern as the wind can blow them open and it can make the learning environment uncomfortable. Due to these issues, the doors in Stage Two were made smaller and lighter. However, during the interviews it was stated that these doors were "too lightweight" for their purpose and that they "derailed" frequently. It was evident during the evaluation that the school had made attempts to improve the performance of the internal sliding doors by installing additional guides, however, this will be an ongoing maintenance issue for the school. Consideration should be given to this by future design teams.

Stage One studio doors

2. The internal sliding door tracks, which divide the Stage One studio spaces from the withdrawal and collaboration spaces, frequently misalign. These doors were designed to slide together to meet in the corner, however more robust commercial tracks and/or hardware are required. It is recommended that the internal sliding doors are reviewed by a specialist in detail so that robust recommendations and guidelines can be provided.

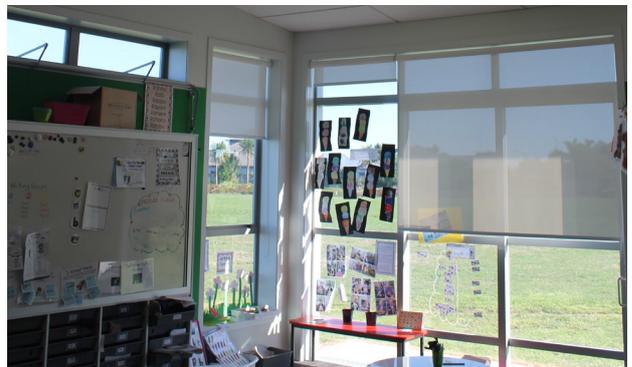
The Stage One buildings, in general, have standard eave overhangs. As the Master Plan has positioned the new learning centres in a ‘semi-circle’, each learning centre faces a different way in relation to north, therefore, users experience different natural light levels in the studios and withdrawal spaces. The evaluation team observed that some of the north and west facing studios had insufficient solar protection. The school had installed internal blinds in some spaces to help prevent over-heating. It is recommended that external shading devices are installed to help manage the most affected areas.

Stage One west facing windows have had internal blinds installed

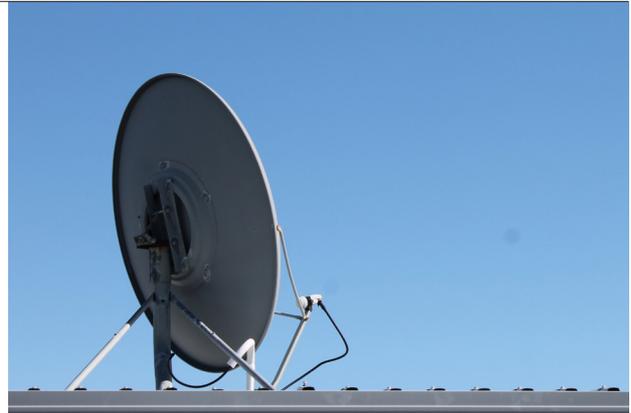
During the interviews staff stated that the project team had planned for and had installed a satellite dish, however, due to its complex system (of which was not understood by the school), is not being fully utilised. The equipment was a significant investment for the school and it now appears that this technology may be obsolete. While advancements in ICT are important, further research could have been undertaken in this case. Further investigation is recommended to understand this situation in detail before recommendations can be made.

Satellite installed at the school

To help future schools understand and benefit from their new equipment, it is recommended a robust hand-over strategy is implemented.

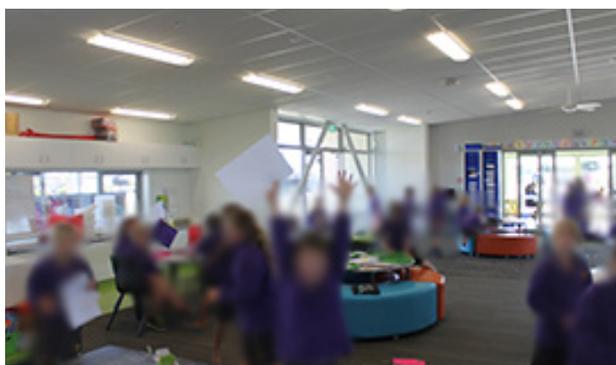
The structural approach of Stage Two ensures it can be easily adapted
