POST OCCUPANCY EVALUATION

ORMISTON PRIMARY SCHOOL Flat Bush, Auckland

March 2016

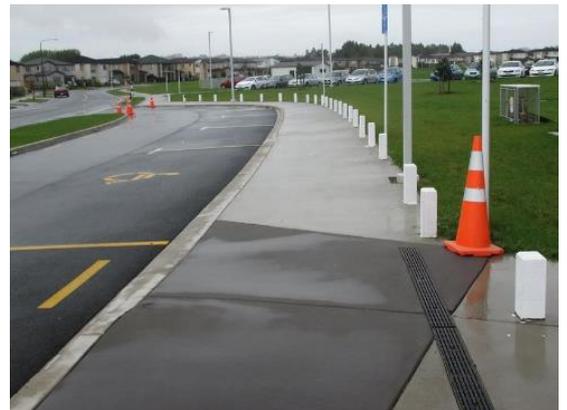
- The pickup/drop-off zone is positioned in front of the school, and is separate from car parking areas. There are accessible car parks provided within the pick-up/drop-off zone directly adjacent an accessible path to the buildings. See Figure 3 of the drop off zone.

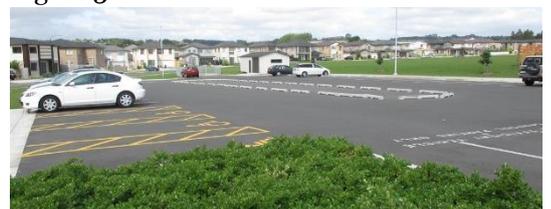
- Accessible visitors car parks are provided within the separate car park as close to reception as possible. The pedestrian route from the car park to reception is accessible for high dependency users via a concrete path and ramp with the accessible handrails provided. Figure 3 and Figure 4 show the accessible car park within the drop-off zone and within the car park respectively. Figure 5 shows the pathway from the car park to reception.

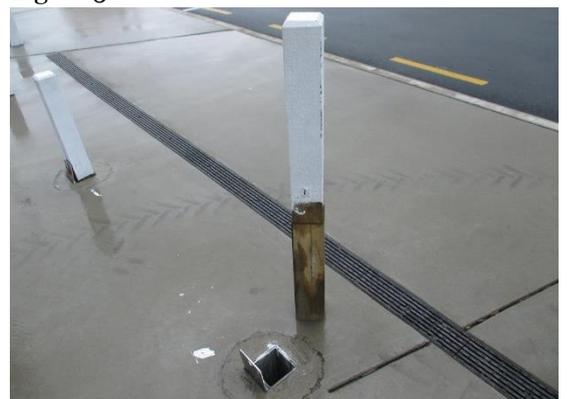
Figure 6

- Access for emergency vehicles is provided from within the pickup/drop-off zone. Removable and lockable bollards are in place adjacent to the roadside of the school buildings, which provide a barrier between student and vehicle areas, while enabling access to vehicles in an emergency. See Figure 6.

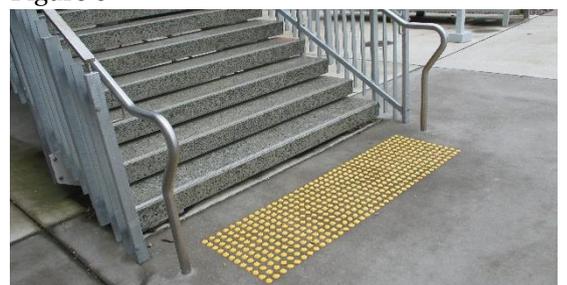
Figure 7

- The building layout is easily understood by users, assisting with wayfinding through its looping circulation route. Tactiles are provided at lifts and footings of stairs to support sensory way finding for users. See Figure 7.

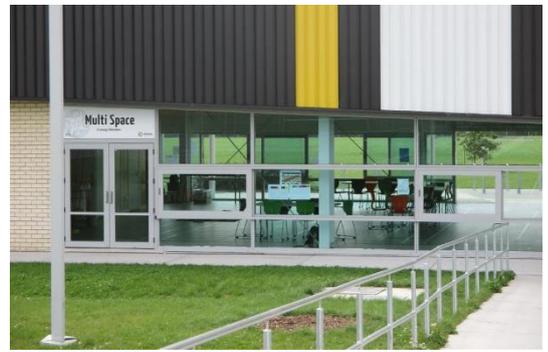
Figure 8

- Staff reported that the large amount of glazing to walls in the Multipurpose Space greatly assists oversight to the grounds. See Figure 8, looking from the south through the multipurpose space.

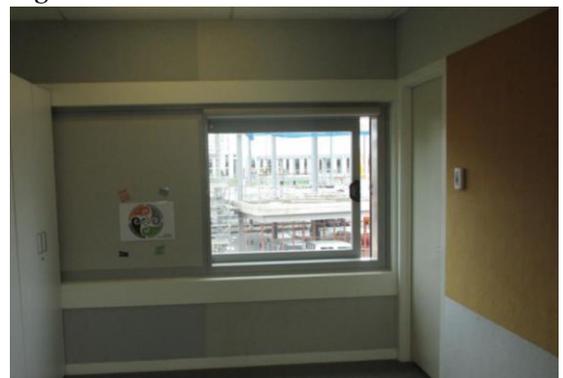
Figure 17

- Windows do not open onto out onto circulation routes anywhere in the school. This has been achieved by specifying sliding windows. See Figure 17.
- The Principal has stated the fencing along the main roads surrounding the school is effective as a barrier for students. Pool fencing runs along the main (Ormiston) road, with timber bollard fencing between the drop-off zone and school grounds.

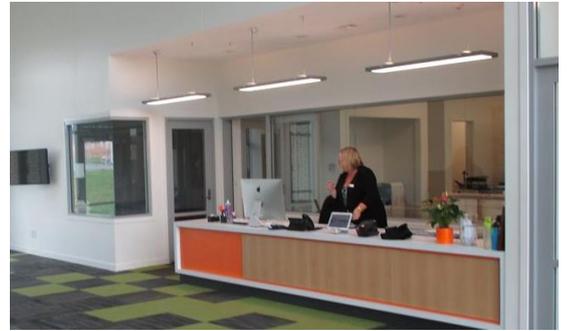
- The reception area has good line of sight into the health space. This makes monitoring ill students less onerous for reception staff. See Figure 18 with the health space through the glass door and window to the left of the image.

- Window controls have winder handle at child's head height. See Figure 23.
- The reception desk cannot be closed off from the reception area. Staff advised that this can be a problem when counting cash, when in a lockdown situation, or when the multi-purpose space is used by a community group. See Figure 18.

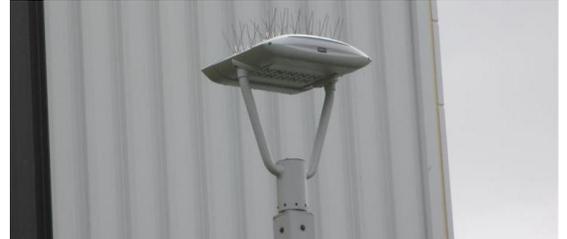
Figure 19

- Staff advised that all areas of the school appear adequately lit. Downlights and bulkhead lights effectively illuminate the building perimeter, exterior entrances and walkways. There is pole-mounted lighting to the drop-off zone and car park areas. The pole-mounted lighting includes bird protection as seen in Figure 19.

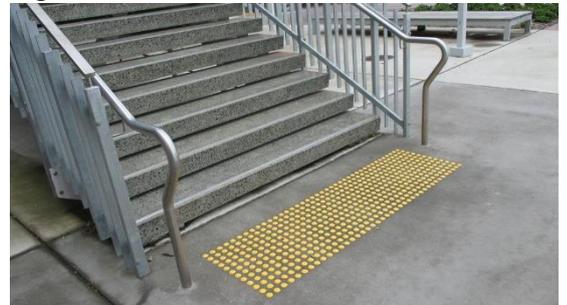
Figure 20

- Tactile features have been provided on stairs to assist with students, staff or visitors who are visually impaired. See Figure 20.

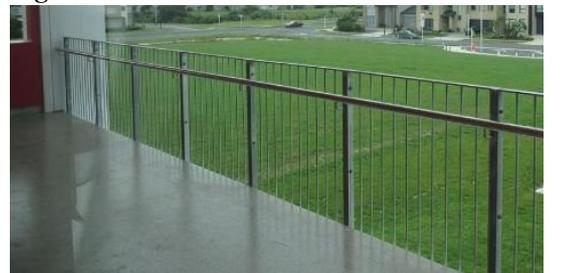
Figure 22

- The Principal reported that the polished concrete surface on the stairs and upper storey covered way was slippery, especially during and after rain. While the balustrades prevent students from slipping and falling from height, staff advised that the risk of students falling onto the concrete surface requires significant management. The Principal advised that an alternative coating was trialled to provide more friction to the surface. The two trials of the alternative coating were unsuccessful. The top layer of the polish has now been 'ground off' and this is much better solution." See Figure 22.

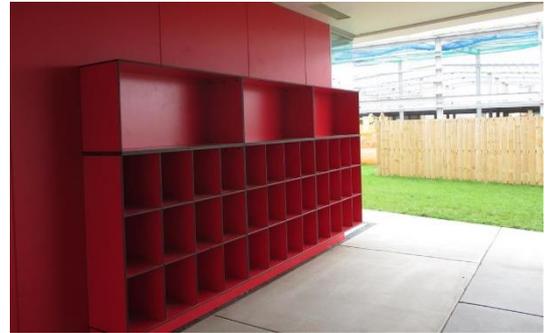
Figure 24

- The Principal is concerned about security for student storage cubbyholes in the open walkway. He considers that this will become more of an issue once there is pedestrian traffic to the adjoining Junior College. See Figure 24.

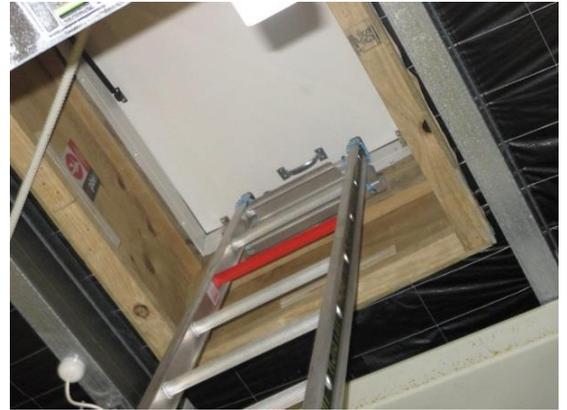
Figure 25

- The plant room access ladder is too lightweight (in rated weight capacity), secured at only one point (at the top with a rope), and is on too steep an incline. WorkSafe New Zealand ladder guidance published in 2013 indicates this is not aligned with best practice for safety of ladders. See Figure 25.

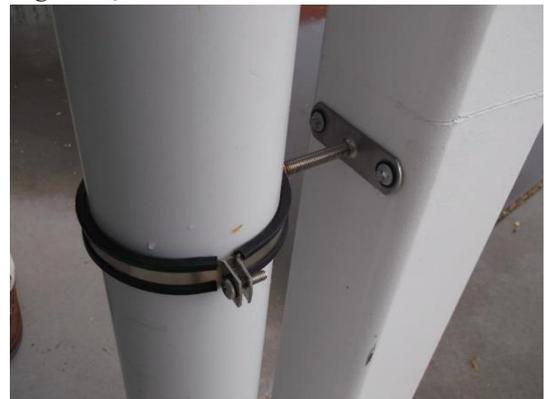
Figure 26

- There are a number of sharp fixings and brackets to rainwater downpipes that protrude into the path of pedestrians and could cause injury. See Figure 26.

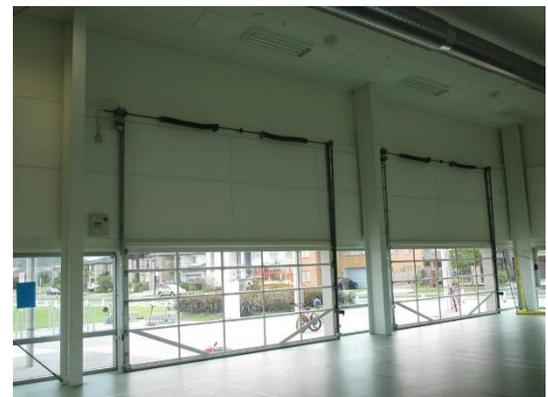
Figure 27

- The Principal reports that the heating and hot water system throughout the school is good and that staff found it effective.
- The roller doors in the Multi-purpose space work well to open up this space to allow indoor/outdoor activity. See Figure 27.
- Staff reported that the installation of the Autex lining to all walls in the learning spaces prior to installation of furniture has contributed to good acoustics, a versatile display area and has allowed flexibility in furniture placement. See an example of this lining in Figure 28.
- The manual controls for the opening windows are preferred by the staff and seen as less of an invitation for children to play or tamper with controls.

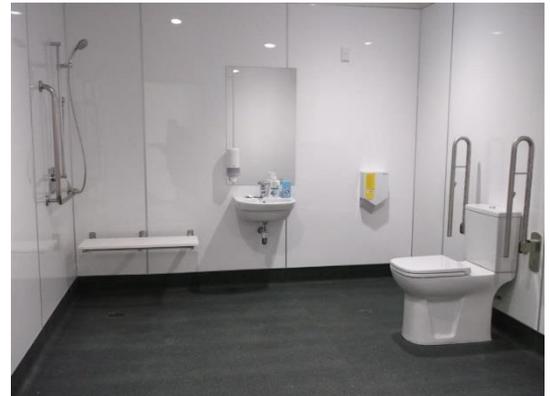
Figure 29

- Toilets and bathroom fittings and linings are well specified and are easy to clean. See Figure 29.

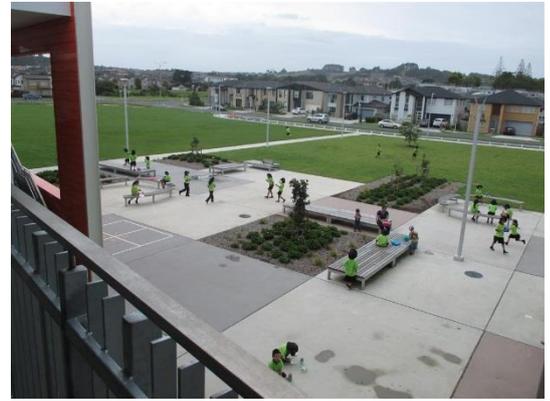
Figure 33

- Reception has insufficient opening windows to provide ventilation. Reception staff also identified the winders to windows are slow and noisy.
- There is no shade provided to any outdoor seating within the school grounds. See Figure 33.

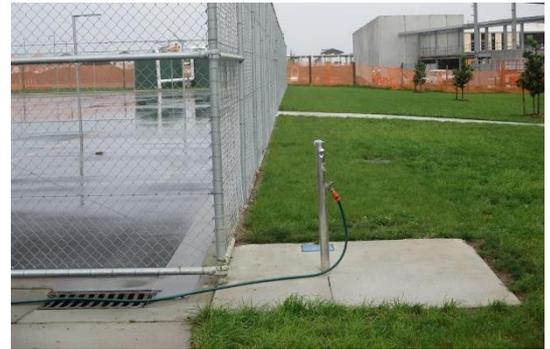
- Drinking fountains are provided by the sports courts, and are considered sufficient by users for that area. However, users are concerned that there are not enough drinking fountains throughout the rest of the school. See Figure 34 of the fountain adjacent the playing courts.

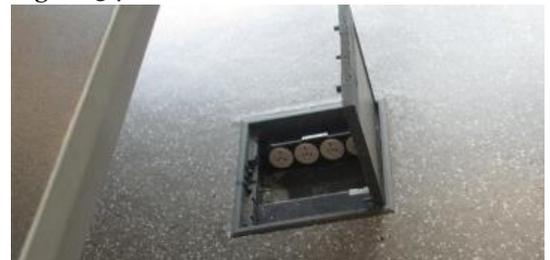
Figure 35

- The Principal has questioned the practical merit of the floor power boxes and general power point layout. The current arrangement has little use for the school operations and is not practical for either staff or students. See Figure 35.

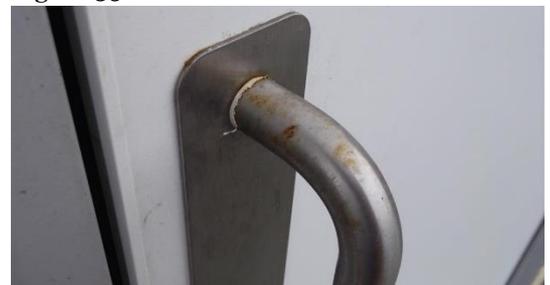
- Exterior door handles to the externally accessed bathrooms near the multi-purpose space were noted to be corroding. This indicates that the steel installed is not suitable for the level of exposure they experience. See Figure 36

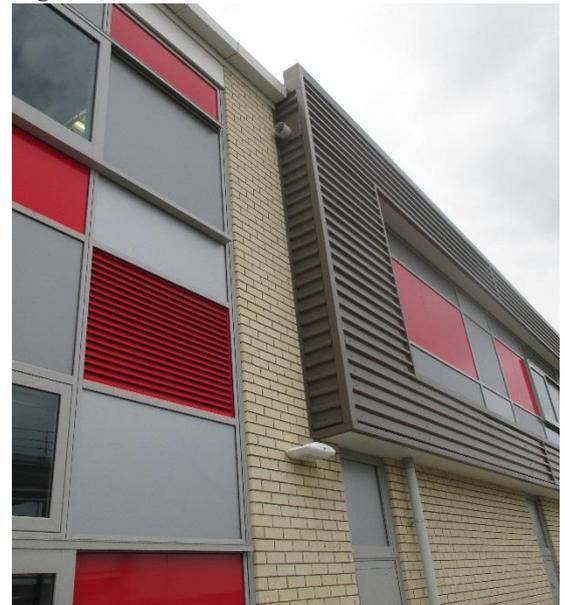
Figure 38

- Bicycle and scooter parks are available on site. Users report these are effective, and they appreciate these have been located in an area with good lines of sight from learning spaces for security of the bikes/scooters.
- The exterior cladding, which consists primarily of brick, fibre cement and profiled metal, has been well specified for durability. The cladding material selections meet MoE Weathertightness and durability requirements, as well as those of the building code. See Figure 38.

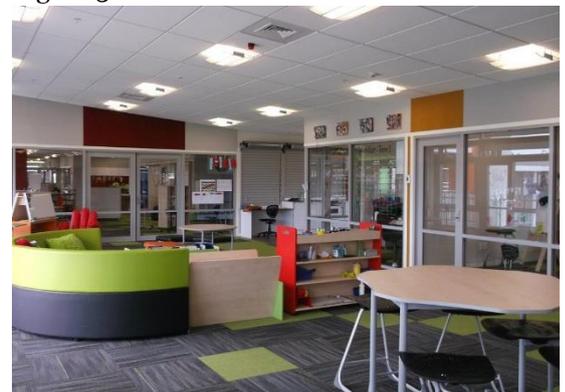
Figure 39

Carpet tiles have been installed to all learning spaces and high traffic areas. The specification of carpet tiles enables replacement of only damaged areas of the flooring, as opposed to replacing carpet through an entire room. See Figure 39.

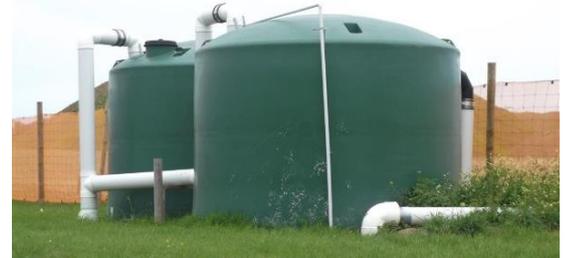
Figure 40

- Ormiston Primary School has a rainwater harvesting system in place. The two large water storage tanks are located by the courts. These are linked to act as a 'first flush' system, which removes the majority of microbiological contamination. See Figure 40.

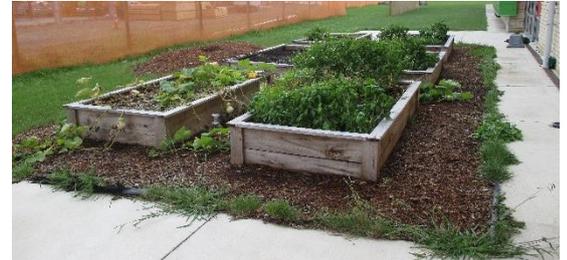
Figure 41

- The school has a vegetable garden area, and a worm farm for composting organic waste. These are used as an educational facility within the school. See Figure 41.

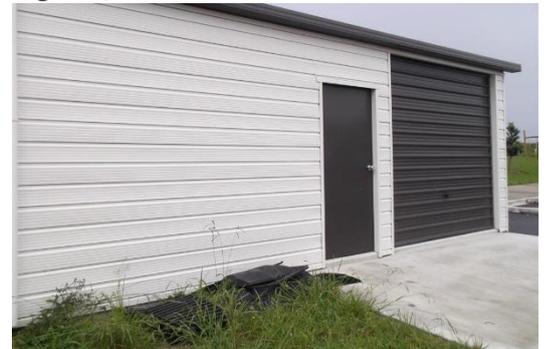
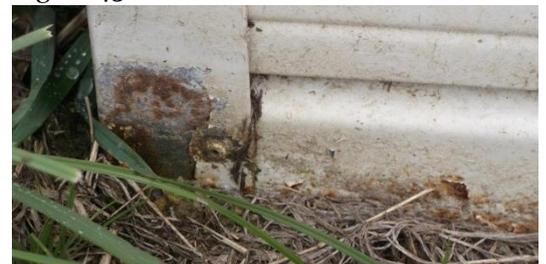
- A separate caretaker's storage shed was put up by the contractors during the build period, but does not appear to have been part of the masterplan. The door does not shut properly and the unit is already showing signs of corrosion at the base due to lack of ground clearance. See Figure 43 and Figure 44.

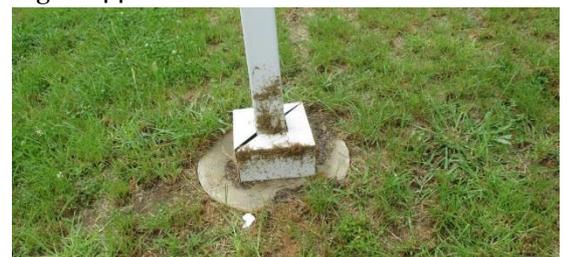
Figure 45

- Protective ground boxes at the base of light poles are easily damaged. These now expose the pole foundation and sharp edges to students. See Figure 45.

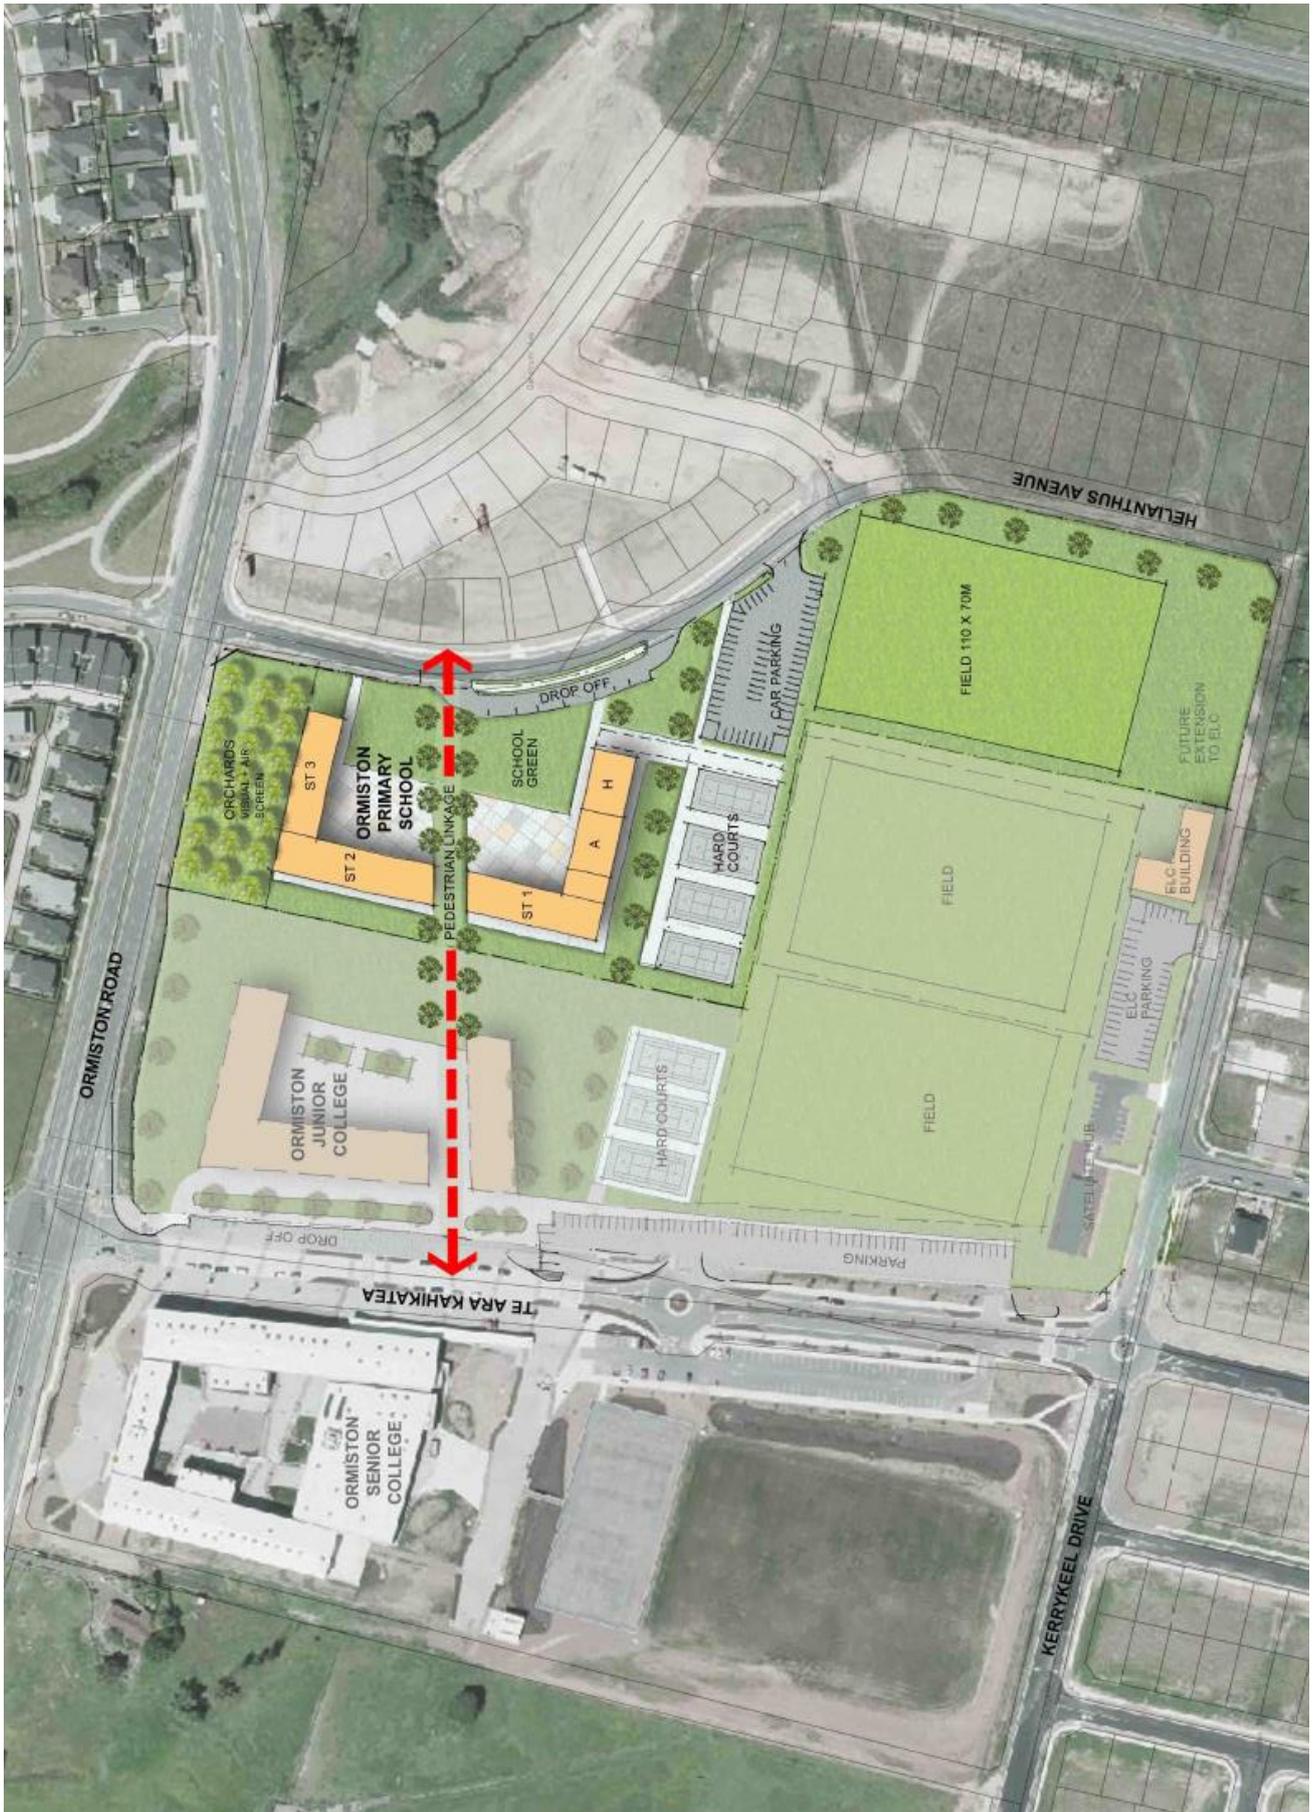
6.3 DESIGN SITE PLAN

Figure 46 – The building comprising ST1, A and H were complete at the time of the survey. The building containing ST2 and ST3 is planned for future construction.

- The layout of Ormiston Primary School is such that it will provide pedestrian flow through to the adjoining junior college when it is completed. See Appendix 6.3 for how this connection is planned to function.
