POST-OCCUPANCY EVALUATION REPORT

TE KARAKA AREA SCHOOL

GISBORNE DISTRICT | JUNE 2015

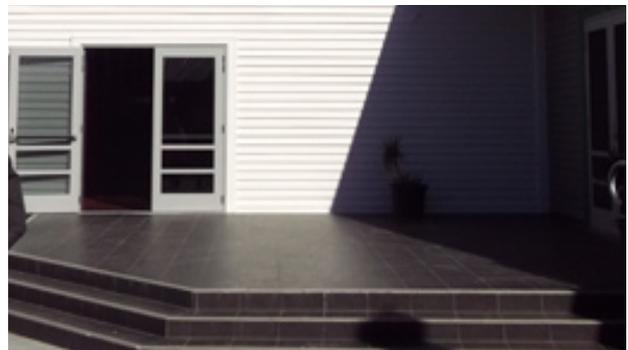
Of those surveyed, 55% stated that some of the internal and external finishes were ‘not safe’ or ‘quite safe’ for its occupants. The main issue was the external tiles to the entrance of the administration and gym buildings being very slippery when damp (see graph Q16 below).

Slippery tiles to entrance of both the administration and gym buildings

1. Exterior landscaping materials need to have sufficient slip resistance to ensure safety. The tiles in front of the gym and administration appear unfit for purpose in this regard.

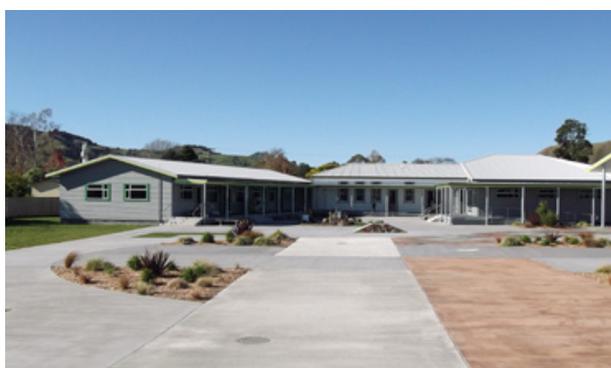
Technology building with continuous external canopies

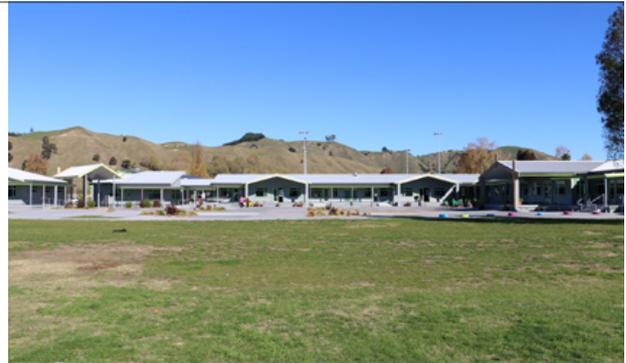
The learning centres have been built using standard timber frame construction with horizontal weatherboard cladding. The school buildings have good eave protection with external gutters. These buildings are simple and low-risk. During the interviews it was noted that the school is not currently experiencing any abnormal maintenance issues. The buildings are in good condition and there are no obvious indications that the structure will not be easily maintainable and have a long service life.

Learning centres built with standard timber frame construction

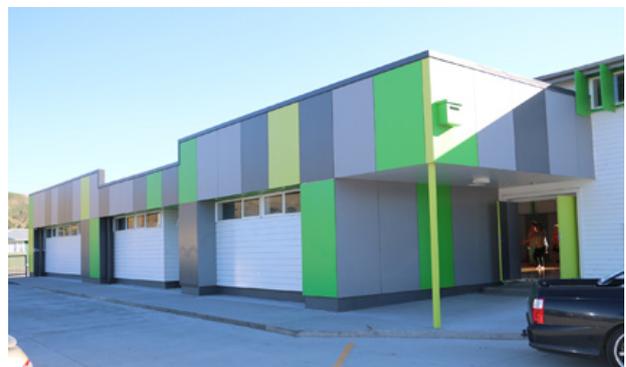
The gym is mostly clad in a weatherboard, with the roadside elevations to the gym clad in a more modern flat sheet material. These areas appear to have internal gutters, which is not recommended. This will require ongoing monitoring maintenance by the school.

Gym clad in weather board and flat sheet metal

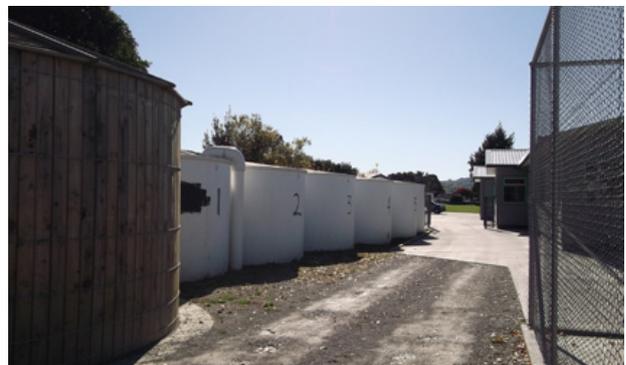
The school's location meant that it needed a potable water storage system. The roofs collect the water for reuse. During the interviews it was stated that the system at handover was undersized for the school's needs and the school had to limit the attendance of the students shortly after opening due to water shortages. Further investigation is required to understand this issue in more detail before making any recommendations.

Portable water storage system undersized for usage

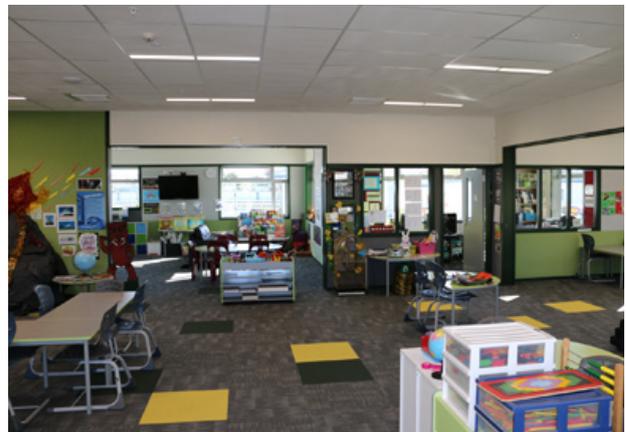
During the interviews it was noted that the interior sliding doors are too heavy for the junior users and the bottom guides continually required realignment, and on-going management by the school. Consideration should be given to this by future design teams.

Large internal sliding doors are difficult to use

2. The size and weight of doors should be considered in the junior areas of the school. These areas are not always designated in MLE, but consideration should be made in the design stages.

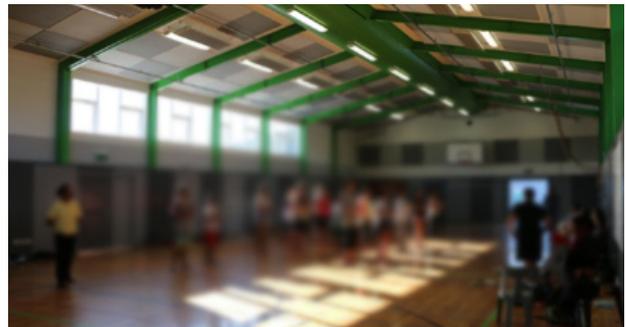
44% were 'quite dissatisfied' or 'very dissatisfied' with the sports facilities. The main feedback on this was that the gym court is very close to the side of the hall. Therefore a very limited number of spectators can stand and watch the sports games. There is no seating area provided in the hall and although the hall was an existing building, adjoining areas were refurbished. Further investigation is required to ascertain why no allocations for seating or spectator areas were made (see graph Q6 below).

No allocations for seating or spectator areas were made in the hall

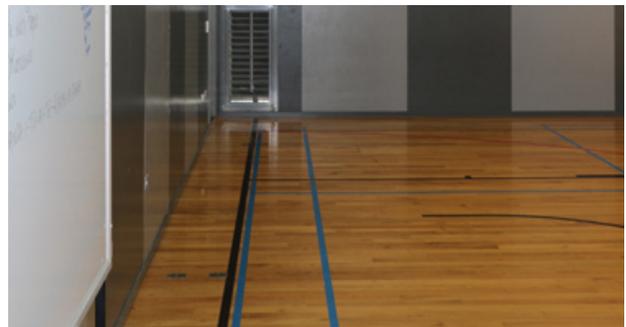
No allocations for seating or spectator areas were made in the hall

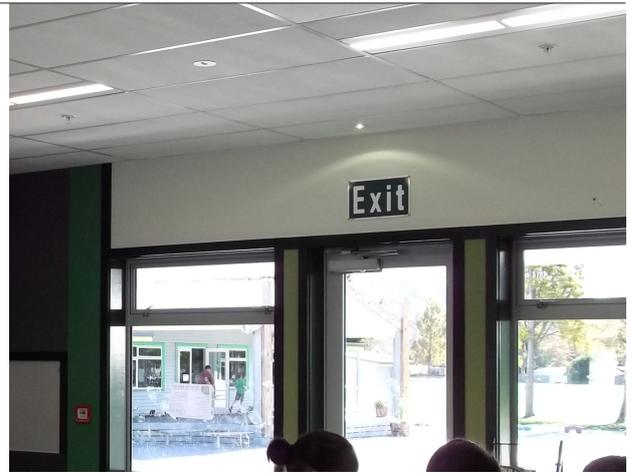
The ventilation is supplied to the learning centres by a natural ventilation scheme (manual operable windows). Mechanical extraction fans in the ceiling assist with air movement and circulation and extract stale air out through the roof. The learning centres are designed diagrammatically as a cluster of rooms. The below floor plan shows areas which are two rooms deep, which will minimise the effectiveness of cross-ventilation strategies. The withdrawal spaces (breakout spaces) on either side of the central collaboration space (learning centre) have operable windows on both sides to allow cross-ventilation. Further investigation is recommended to understand the effectiveness of these windows for ventilating the learning environment.

Operable windows

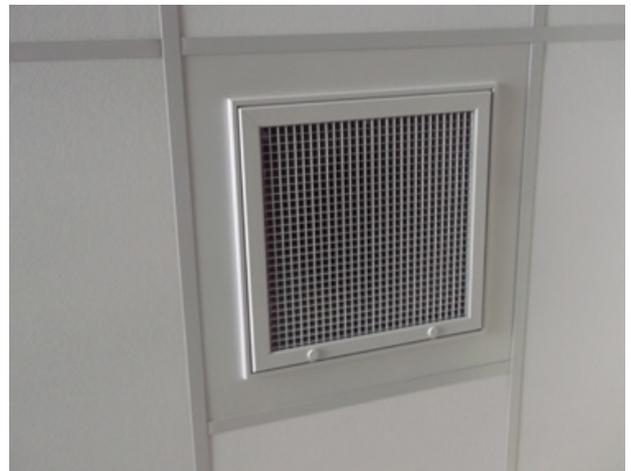
Ventilation extract grill in ceiling

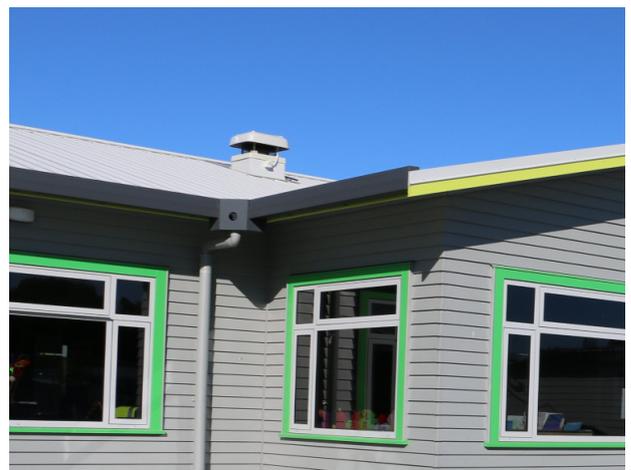
Ventilation extract grill through roof

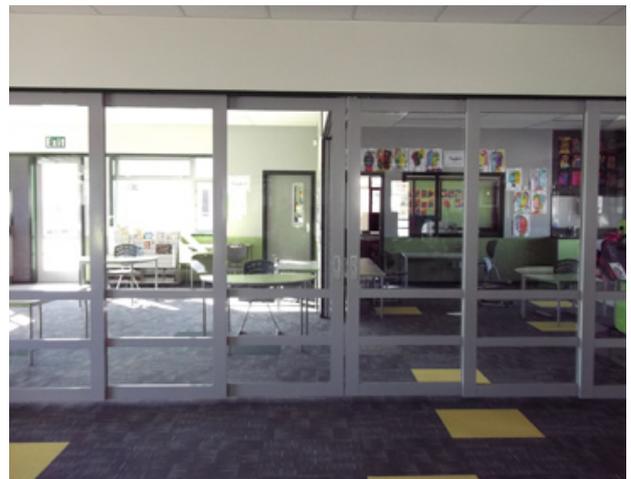
The internal acoustic environment within the learning centres are controlled with a mixture of suspended ceiling tiles, pin-boards, carpet tiles and large sliding doors assist to control sound between studios

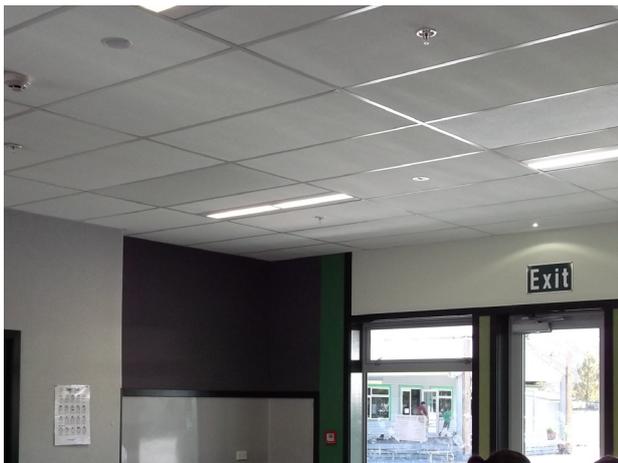
Acoustic pin-board, carpet tiles and suspended ceiling tiles

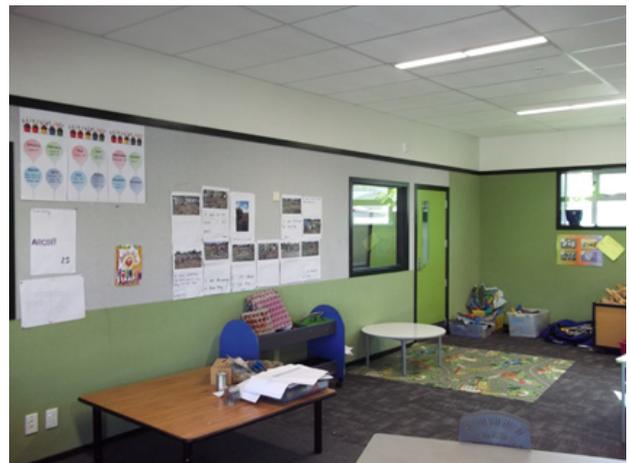
Acoustic pin-board, carpet tiles and suspended ceiling tiles

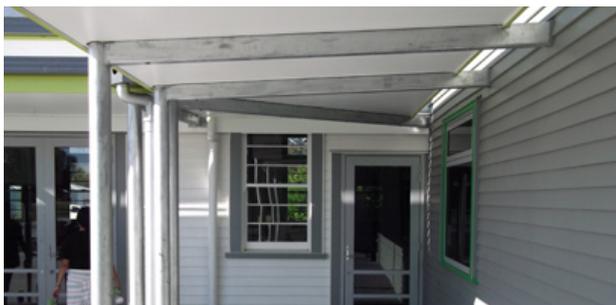
Gap between canopy and building

4. The external canopies should adjoin the buildings to offer full weather protection.
5. In this instance the Principal was part of the design team. This benefitted the school positively as the school's educational vision could be aligned with the facilities at the outset. Further strategies should be explored to assist the pedagogy development of new schools within the design phase.

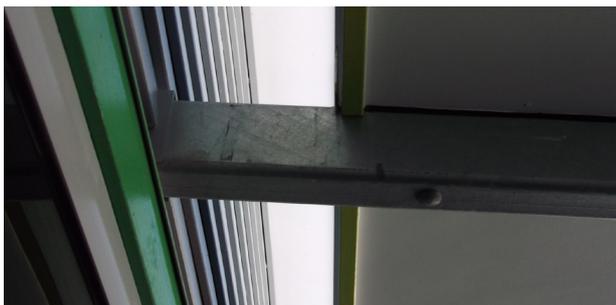
Gap between canopy and building

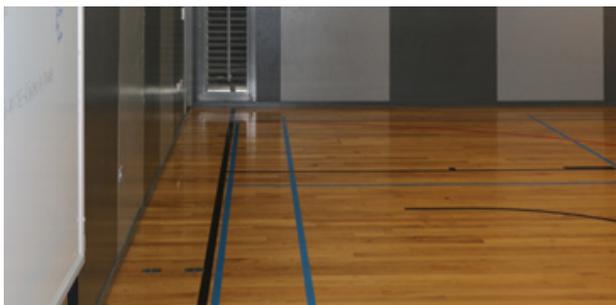
Limited space around court for spectators
