POST OCCUPANCY EVALUATION

KIMI ORA SCHOOL NAENAE, UPPER HUTT

June 2016

Date: June 2016
Reference: 1-46083.00
Status: Final

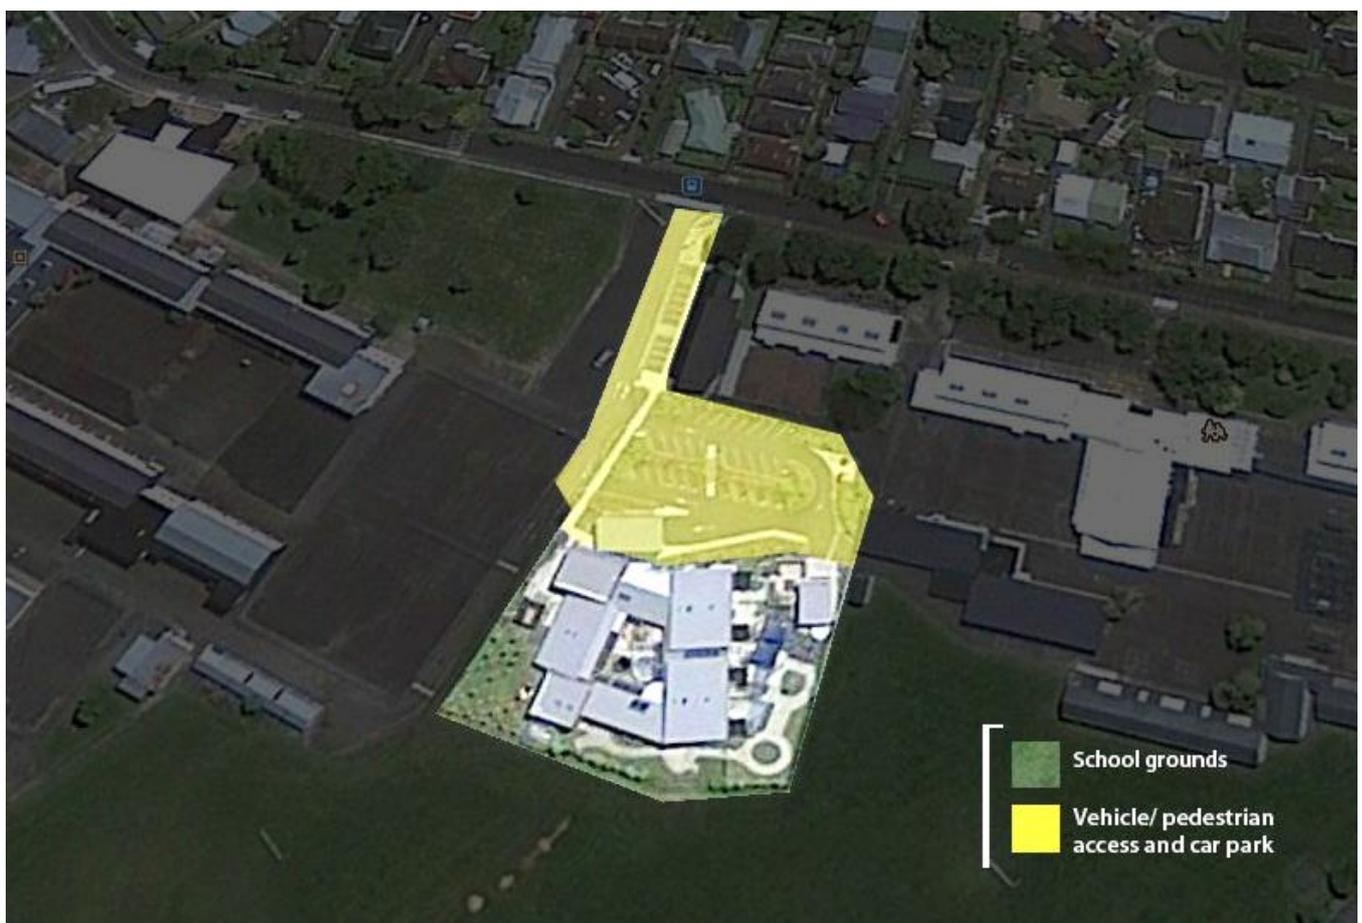
Figure 2

- The school describes the vehicle route onto site as flowing effectively due to the one way loop system with separate entry and exit. The separate entry and exits are in line with MoE guidelines. The looping vehicle route has been effective for buses and taxis too. MoE guidelines require a separated route for buses, however this would not work as well for Kimi Ora, where many students have limited mobility. See Figure 2.

- Car parks for staff, visitors and delivery vehicles are in line with the requirements of the Greater Wellington Regional Council. See Figure 2. Visitor's car parks are clearly labelled.

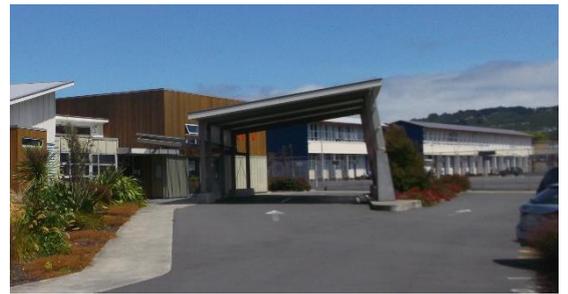
Figure 3

- The drop off zone works well for student arrival and departure. The drop off zone is covered and close to the main building entrance. See Figure 3. Staff, students and parents appreciate the cover provided and the locality to the main entrance given the difficulties the students have with mobility.

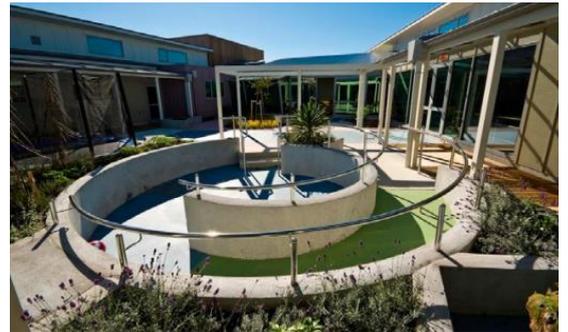
Figure 4

- The accessible route through the site and buildings is continuous. All areas of the buildings are accessible via the internal circulation route, which loops around the central courtyard. Users report that the simple circulation route is effective for wayfinding. See the central courtyard and surrounding building in Figure 4.

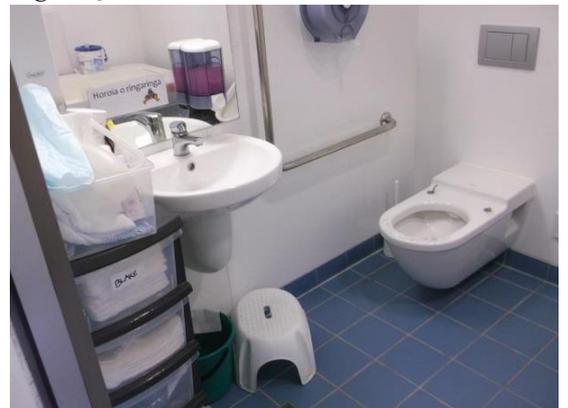
Figure 6

- All toilets throughout the school accommodate high dependency users. Staff report that access to the toilets and the facilities within are of a good standard. The bathrooms meet NZBC requirements for accessibility. See Figure 6.
- The High Dependency Spaces each have a power outlet located appropriately for a hoist. Emergency call/panic buttons are installed. There is an additional power outlet adjacent to the WC, both RCD protected. These aspects are in line with the MoE Guidelines. See Figure 7 and Figure 8.

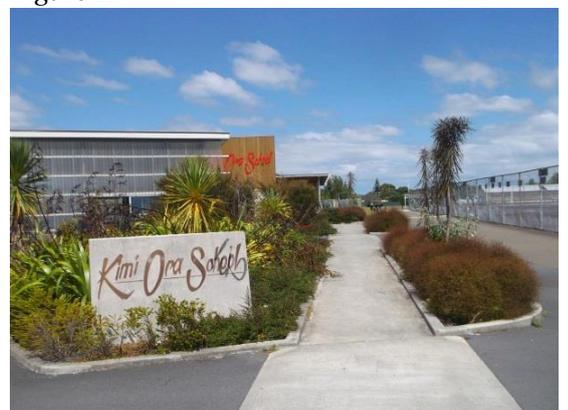
- The pedestrian route to the school is not separated from the main vehicle route. Pedestrians must cross the vehicle route twice to get to the school entrance. See Figure 12 and Figure 13. There is also a pedestrian pathway linking Kimi Ora’s site to the neighbouring college, to which there is no alternative route to access other than crossing the car park.

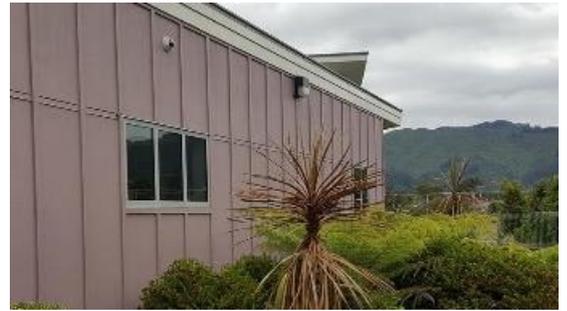
- Cameras have been installed, as have external lights to the building perimeter, exterior doorways, walkways and drop-off zones. The lights ensure the building is well illuminated and at night. See Figure 17 showing a dome-type security camera and exterior bulkhead light to the perimeter of the school.

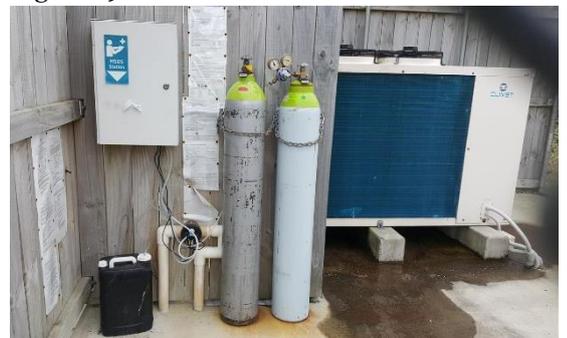
- A low pressure hot water underfloor heating system is in place throughout the school. This system is appreciated by staff as it poses a lower risk to student safety than alternative heating systems. Figure 20 shows the heat pump serving the underfloor heating.

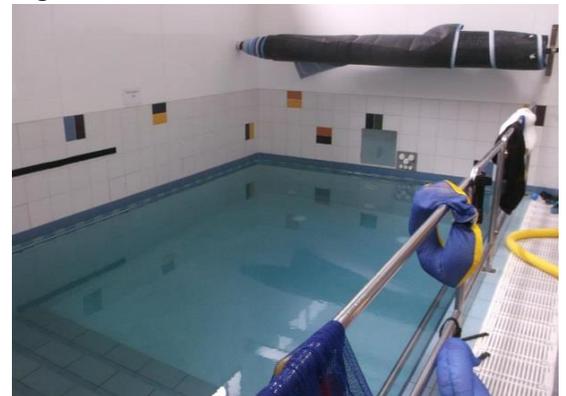
- Lockable roller doors are in place to close off kitchenette and computer desks within the learning spaces to protect equipment. See Figure 27.
- The school has hydro-pool for physical therapy. According to staff the pool facilities work well for the users, aside from the room temperature (noted overleaf). See Figure 28 .

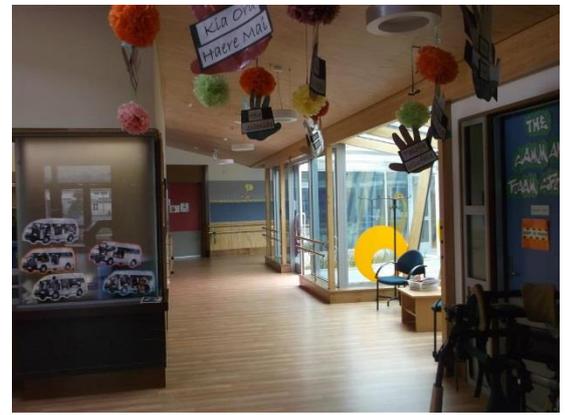
Figure 30

- Staff perceive the lighting throughout the school as effective, stating the school is a “Lovely, light, bright environment”. Of particular favour among the staff was the main circulation route, which was well lit internally, with supplementary natural lighting throughout from the glazed walls to the central courtyard. See Figure 30.

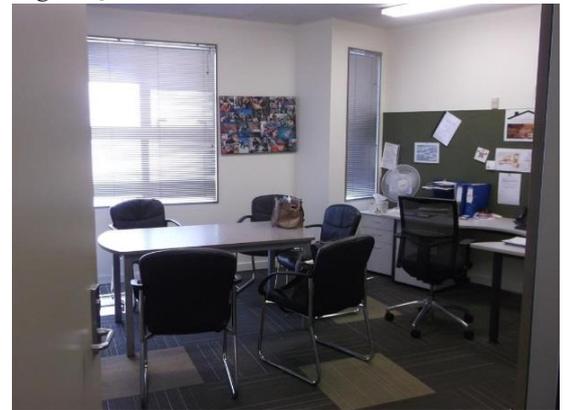
Figure 31

- The staff meeting room is also the Principal’s office, which staff find to be an effective use of space as opposed to a separate Principal’s office. Due to the high-dependency nature of the students, the staff have lots of meetings with parents and have found the room to be useful. See the room in Figure 31.

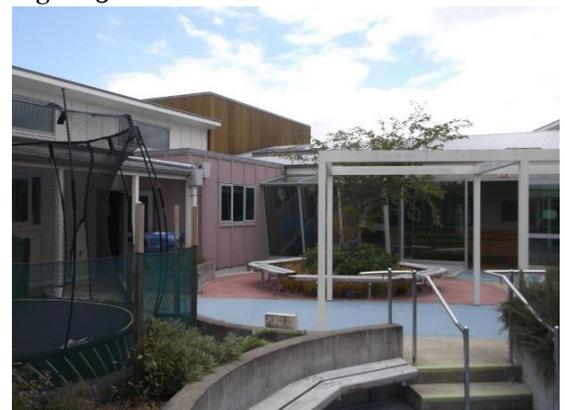
Figure 32

- The outdoor areas are easily accessible, with wide, flat paths and approaches to entrances. The orchard, garden area and courtyard are used both during breaks and class time. Staff found the outdoor areas of the school very practical and useful. See Figure 32.

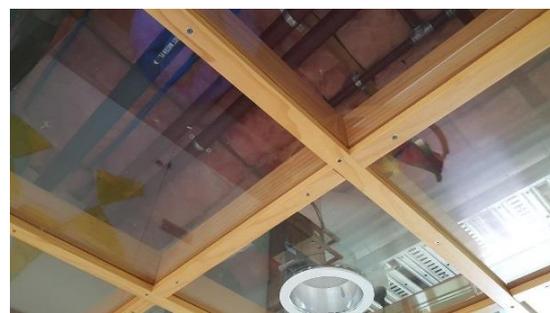
Figure 43

- There is a lockdown system in place for the school, which allows staff to quickly respond to any security event and keep occupants safe.
- Services are well secured behind secure panels, within ceiling voids or in locked cupboards. This ensures the services are not exposed to potential damage do not impede circulation routes. See Figure 43.

- Fixtures, fittings and linings in wet areas and bathrooms were generally well specified, allowing for ease of cleaning and are robust.
- The buildings and site effectively provide opportunities for use as a learning resource. There are several glazed panels throughout the school that expose the ceilings, walls and service features to users, such as waste and water connections and the underfloor heating control panels. The rainwater collection system for the garden is out in the open and accessible to students and is sited alongside the gardens at the rear of the school. All these features provide opportunities to learn about sustainability, energy efficiency and buildings themselves. See Figure 43.

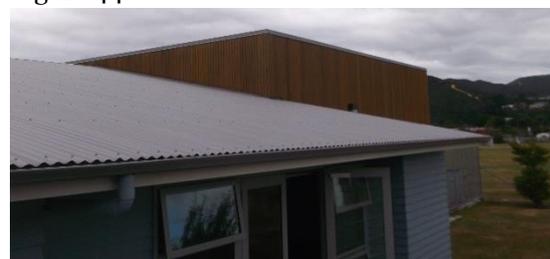
- The building roofs are of simple form, avoiding complex junctions and internal gutters where possible. The roof material is primarily profiled metal, which is widely available and understood, and easy to maintain. These aspects are in line with the NZ Building Code, and are best practice for minimising maintenance requirement and weathertightness issues. As yet there have been no issues with building leaks according to staff. See Figure 45 showing the simple roof forms and details.
