POST-OCCUPANCY EVALUATION REPORT

TKKM O TAUMARUNUI

TAUMARUNUI | FEBRUARY 2016

DRAFT REPORT

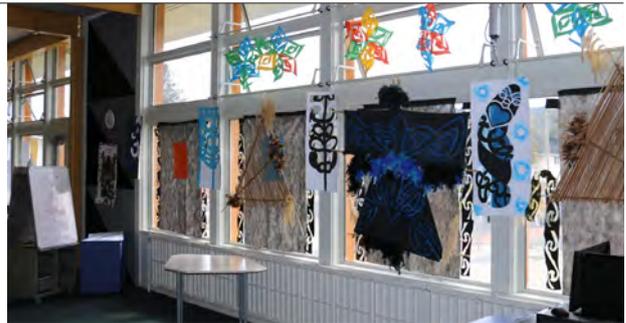
Operable windows in the learning environment (north facing)

The survey respondent, principal, and office manager all stated that the internal temperatures of the learning spaces were insufficient in summer to support student learning. It was stated that the learning environment was ‘very hot in summer with no cooling system available’. It is evident that the natural ventilation strategy is not providing enough cooling to control the internal environment in summer. It is recommend that options to reduce the northern solar heat-gain is explored, with external shading a possible option. A more effective cooling strategy should also be developed and implemented to ensure the comfort of its occupants.

6. The natural ventilation system does not provide sufficient cooling in the warmer months. The evaluation team recommend that additional external solar protection is installed on the north facing windows of the learning environments in order to reduce the heat-gain in the space. In addition, a more effective cooling strategy, which includes both passive and active systems, is recommended.

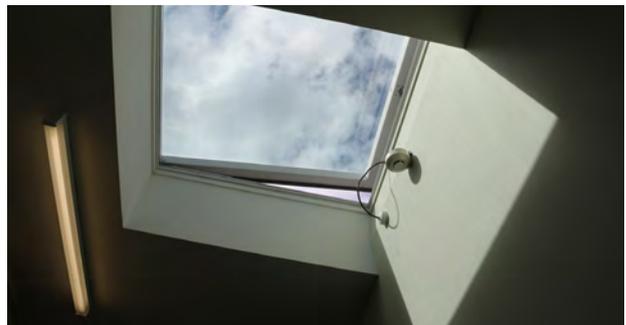
It was stated during our on-site evaluation that 'the skylights did not always open, or if it rained they closed'. It was also stated that the skylights had leaked on occasion requiring repairs and maintenance.

Skylights in the 'learning street' area are designed for cross-ventilation

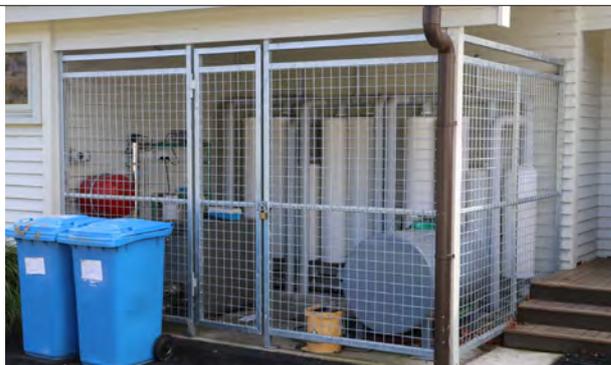
Diesel boiler provides good heating to the kura

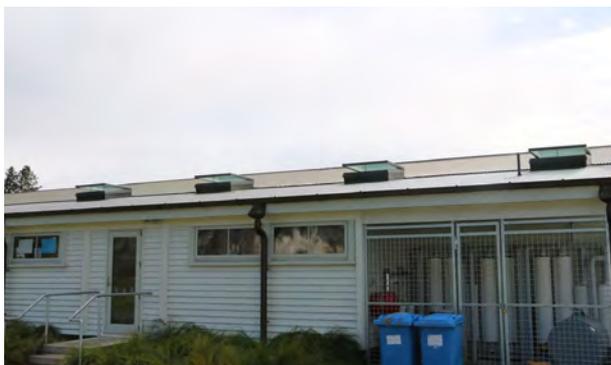
Skylights open on a sunny day

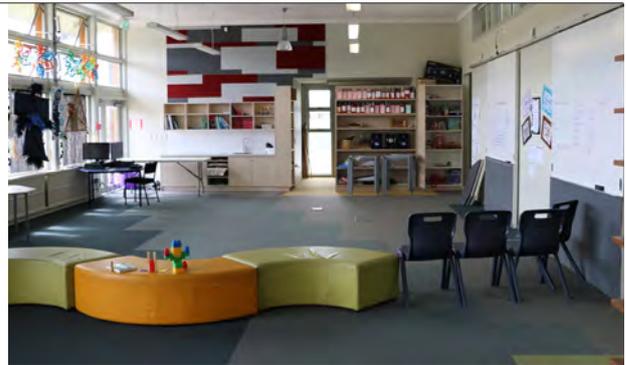
The evaluation team noted that the acoustics of the learning spaces could have the ability to become quite 'lively' when at full capacity due to the plaster board ceilings, volume of glass and limited acoustic absorbing material on the walls and ceilings. This could be a particular issue within the Wharekura learning space when two classes are working simultaneously. During the interviews staff stated that they found the Wharekura space difficult to teach in at times due to the poor acoustics.

The survey respondent, when asked to rate the acoustic environment of their classroom, stated that it was 'poor' and it 'echoes'. The respondent stated that distracting 'noise from other classes' was also an issue. Since opening, the kura have installed additional acoustic wall and ceiling panels, however, the evaluation team recommend an acoustic engineer provide specialist advice on each space.

Wharekura learning space has pin board, carpet and ceiling panels

2. Staff who taught in the Wharekura learning space expressed that they found it difficult to deliver their pedagogy due to 'poor acoustics'. Although additional acoustic panels had been installed by the kura, the evaluation team recommend that an acoustic engineer undertake diagnostic testing.

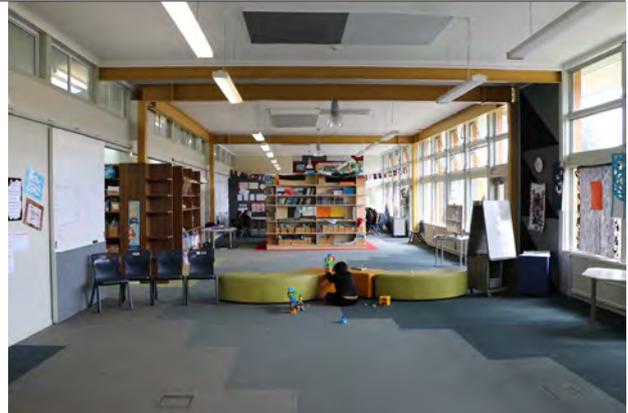
A commercial method of structural design has been applied to the new learning environment. The existing timber structure has been supported by a new steel system, which allows for open and airy spaces. The new structure spans the width of the building, effectively limiting the amount of bracing or load bearing on its internal walls. This allows the internal spaces of the building to be adapted, should the need arise. The regular and simple form of the spaces will lend themselves to be cost-effectively adapted in the future. In most instances, learning space ceilings are generous in height which is viewed as a positive attribute of the learning environment.

Flexible learning spaces

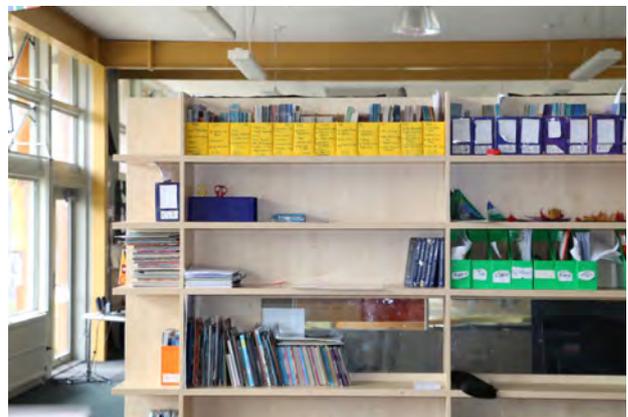
The new structural steel system can be seen in the back ground

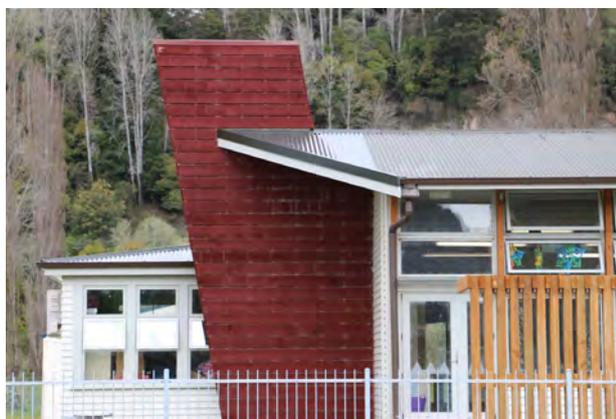
The existing building has been designed to represent a waka

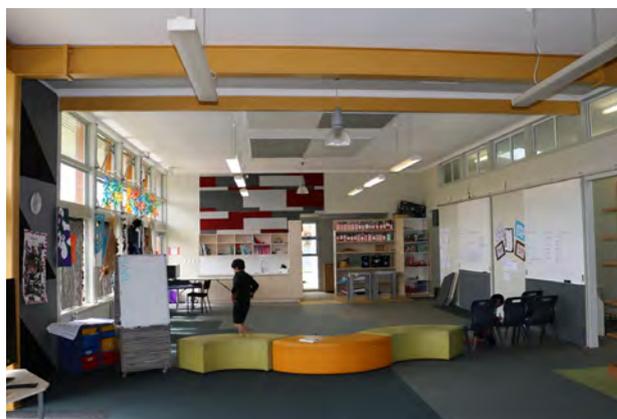
1. 'The size of the Wharekura learning environment for multiple uses like Kapa Haka' was seen as a positive attribute
2. The 'height of the rooms' which 'give a spacious feeling'
3. The 'power sockets' in the floor boxes to allow digital devices to be used in a flexible manner
4. The 'external canopy provides good protection' to the outdoor learning/performance area.

The Wharekura learning space

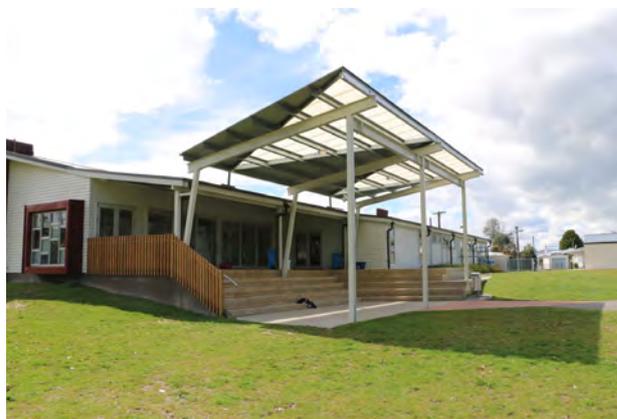
The external canopy provides good weather protection
