POST OCCUPANCY EVALUATION

TE KURA MANA MAORI O WHANGAPARAOA, NEAR OPOTIKI

May 2016

Date: May 2016
Reference: 1-46083.00
Status: Final

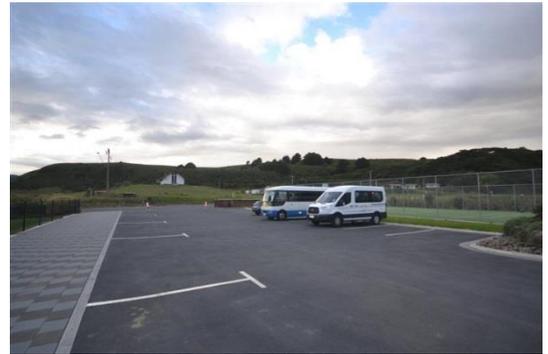
Figure 4

- The School car parking facilities are off street and within secured school grounds. Staff car parking is located adjacent to the school buildings. See figure 4. Users report that the car parking areas work well.

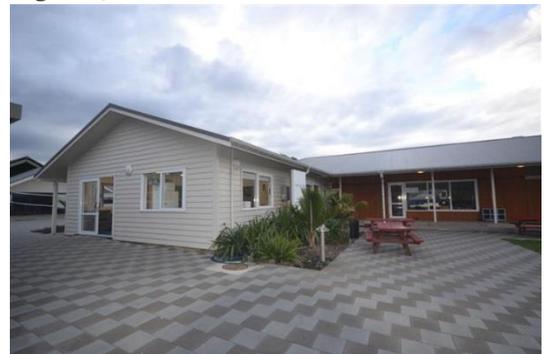
Figure 5

- The school grounds are relatively level and the buildings are all single storey - see figure 5. Staff advised that all areas of the school are accessible to those with special needs.

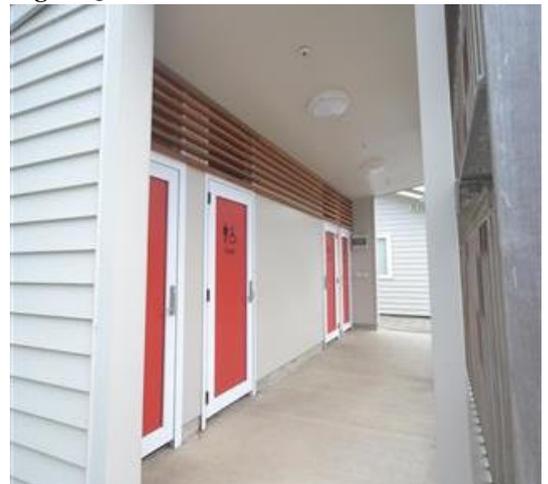
Figure 6

- According to users, the outdoor toilet block is well placed. The toilet block is located centrally between teaching blocks and the hall. There is natural ventilation above toilet doors and an external lobby area which is sheltered from wind and rain- see figure 6.

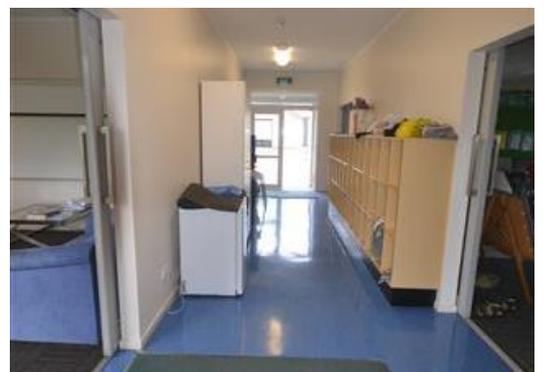
Figure 7

- Users advised that the building services are well placed in and around the school grounds and do not protrude into spaces or circulation routes.
- The width of internal circulation routes and corridors meets minimum Building Code requirements for accessible / wheelchair users - see figure 7.

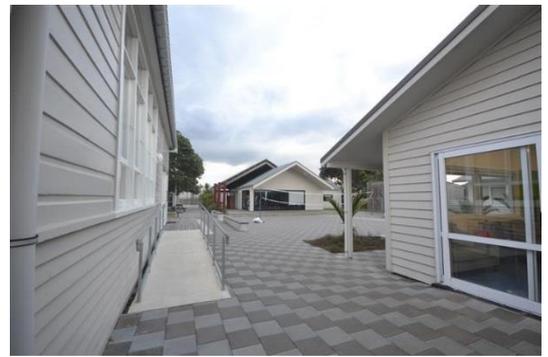
Figure 8

- The main reception is accessed via steps and an accessible ramp. The ramp complies with the criteria of the building code in terms of slope and provision of handrails. There is ample space internally for wheelchair users and a seating area provided for visitors. See figure 8 of the accessible ramp.

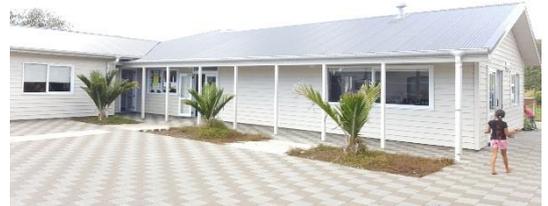
Figure 9

- The entrances into the buildings have verandahs and canopies which provide weather protection to the building and students navigating the grounds. See figure 9 of an example canopy/verandah.

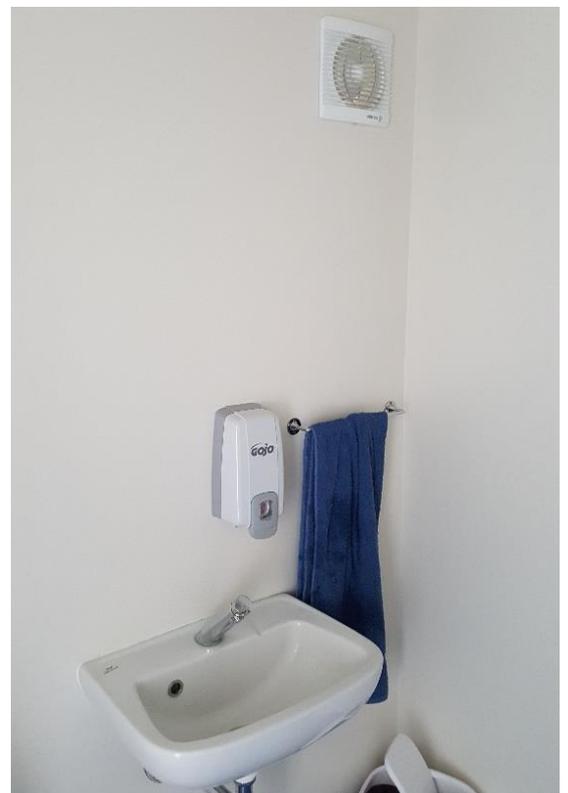
Figure 13

- There is a panic alarm in the school to signal / alert an external security monitoring company in an emergency.
- Staff advised that ventilation is good within toilet facilities. All internal toilets are equipped with a mechanical extraction system. External bathrooms are naturally ventilated. See figure 13 of an internal bathroom with a wall mounted extractor fan.

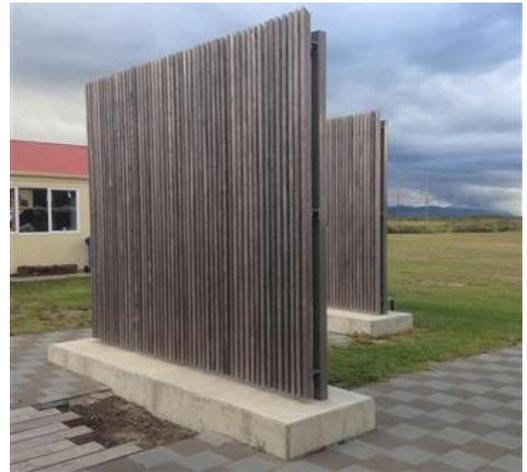
Figure 14

- The wind buffers between the rear playing fields and school grounds effectively protect the site from the severe coastal winds according to staff. Staff believe that the outdoor play and

circulation areas are more functional spaces than they would have otherwise been as a result. See figure 14 of the wind buffers.

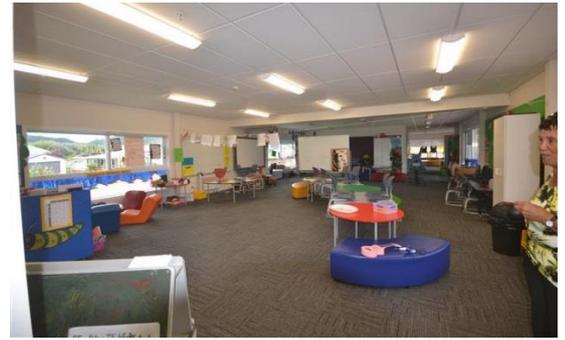
Figure 17

- The new, modern learning spaces deliver large, open plan teaching areas which are flexible and practical and encourage collaborative work between classes, according to staff. See figure 17.

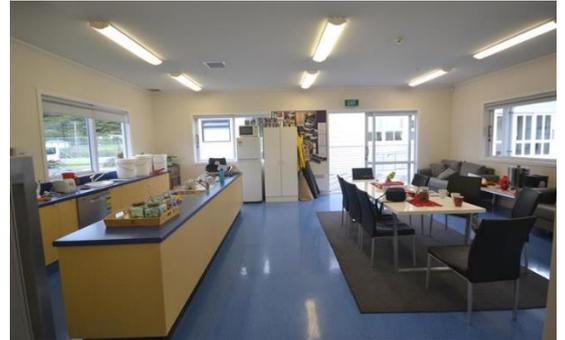
Figure 18

- The staff room is located in the new kitchen area which is utilised for food technology lessons and a breakfast club. It is also utilised as catering facilities for community lead events. See figure 18.

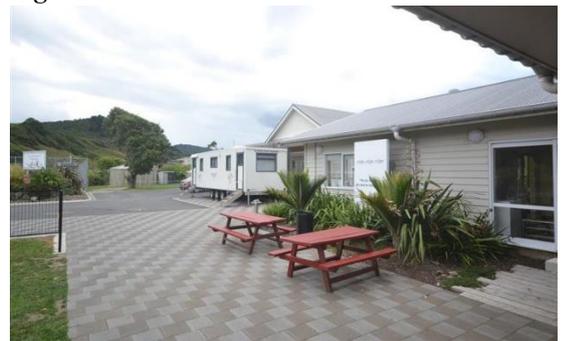
Figure 19

- Movable outdoor seating/tables were preferred by the school as opposed to fixed, as the flexibility it allowed encouraged the use of external spaces. See figure 19.

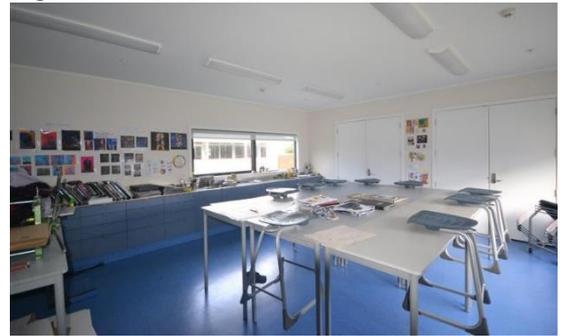
Figure 20

- Users report that the facilities and areas within the school that support project and wet work have stood up well to general use and mess/spills. The project room adjacent the new hall can be seen in figure 20.

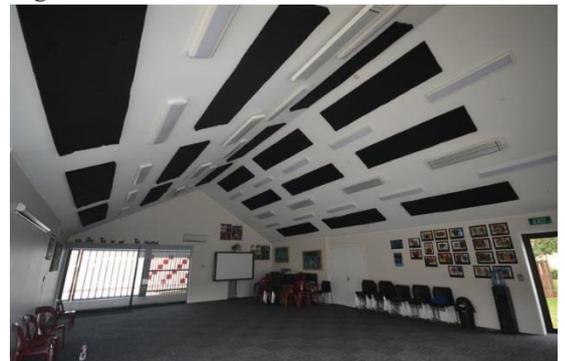
Figure 21

- The new school hall reportedly works well as additional teaching space and for group assemblies. The hall is also utilised by the local community, and is easily accessible to all users including those with special needs. See the hall in figure 21.

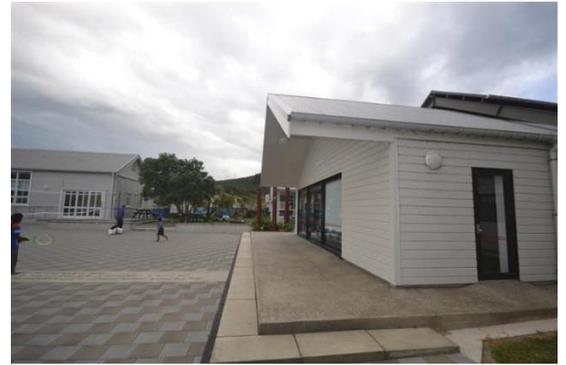
Figure 22

- The hall is located such that it is connected to both the rear playing fields and front courtyard, which staff found effective in providing an extension on the space available for physical education classes. See figure 22.

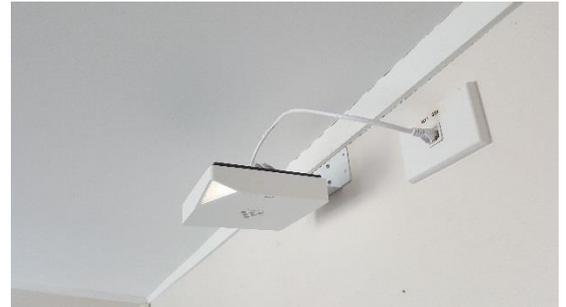
Figure 23

- The School almost exclusively uses their own Wi-Fi network. Hard wired LAN data points are located and installed in accordance with the MoE guidelines in place at time of design. See figure 23.

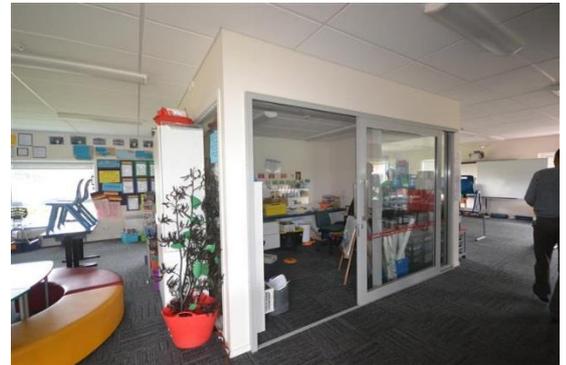
Figure 24

- Staff feel that the teachers work room did not provide enough privacy and quiet for their use, so this has been adapted for use as breakout rooms instead. The staff commented that there is no space available in the school and appropriate for use as teachers work rooms. See figure 24.

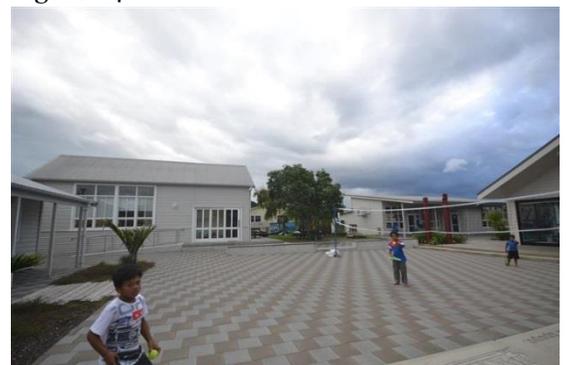
Figure 25

- There are no sheltered outdoor areas on school grounds or rear playing fields apart from verandahs on the buildings. According to staff sun shades were initially provided, but these did not last due to the extreme weather conditions experienced at the site. See figure 25 of a central location of the school, indicating the lack of shaded areas for students.

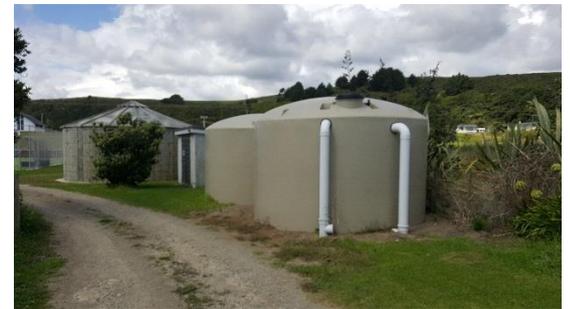
Figure 28

- The school has a rainwater harvesting system with water storage tanks on the school grounds to feed sprinklers. The rainwater harvesting is supplemented by a local community bore. See figure 28 of the rainwater tanks.

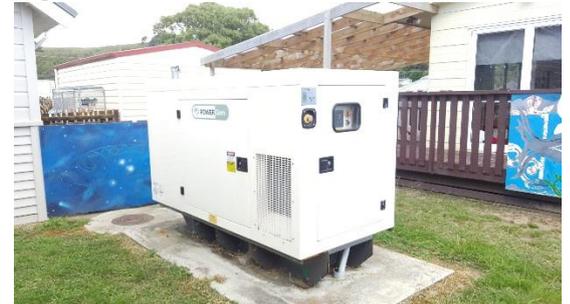
Figure 29

- There is an emergency generator on the site for when the main power cuts, the head of school reported that this happens on quite a regular basis- see figure 29.

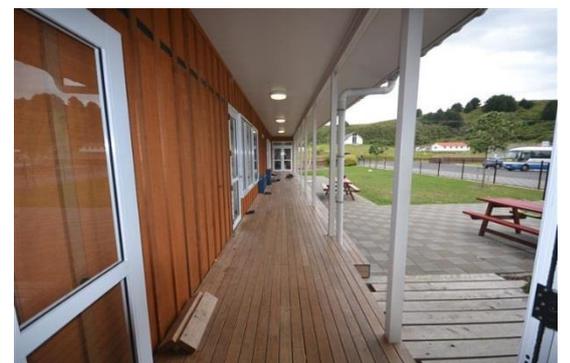
Figure 30

- The materials used for the external decking and paving is durable and fit for purpose. Staff perceived the finish as high quality. See figure 30.

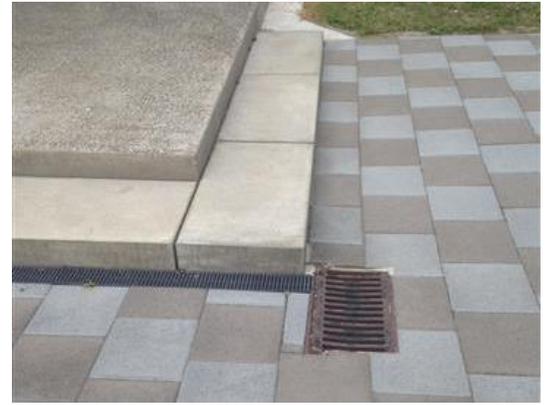
Figure 31

- The paved outdoor courtyard often floods. According to staff the drainage facilities are not adequate to cope with the high levels of storm water in the area. See figure 31.
