POST OCCUPANCY EVALUATION

PEGASUS BAY SCHOOL PEGASUS, CHRISTCHURCH

Date: July 2015
Reference: 1-46083.00
Status: Final v 7

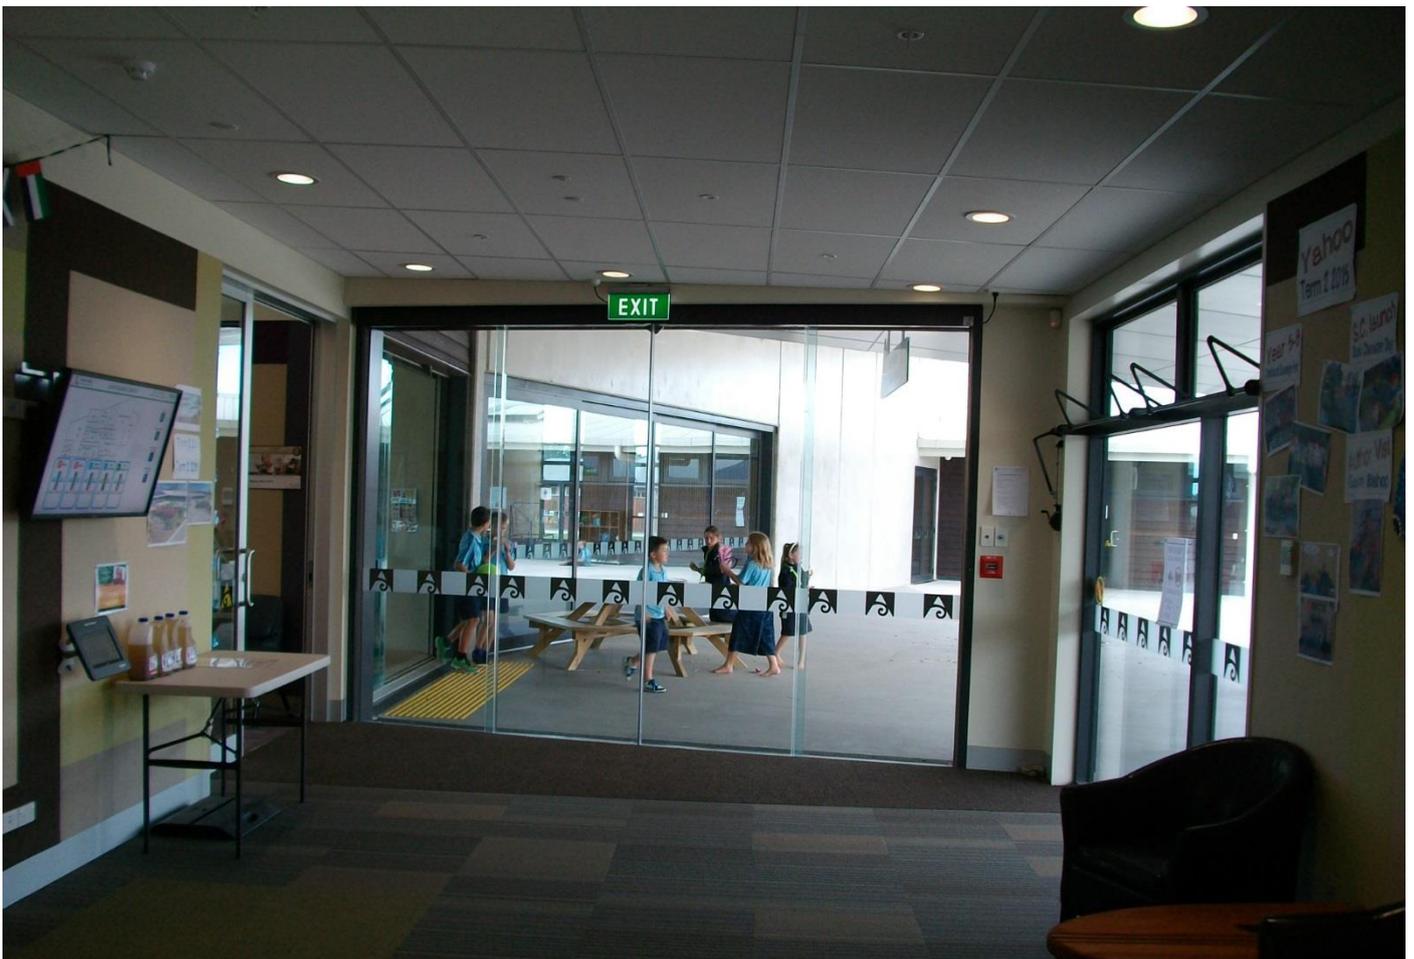
Figure 6

View from reception towards reception entrance doors and central courtyard.

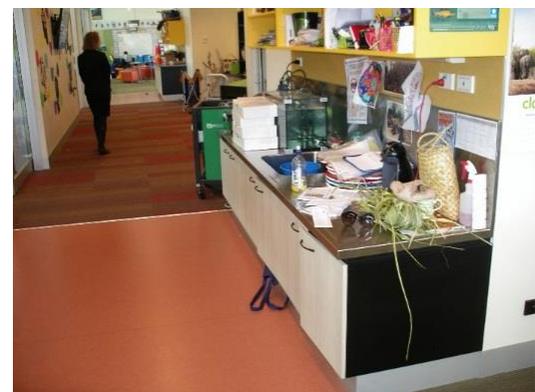
- There are child safety risks associated with the road finish adjacent to the school where the roundabout has a cobble finish used by students as a pedestrian way.
- Reception has no visibility to the front of the school with no way of monitoring visitors unless they report voluntarily.
- The main entry door is automatic and unmonitored allowing students to access the car park and road.
- Wet areas incorporated into circulation areas are a possible slip hazard as the vinyl is not slip resistant. See Figure 10
- The office glazed partition wall adjacent reception has an exposed unfinished glass edge and is a cut hazard.

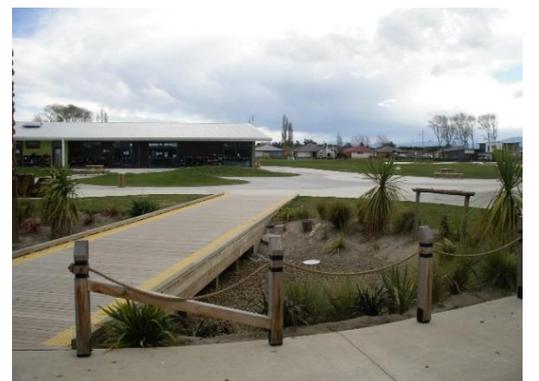
- Roof pitches which carry the rainwater to external gutters and downpipes decreasing the likelihood of internal leaks. See Figure 24.
- High level natural light provided by roof level ribbon windows. See Figure 25.

- Good provision for both bicycle and scooter storage.
- Water supply has adequate isolation valve systems that enable maintenance and alterations.
- Extensive use of landscaping to improve the visual appearance of the courtyard and provide water attenuation during heavy rainfall. Figure 25
