# POST OCCUPANCY EVALUATION

## TE KURA KAUPAPA O WHANGAROA, MATAURI BAY, NORTHLAND

Date: November 2015  
Reference: 1-46083.00  
Status: Final Rev 05

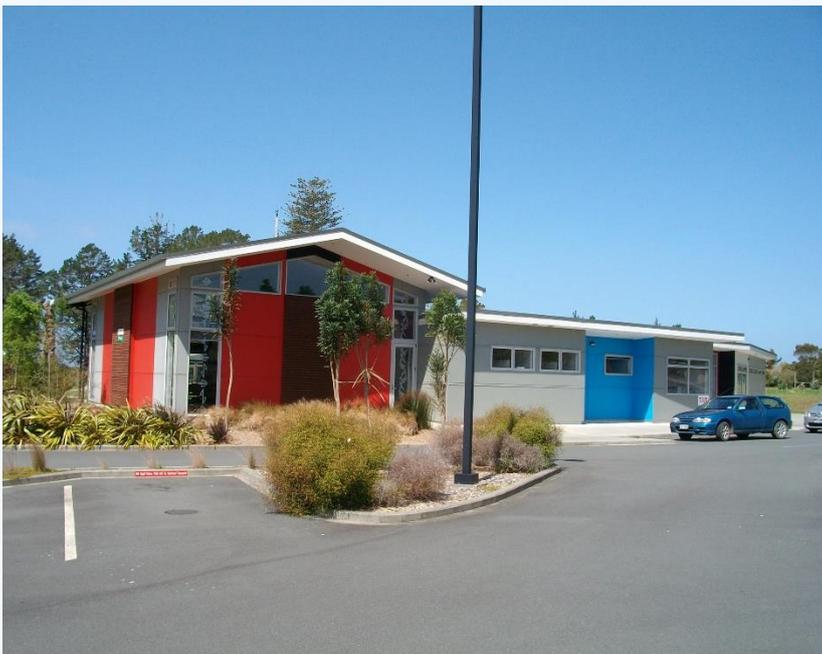
- The main entrance located adjacent to the road intersection is welcoming with an in out horseshoe arrangement for controlling traffic flow. See Figure 3 and Figure 4.

- Car parking is well located within the main street entrance area. See Figure 3 and Figure 4.
- The school reception is located in the building adjacent to the carpark, drop off point and footpath which is separate from the new development under evaluation in this report. Visitors register here before entering the rest of the site. See Figure 3.

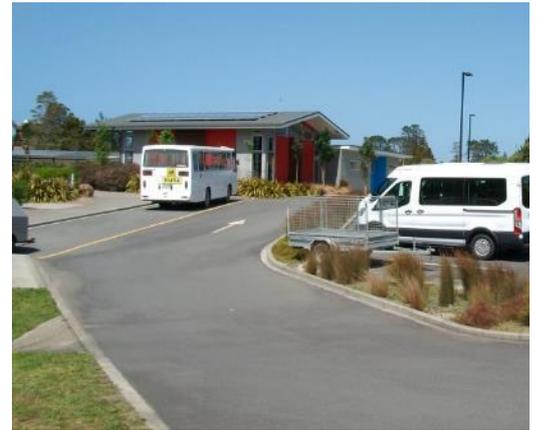
Figure 4

- Signage for the school is effective and well located, being visible easily from the main road. See Figure 5.
- Visitor car parking and drop off area is contained within the school boundaries and is in close proximity to the main entrance. See Figure 3 and Figure 4.

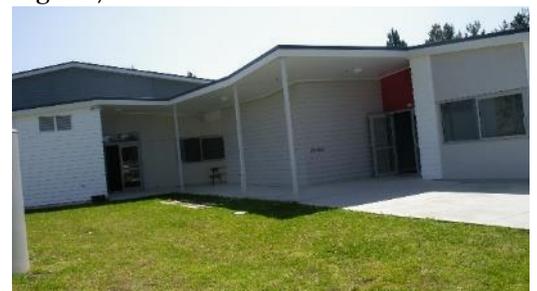
Figure 8

- Main building entrances are generally well protected from the weather. See Figure 8.
- General circulation around the school works well for all users, according to staff. The building entrances<sup>2</sup> are generally located well for circulation.

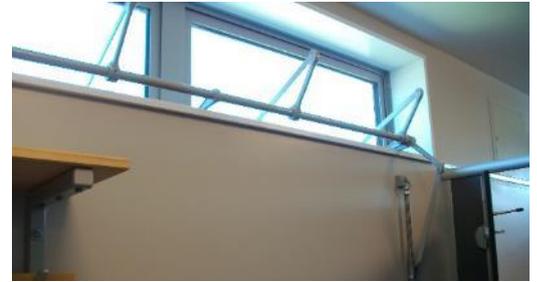
Figure 9

- Windows controls and other operable systems within the school are easy to use. Windows and ventilation are generally manually operated and easily accessible with remote winding top hung casements and sliding sash windows. See Figure 9.

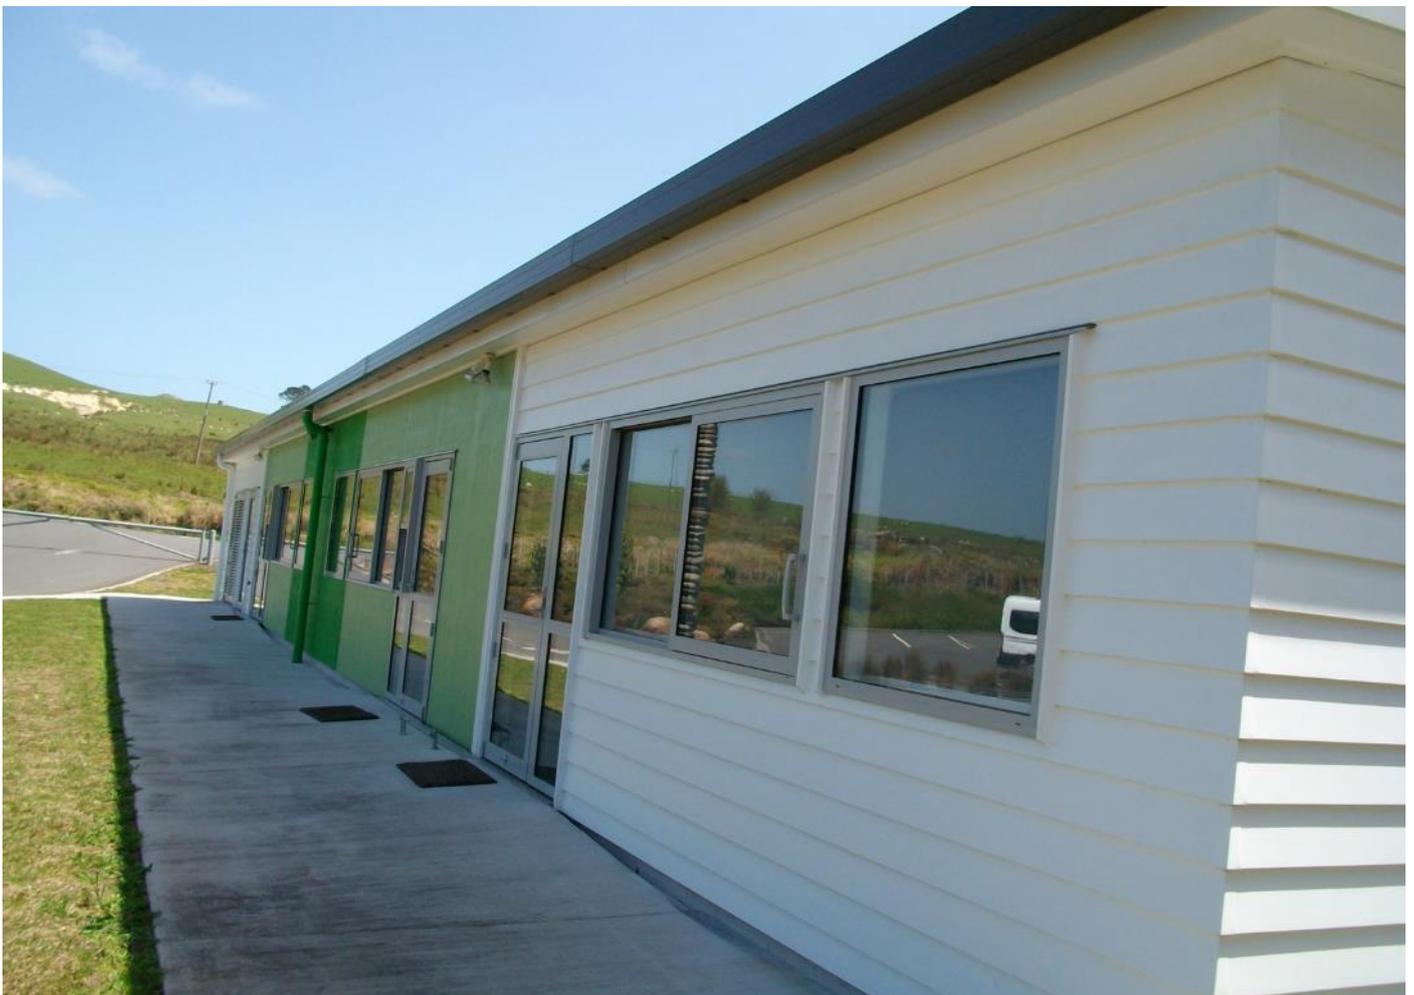
Figure 11 - Paths laid to shallow gradients to provide level threshold access.

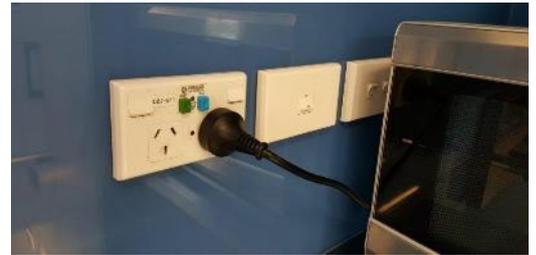
Figure 17

- Perimeter lighting is very good. School is well lit on approach. Car park is well lit. See Figure 18.
- General power outlets are in appropriate locations as required for classrooms and administration areas and have 10mA protection. See Figure 17.

- Power outlets have also been installed above bench levels where necessary to facilitate access and use. See Figure 17.
- Services have been installed such that they are secure and provide adequate protection for occupants. Electrical distribution boards are located either within service cupboards or positioned in staff areas with lockable handles.

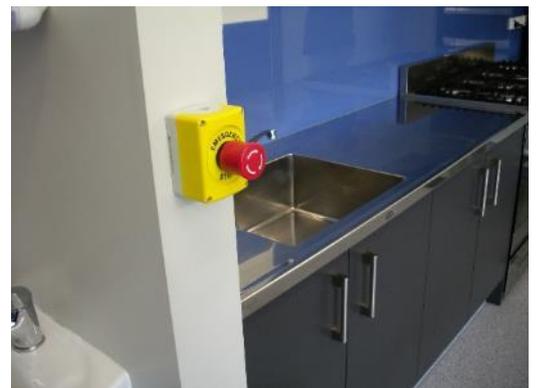
- An emergency power cut off switch has been installed in the kitchen/food prep area. See Figure 19
- The Main Switchboard is safely located in a service cupboard with locked external access. See Figure 21.

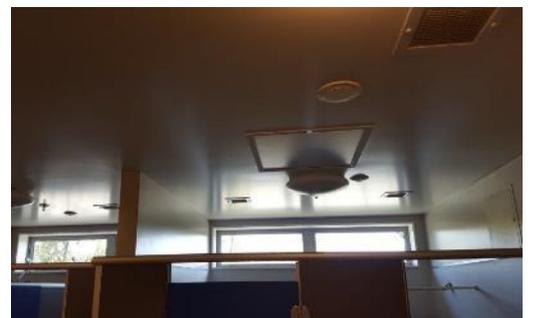
- Toilets have mechanical ventilation installed in addition to natural ventilation. The toilets are all mechanically ventilated with motion sensors/ light switch delay timers. Opening windows are also installed. See Figure 20

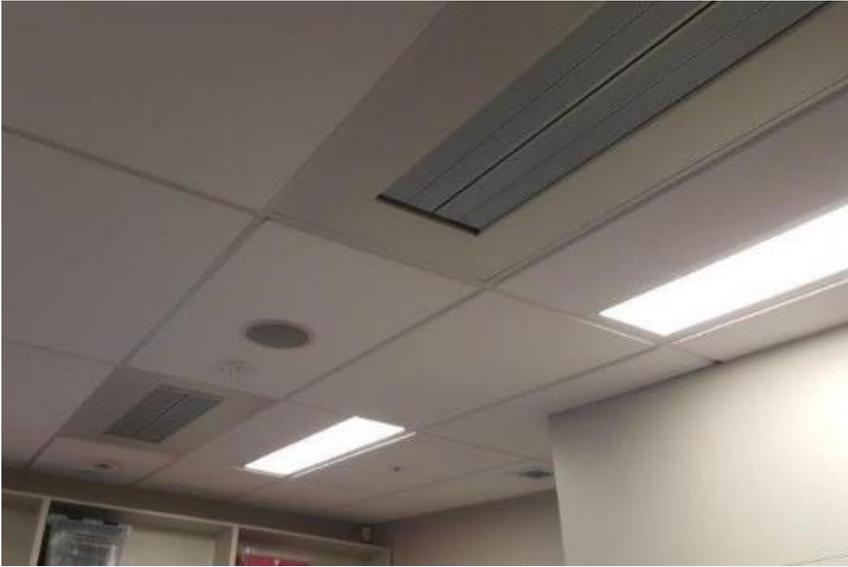
Figure 16

- The heating system is based primarily on ceiling mounted electric radiant heaters, which are out of reach of students and staff and local controls are provided. The heating system can also be overridden off remotely from the respective electric distribution boards. See Figure 16.

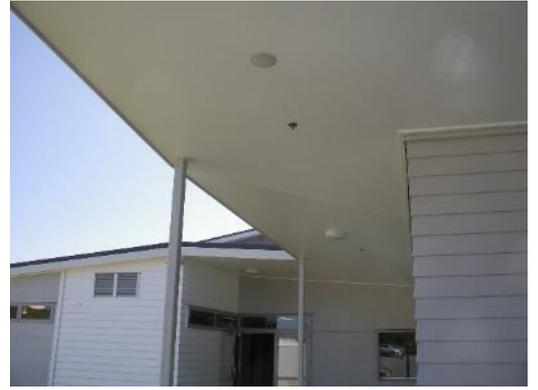
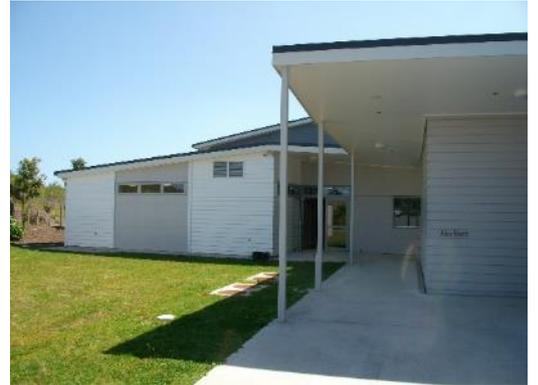
- There is a covered area between the two new blocks to allow sheltered access between blocks. See Figure 25 and Figure 26.
- The hard and soft landscaping compliments the surrounding natural environment, its topography, texture and scale.

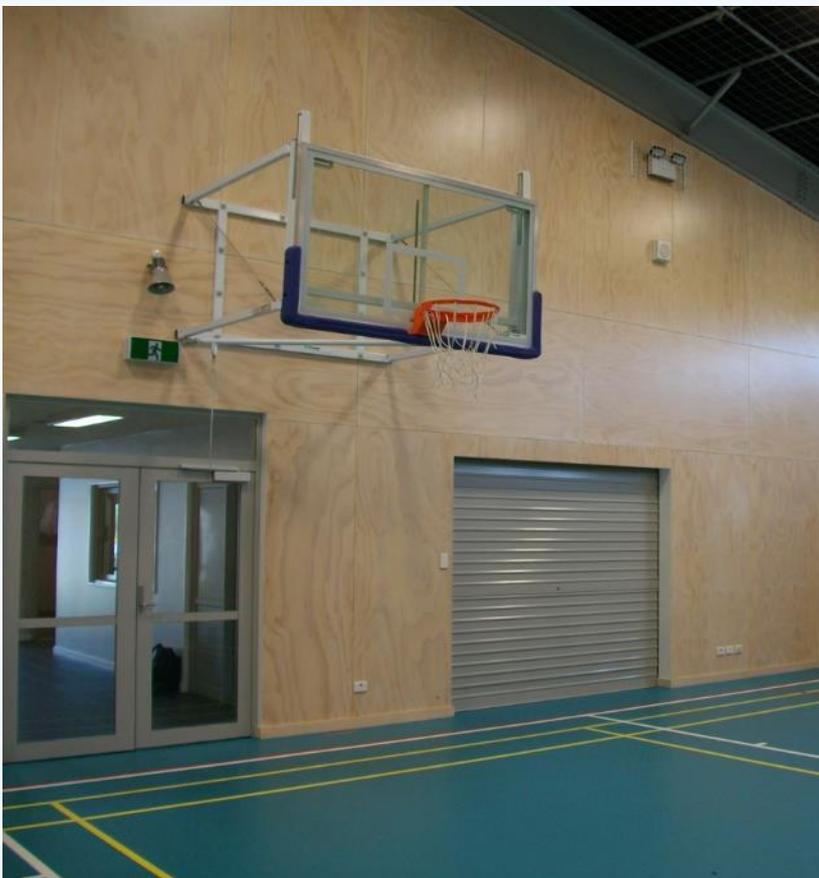
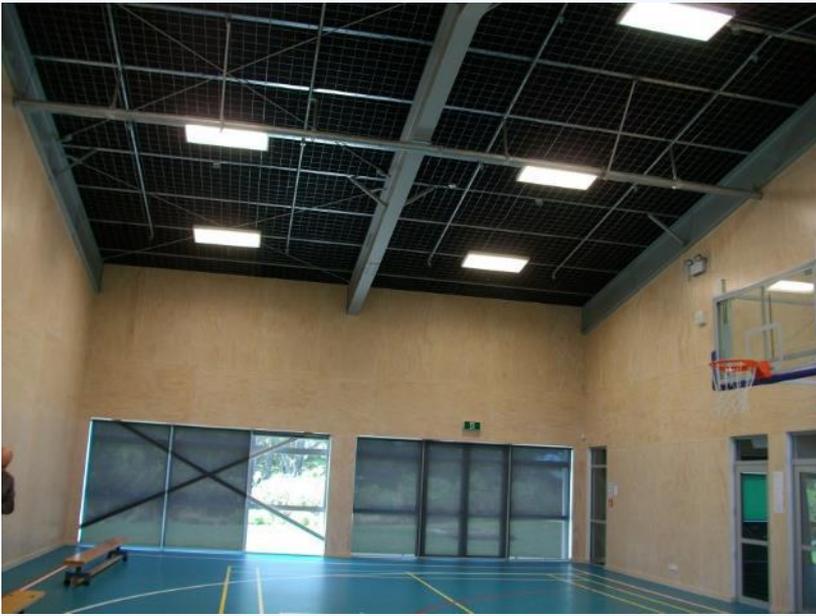
- Block 01: Wet areas have been provided within the art and food technology rooms.
- Block 02: The indoor gym area is highly specified with quality finishes and workmanship evident. The flooring is of exceptional quality. The space is mainly set up for basketball. Figure 23 and Figure 24.

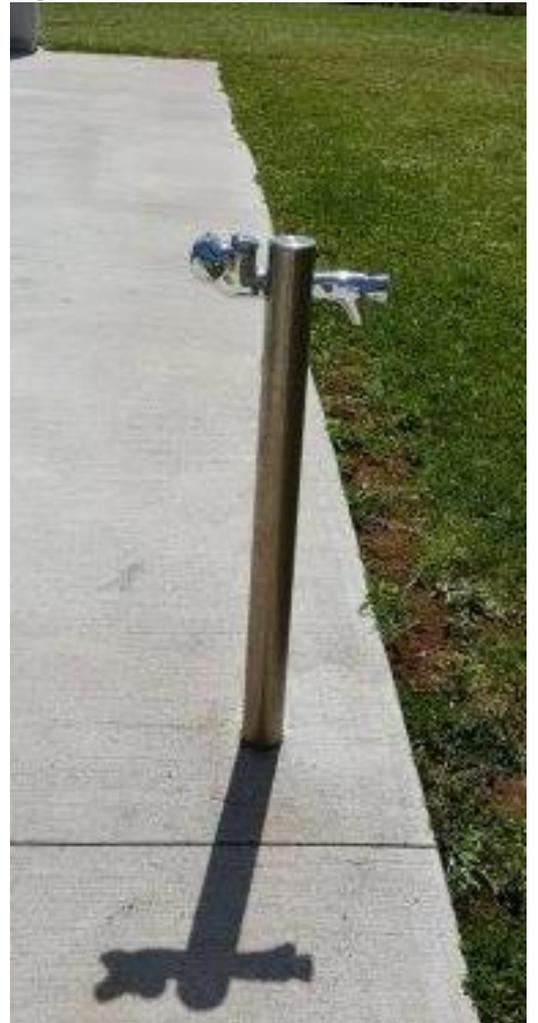
Figure 27

- Drinking fountain and tap provision is sufficient are well positioned. See Figure 27.
- Staff viewed the areas for display of student work as well provided for.

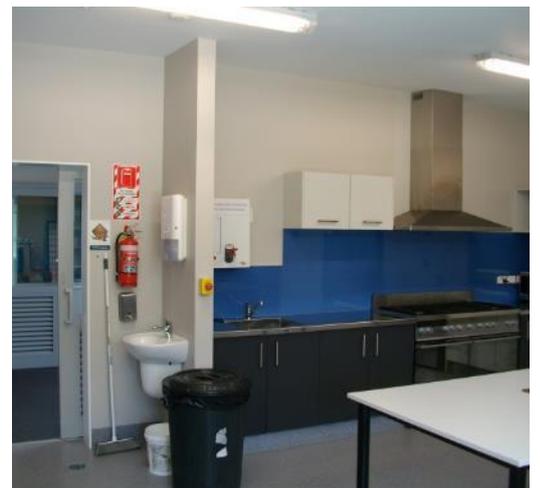
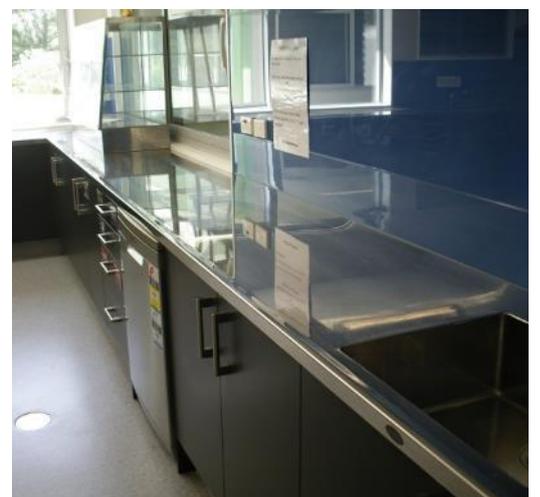
- Food technology area was highly specified and quality finished. See Figure 30 and Figure 31.

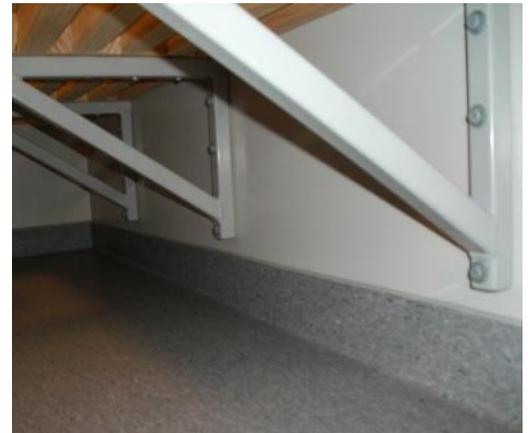
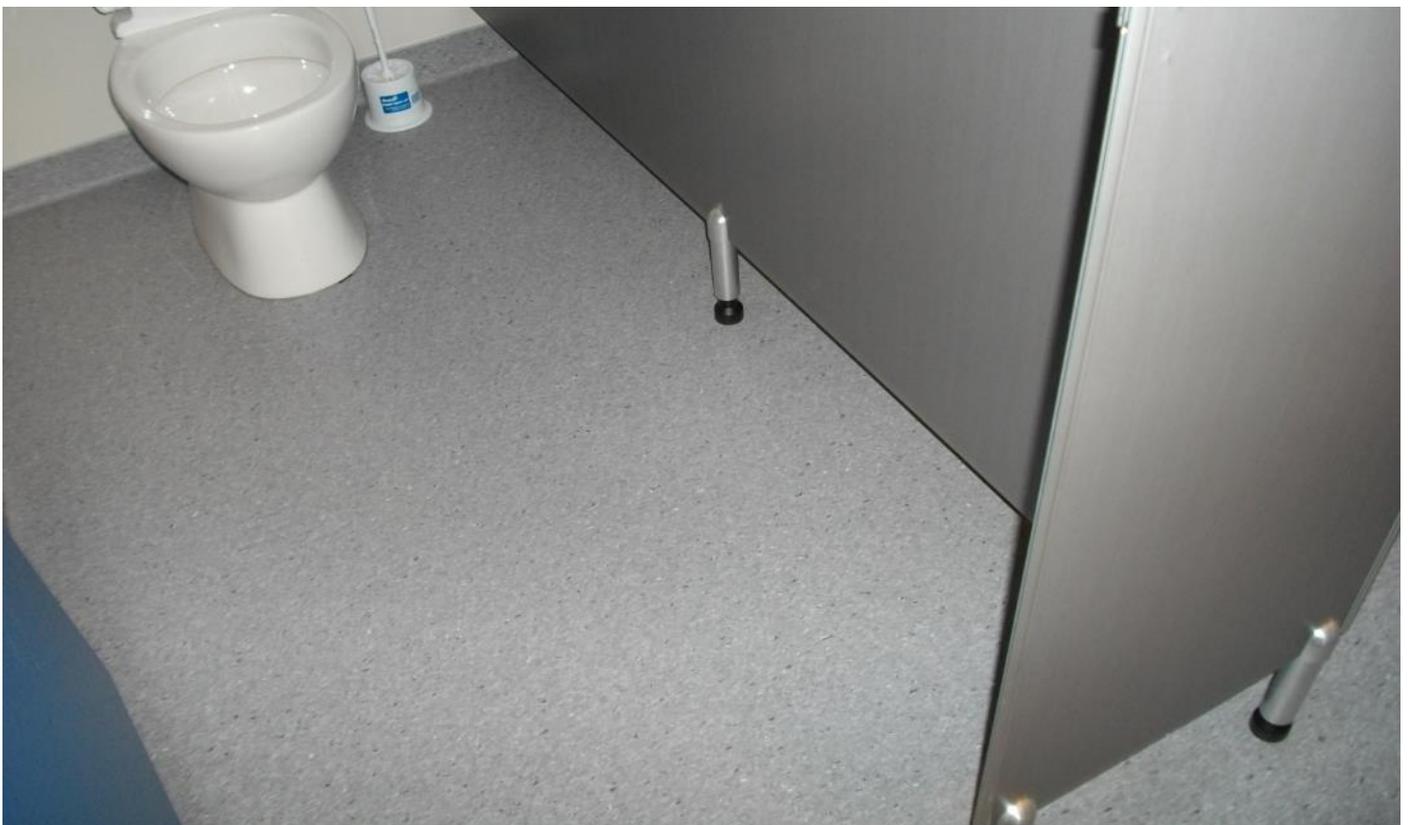
- Hot water is available where required. Heat pump type pressure hot water cylinders are installed with auxiliary heating elements. Two heat-pump type cylinders are provided in a circulating loop which should give excellent energy efficiency.
- A combination of natural and energy efficient artificial lighting systems has provided effective lighting levels for the relevant task to each area. Lighting levels were measured at about 320-400 lux in the teaching spaces with about 850-920 lux in the gym. Lighting is primarily fluorescent throughout.
- Block 02: WC/changing rooms. Very high quality, some of the best we have seen in a school development. Robust and well designed. See Figure 32 to Figure 36.
- Block 02: Changing wet areas have been designed so that they are easy to clean. Fixtures have been wall mounted to allow for easy cleaning. See Figure 33 and Figure 34.

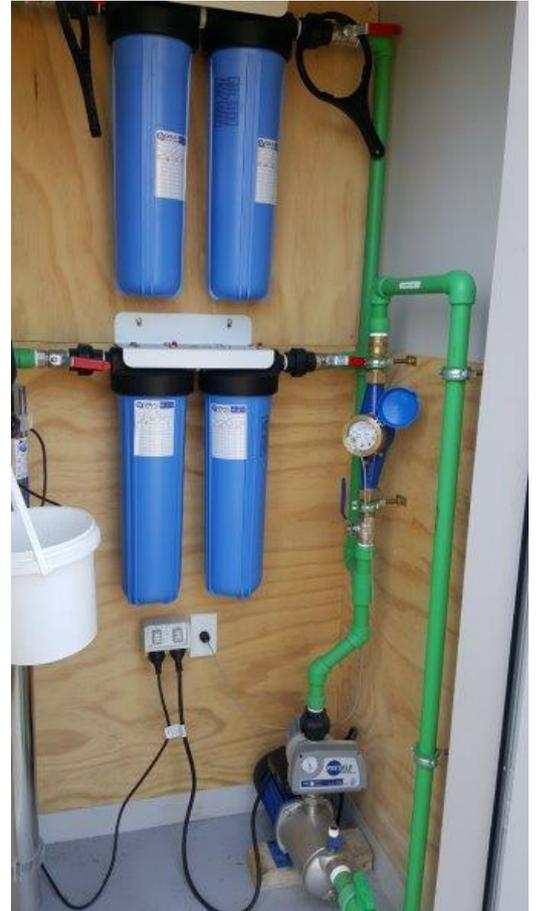
Figure 43

- The heating system is zoned and is controlled via thermostats in each room.
- The school makes use of roof-collected rainwater, which is stored in tanks on the school grounds. No issues with quantity of supply. Opinions vary among staff with regard to water taste. Water is filtered and treated with UV light. See Figure 43.

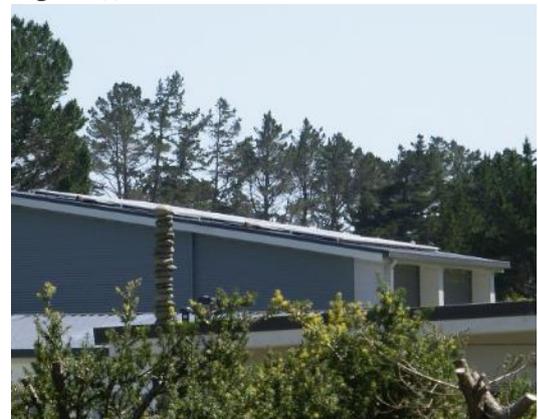
Figure 44

- There are Photo-voltaic (solar power) cells for energy generation on the roof of the gym. See Figure 44.
- The heating is electric, with ceiling mounted radiant heaters which staff have found to be effective. Staff also advise that they find the system to be very complicated, and that anecdotally the local service technician struggles to comprehend its operation.

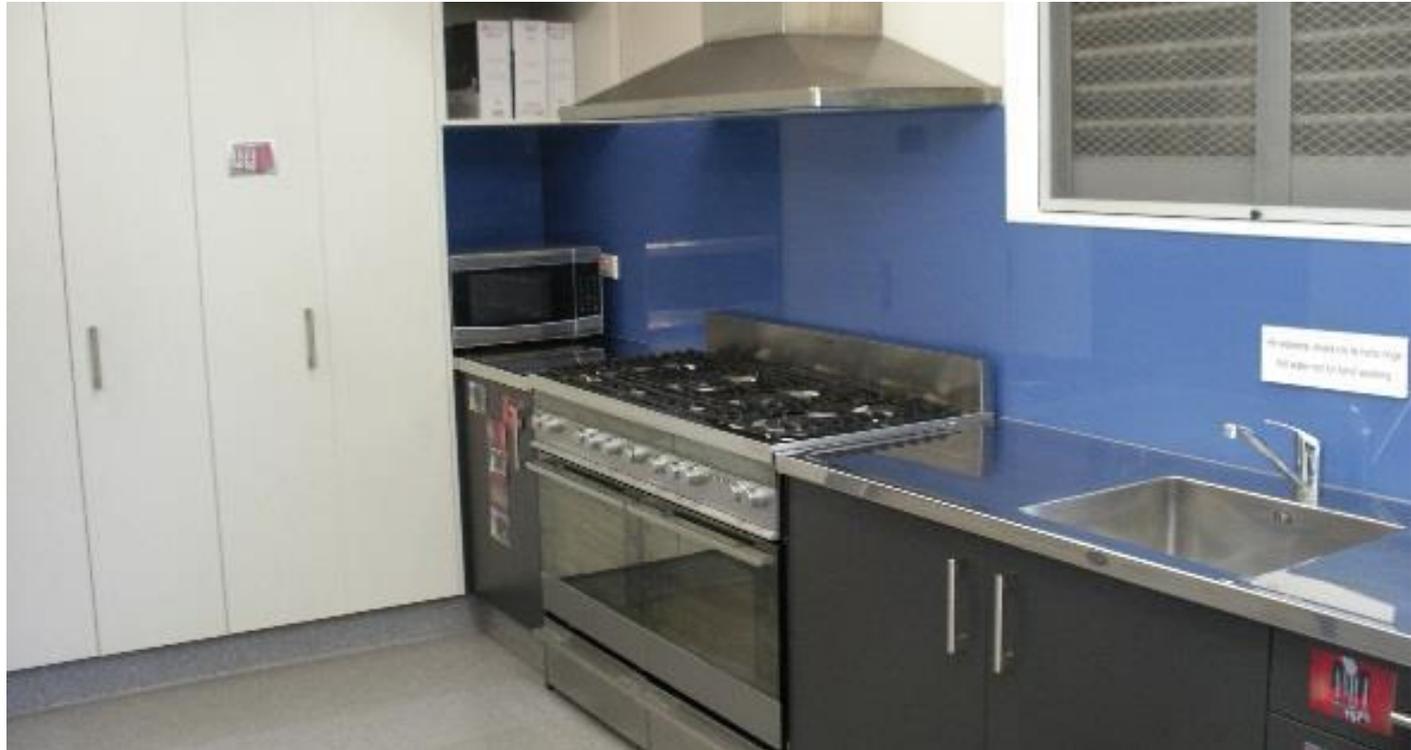
Figure 47

- Materials and finishes in the food technology area are durable and high quality. The stainless steel benchtop and sink are a good example of this. See Figure 47.
